John Stempien, PhD

TRISO Fuel PIE Technical Lead
Idaho National Laboratory

2023 AGR-5/6/7 Compact Cross-Section Microscopy

DOE ART Gas-Cooled Reactor (GCR) Review Meeting

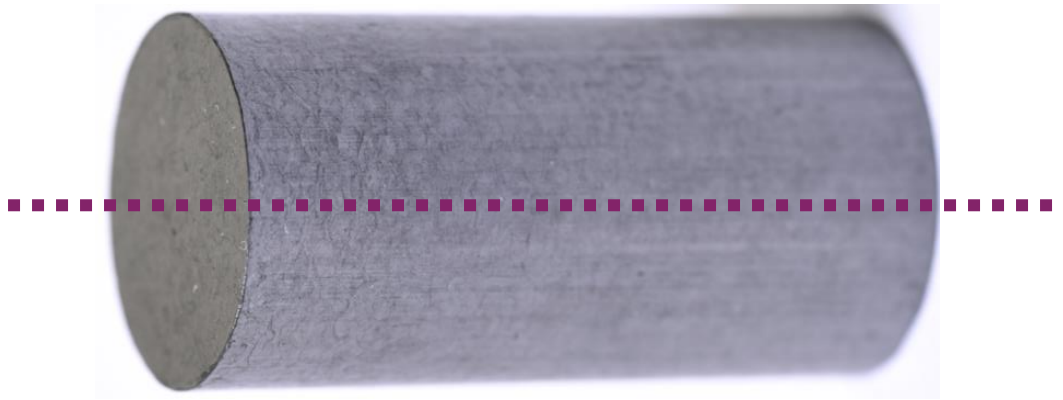
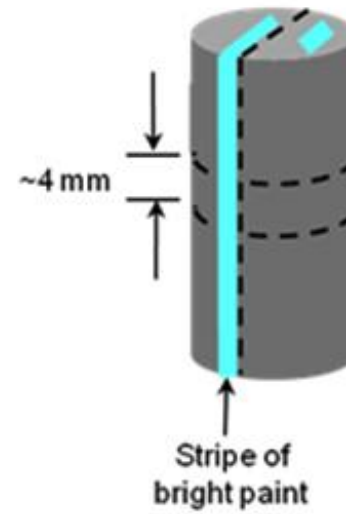
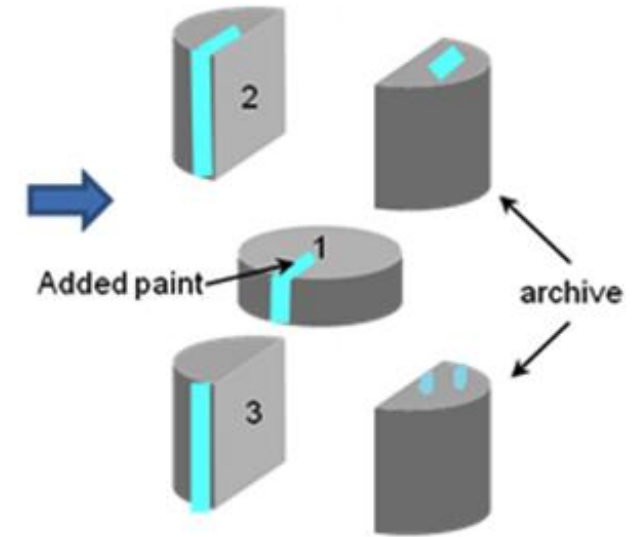
Two Styles of Sectioning Were Used

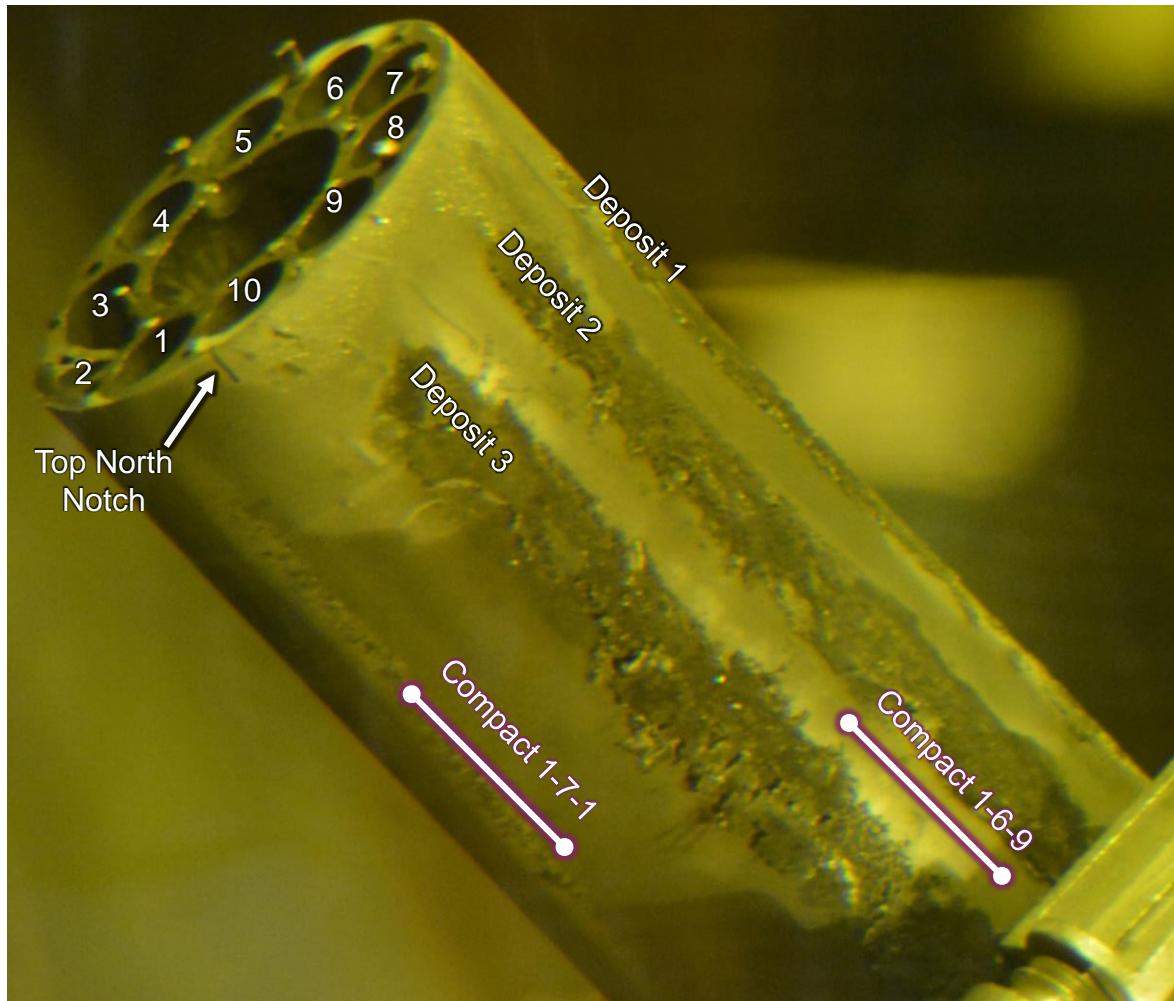
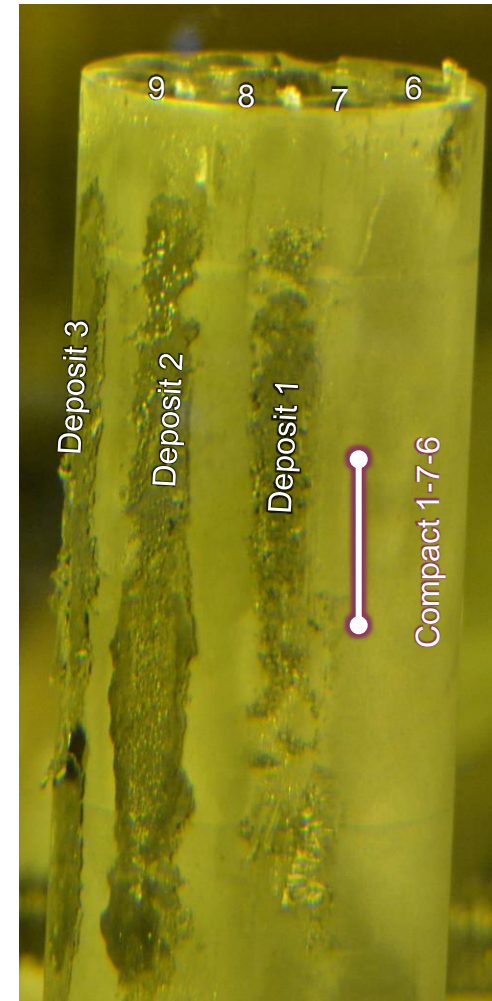
Capsule 1 Compacts Chosen for Proximity to Ni Deposits on Graphite Holder Traced to Overheated Thermocouples

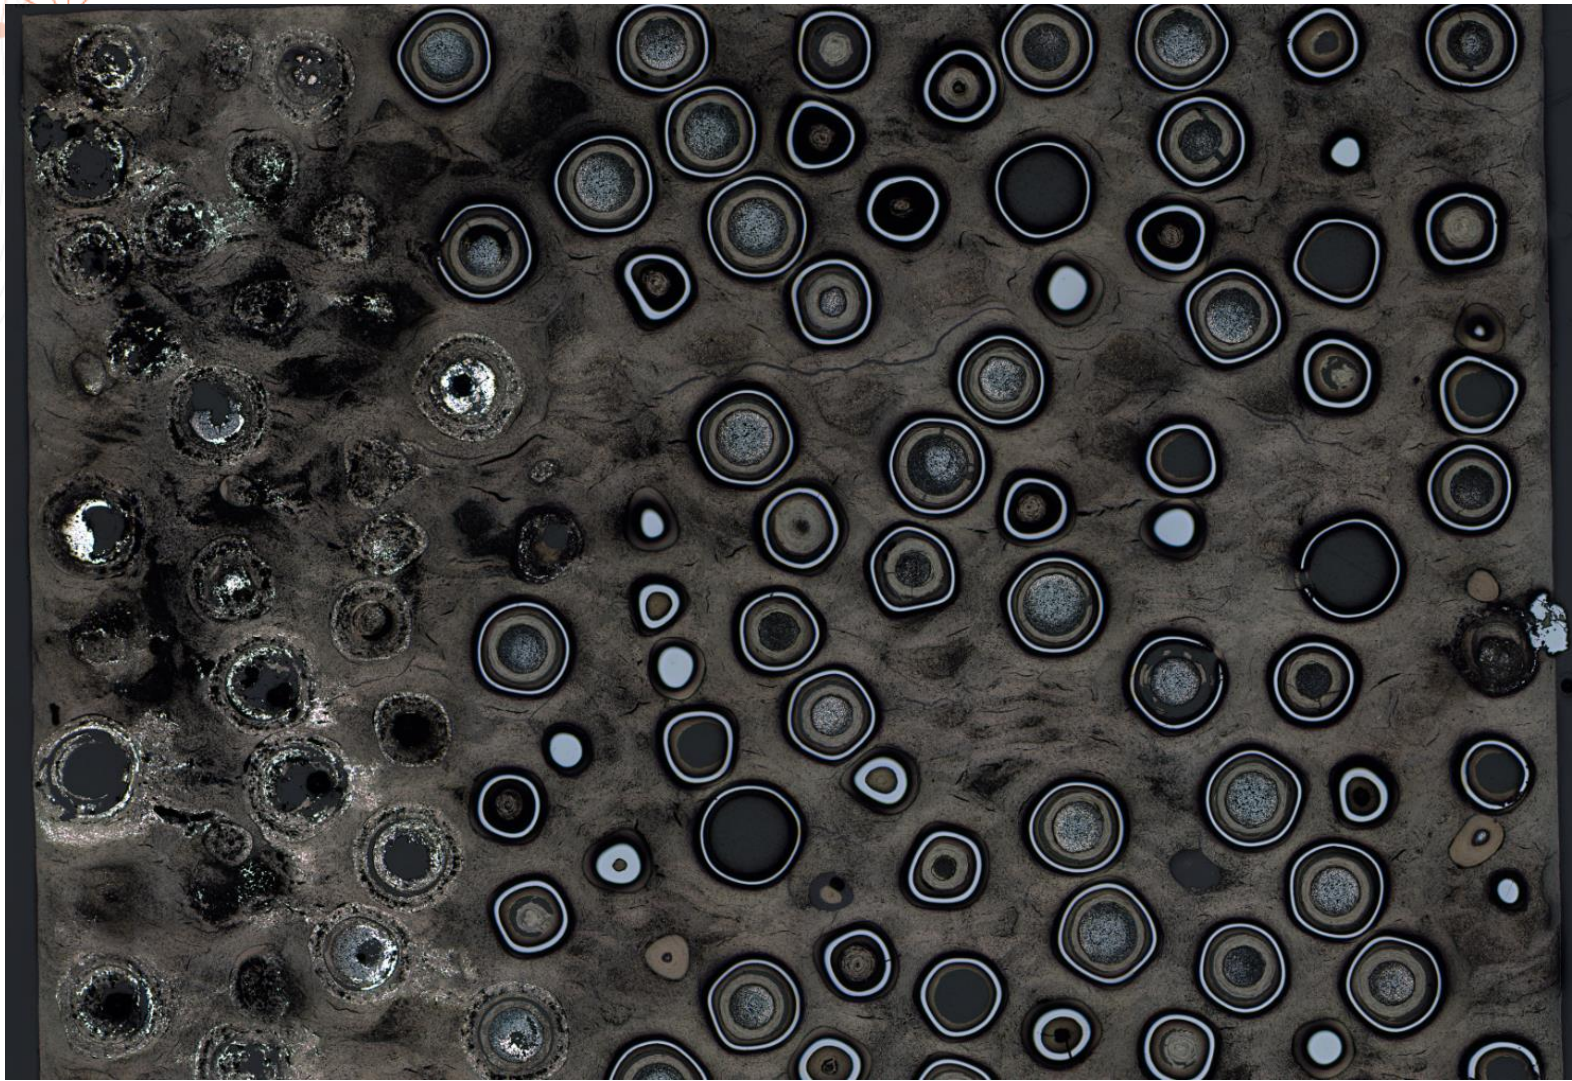
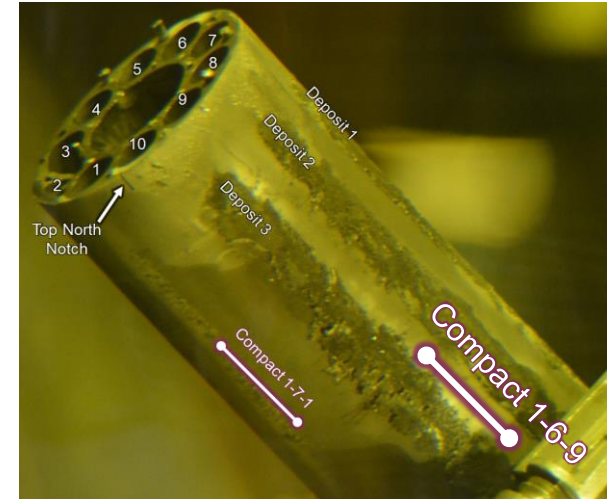
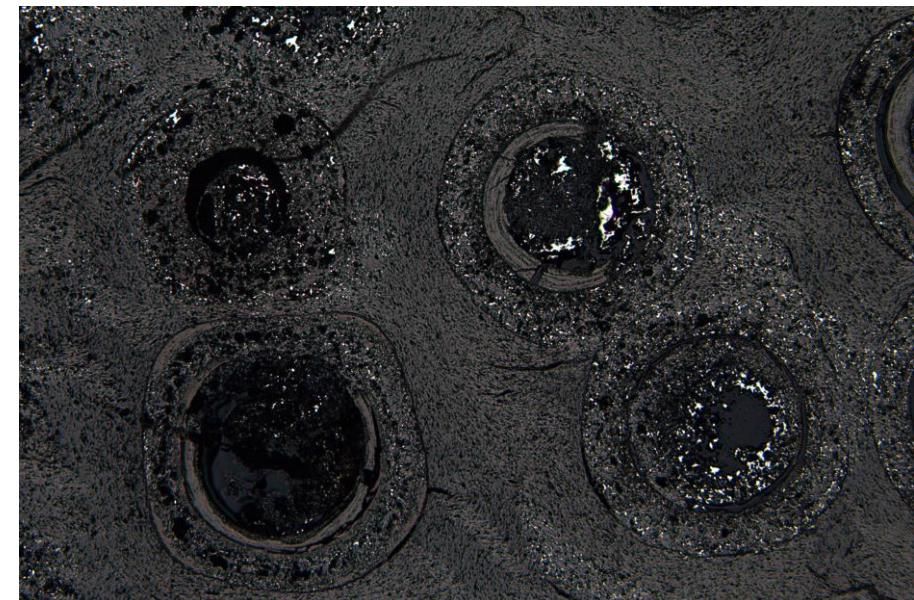
Compact Top

Bulk Foreign Material, Likely Ni, Found in Compact 1-6-9

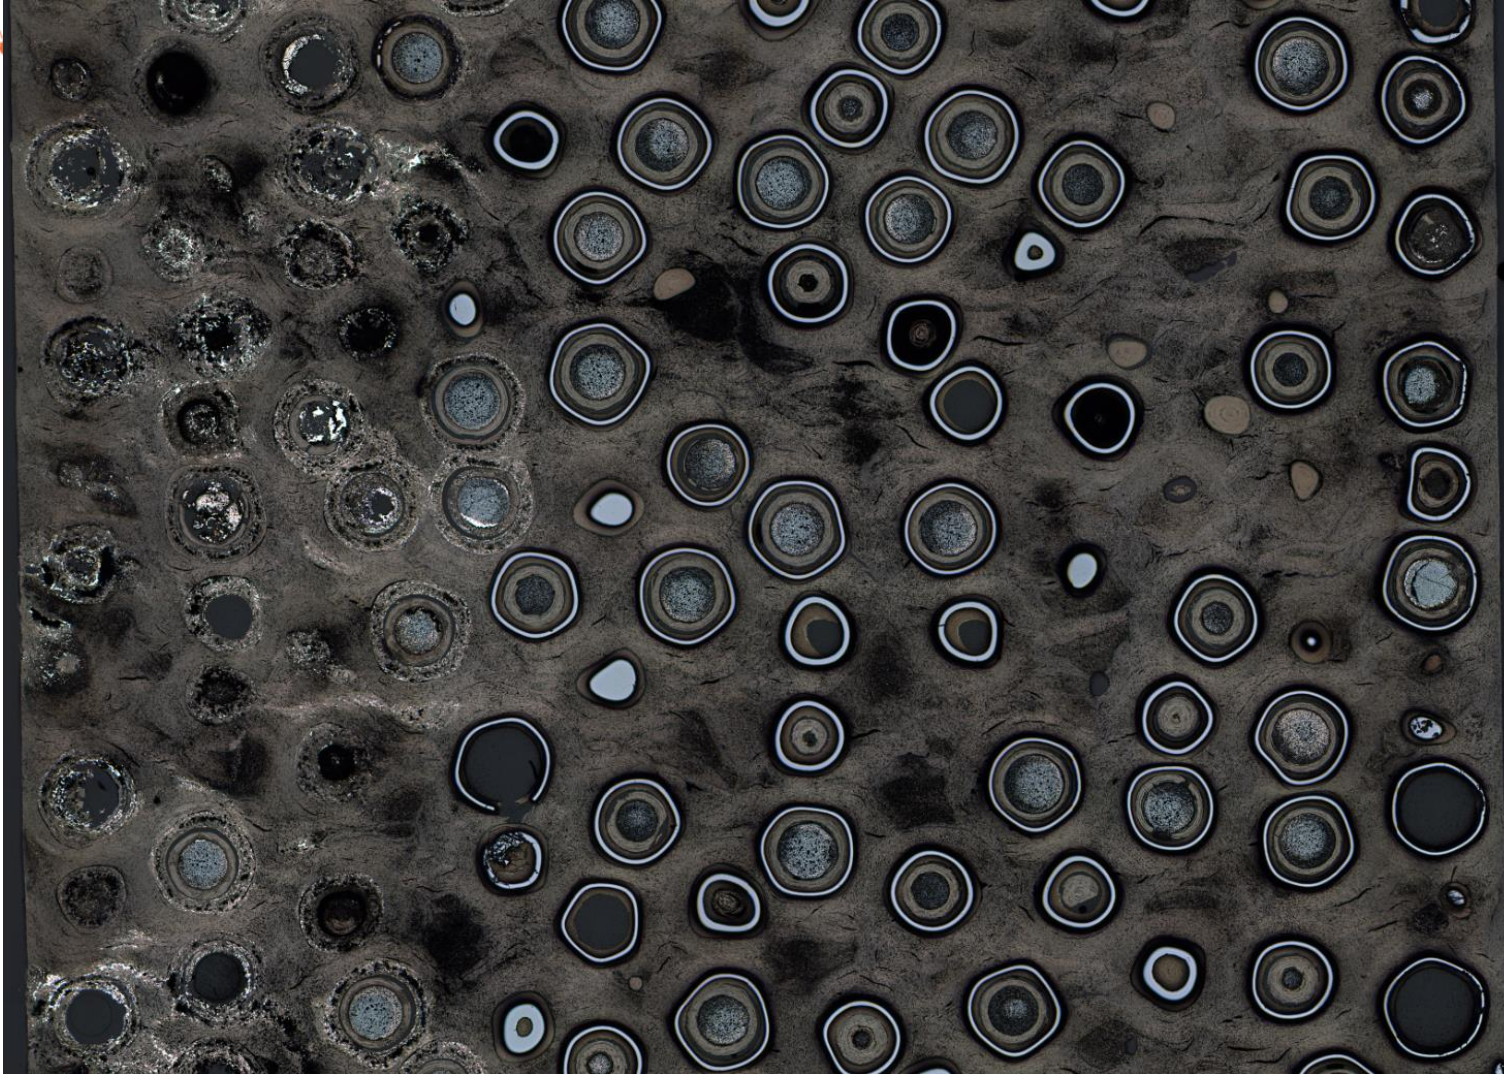
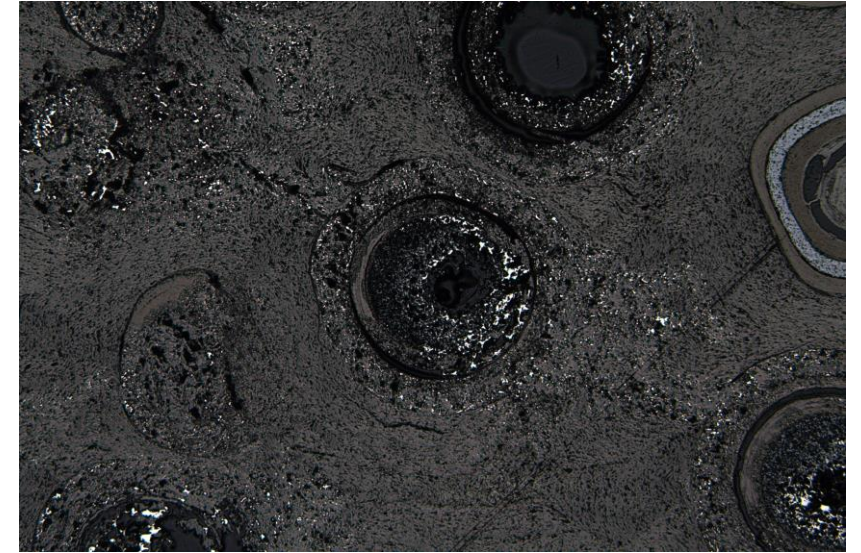
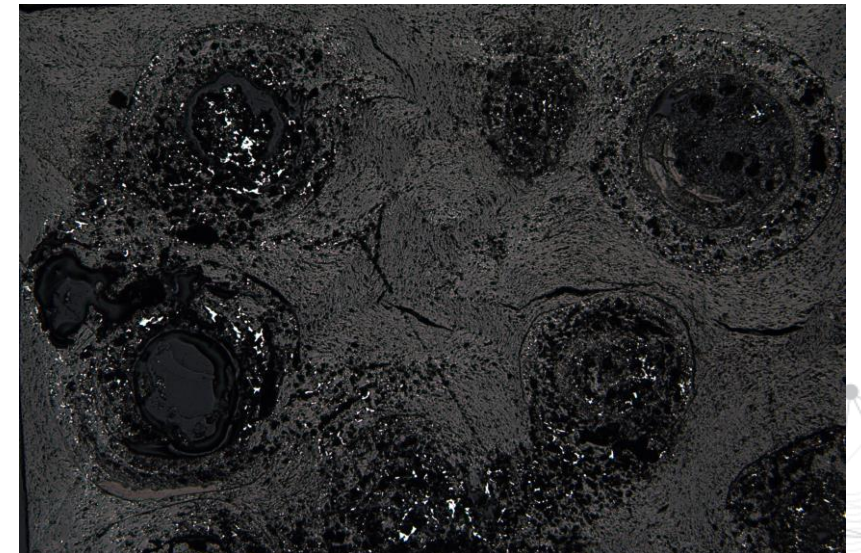
Compact Middle

Bulk Foreign Material, Likely Ni, Found in Compact 1-6-9

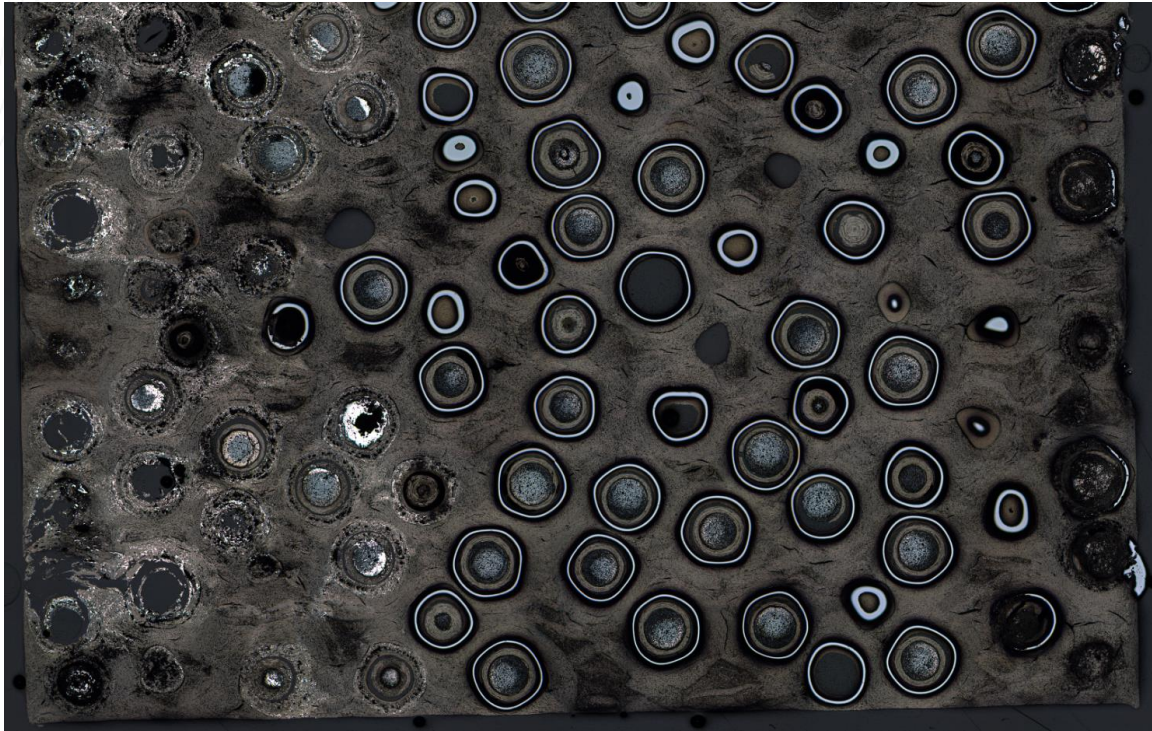
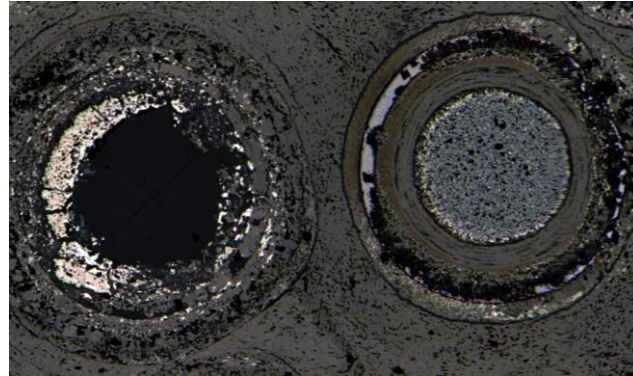
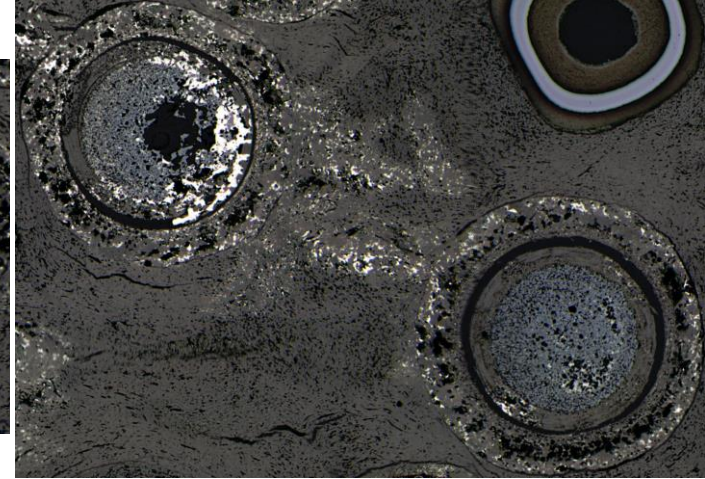
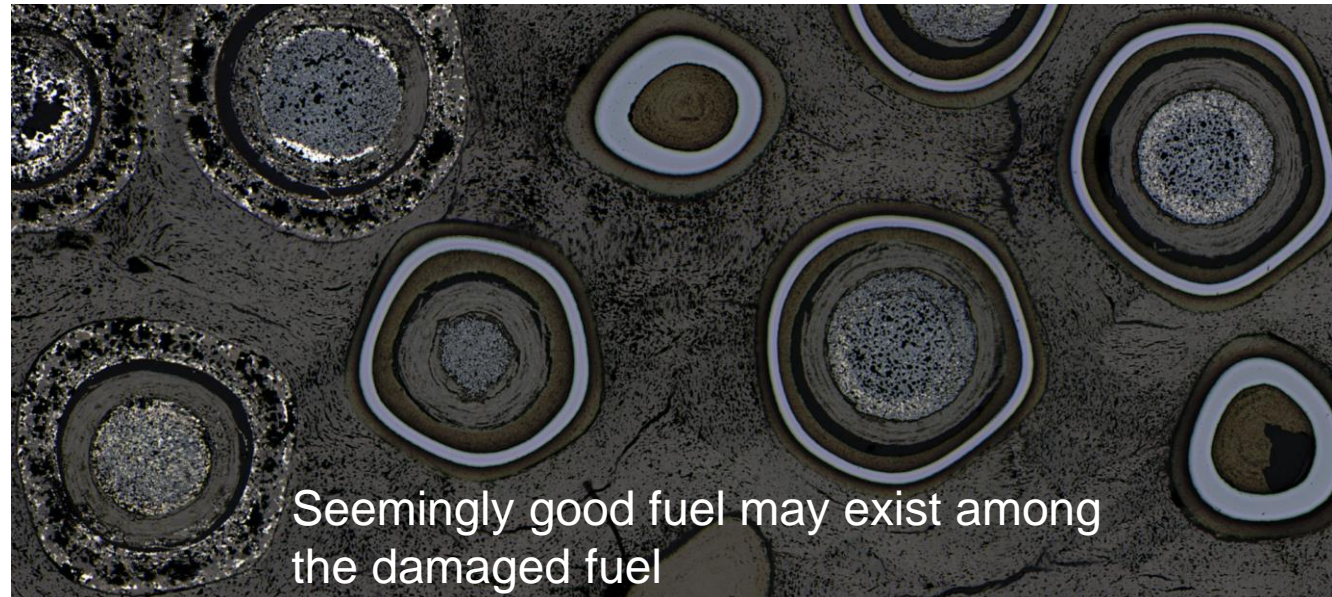
Compact Bottom

Bulk Foreign Material, Likely Ni, Found in Compact 1-6-9

Seemingly good fuel may exist among the damaged fuel

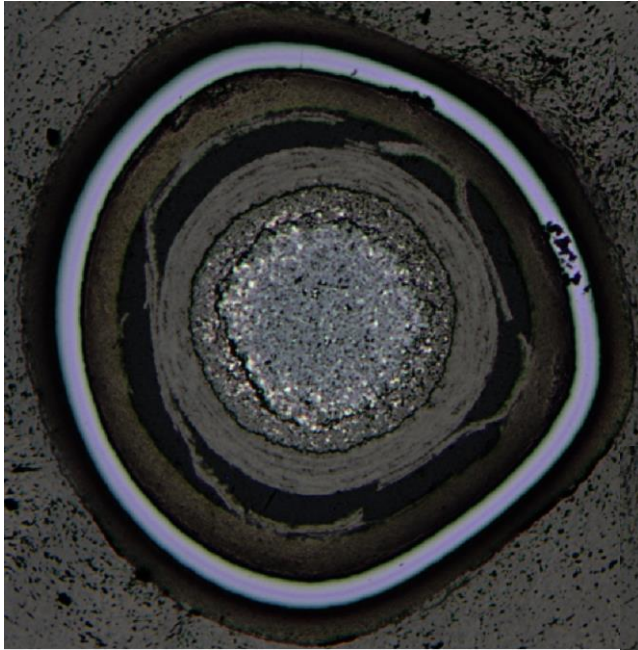
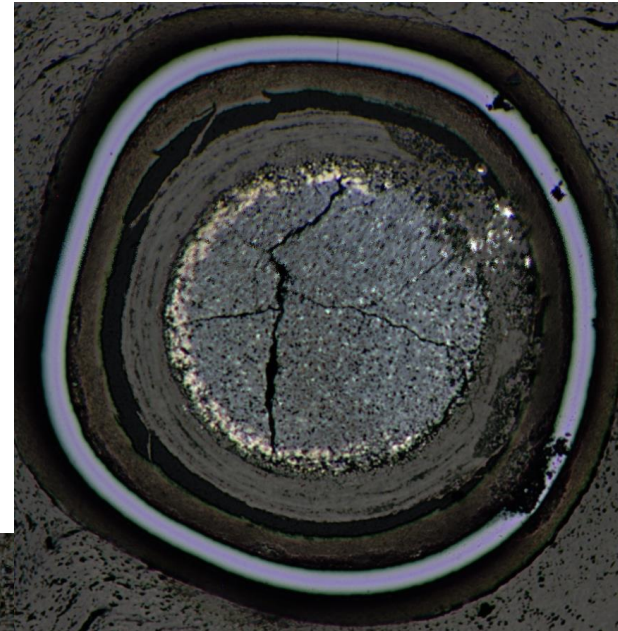
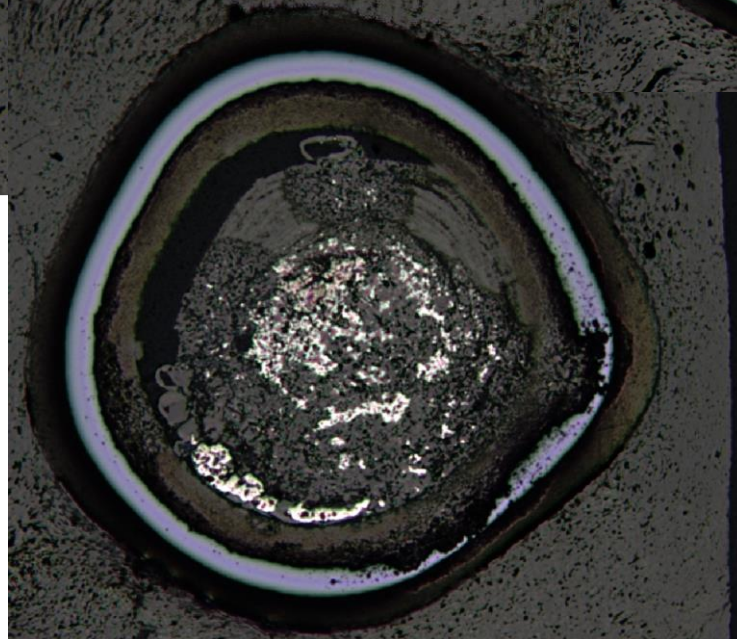
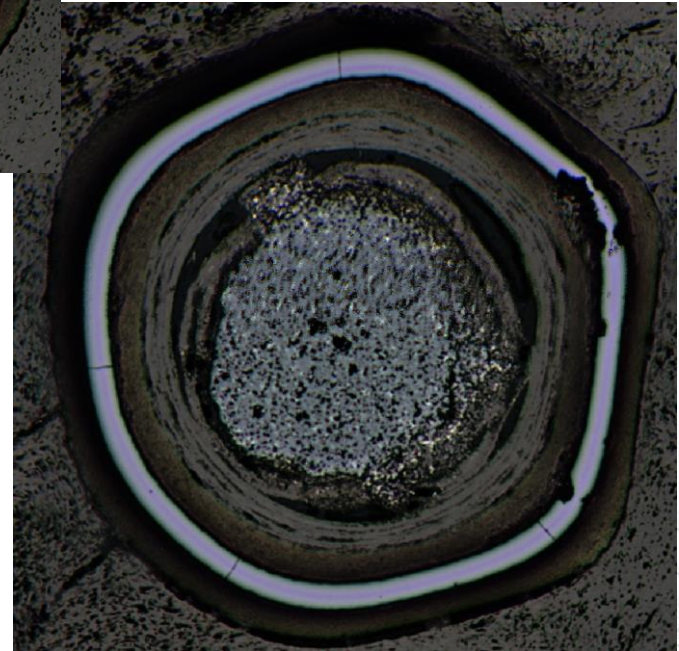
Compact 1-6-9: Directional Ni Attack Can Give Appearance of Inside-Out Attack

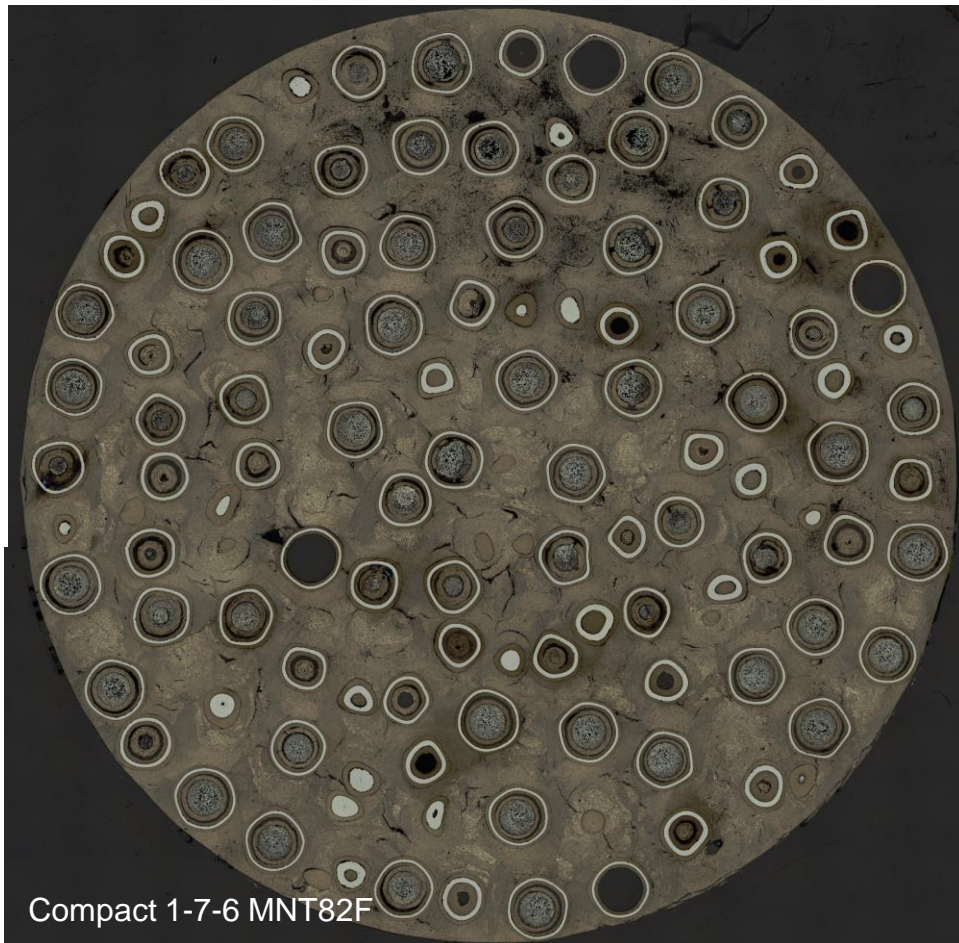
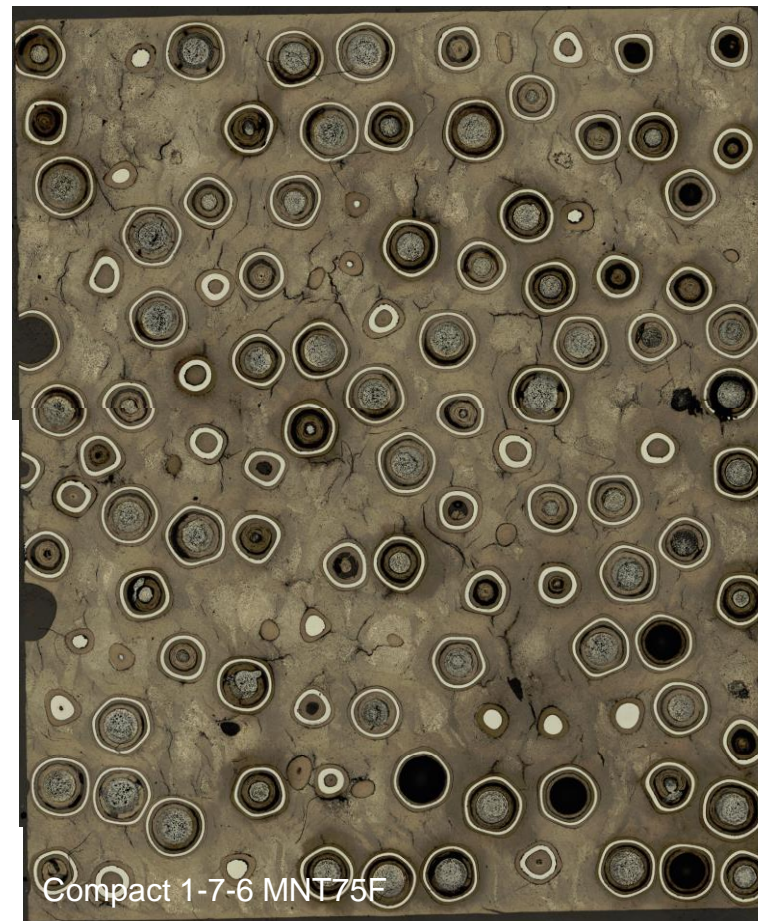
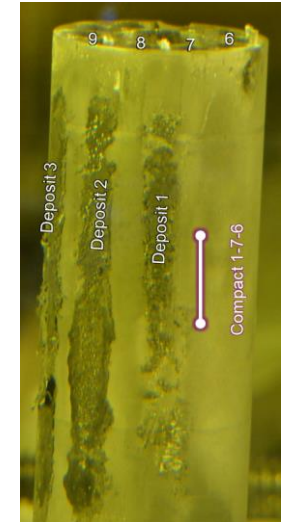
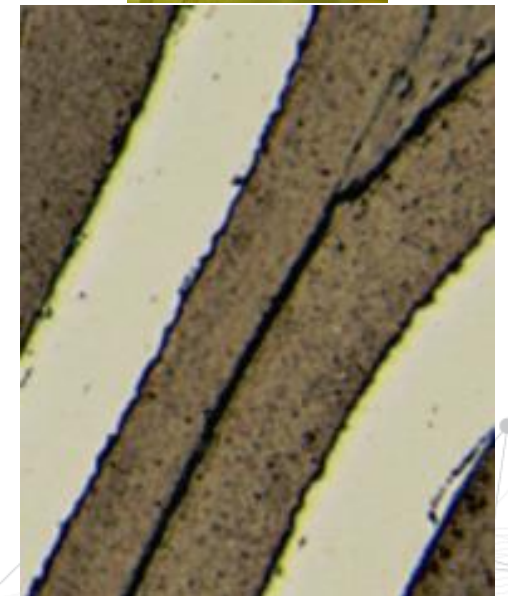
Compact 1-7-6 Shows no Visible Ni

- Very little buffer fracture
- Few small IPyC tears
- Particle-to-particle contact common with no obvious damage

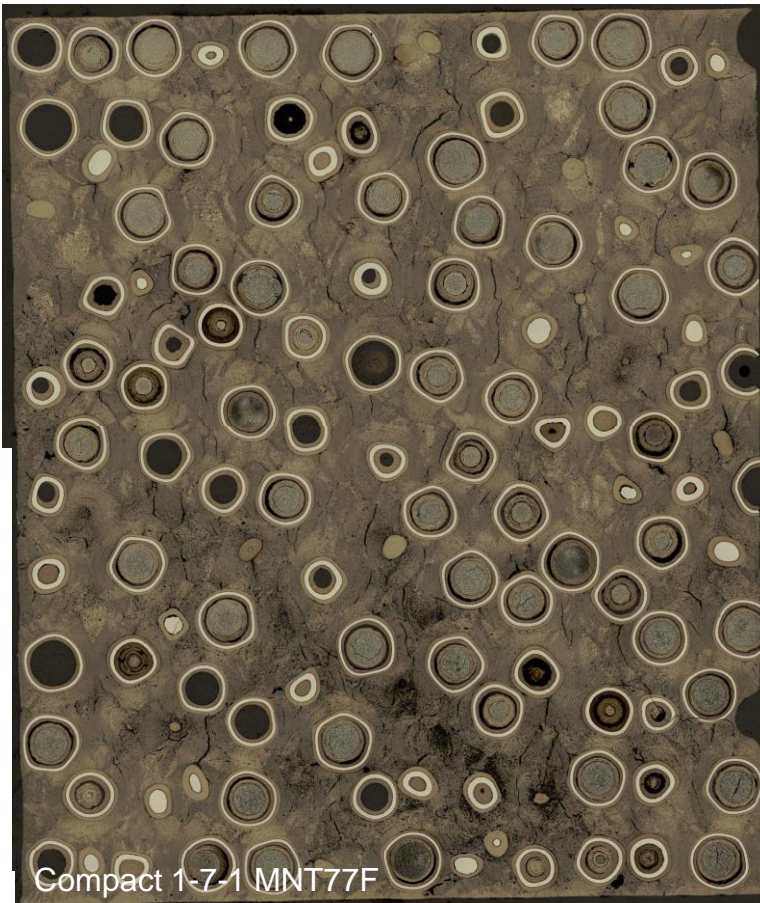
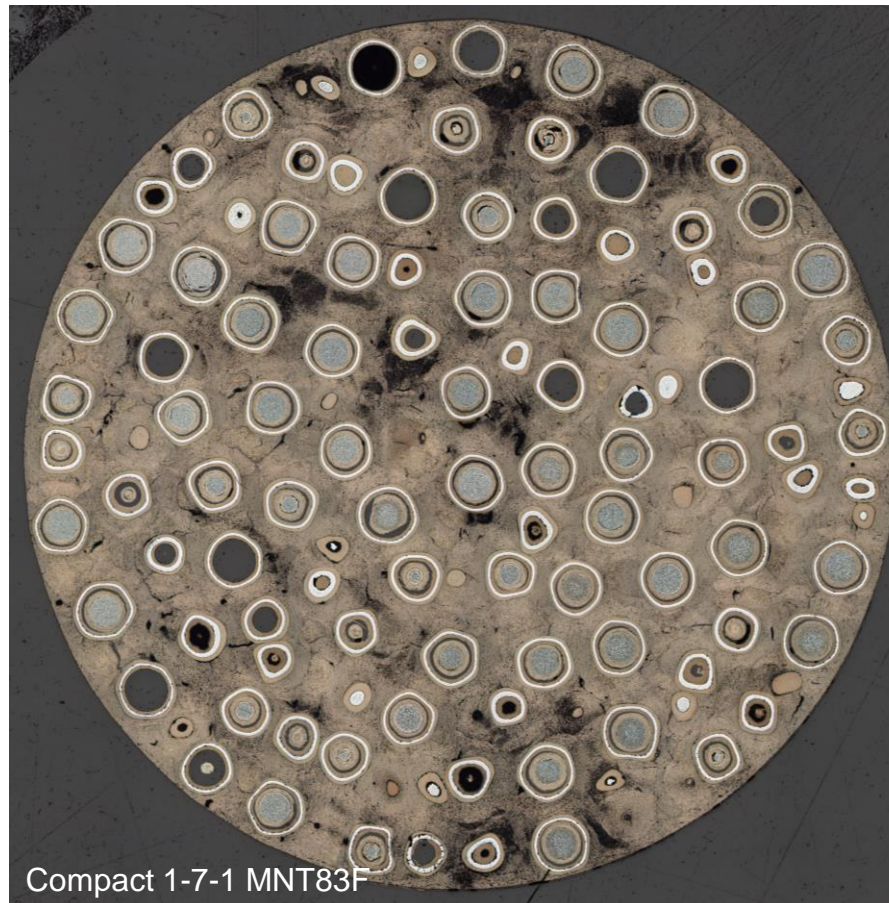
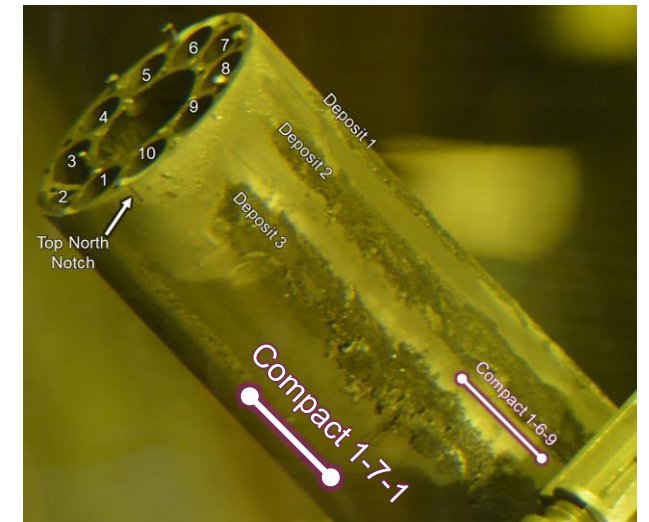
Compact 1-7-1 shows no signs of Ni

- Little buffer fracture
- No apparent IPyC tears
- Kernel morphology suggests fuel considerably cooler than 1-7-6 and 1-6-9

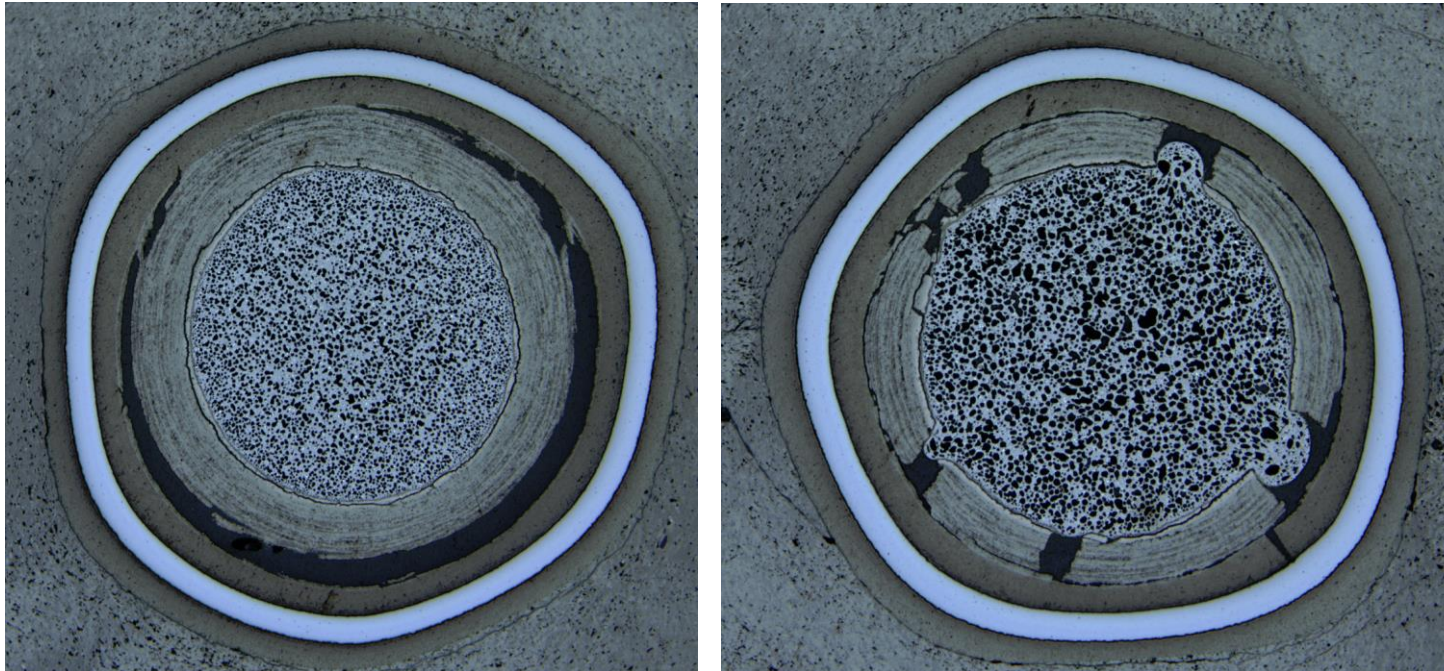
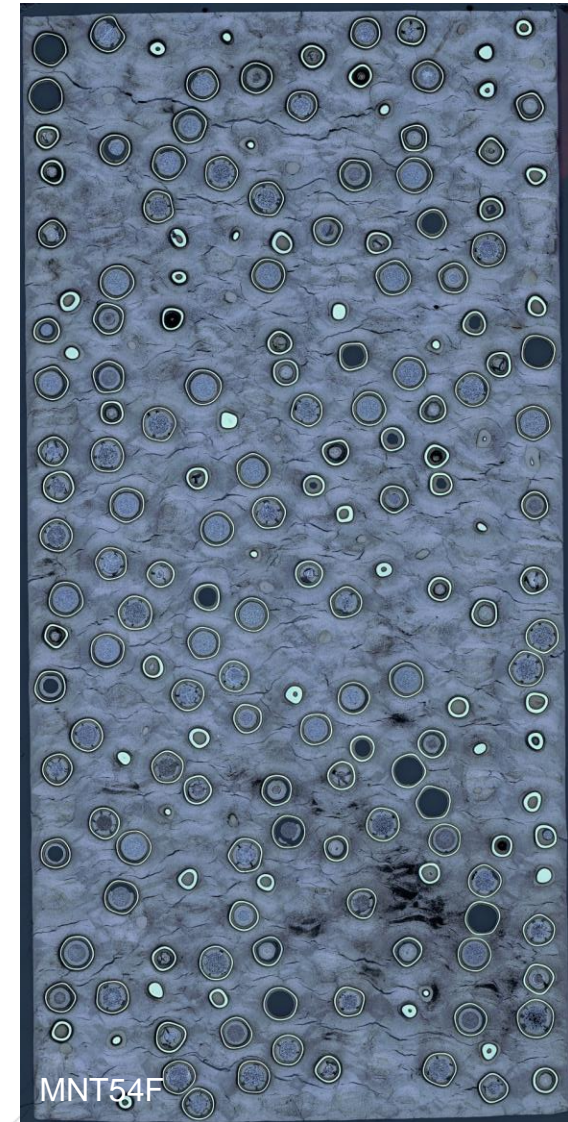
Compact 2-3-3

- Observed one IPyC fracture
- Occasional incipient tearing of PyC
- No apparent SiC degradation
- Buffer fracture common with multiple small fractures around circumference

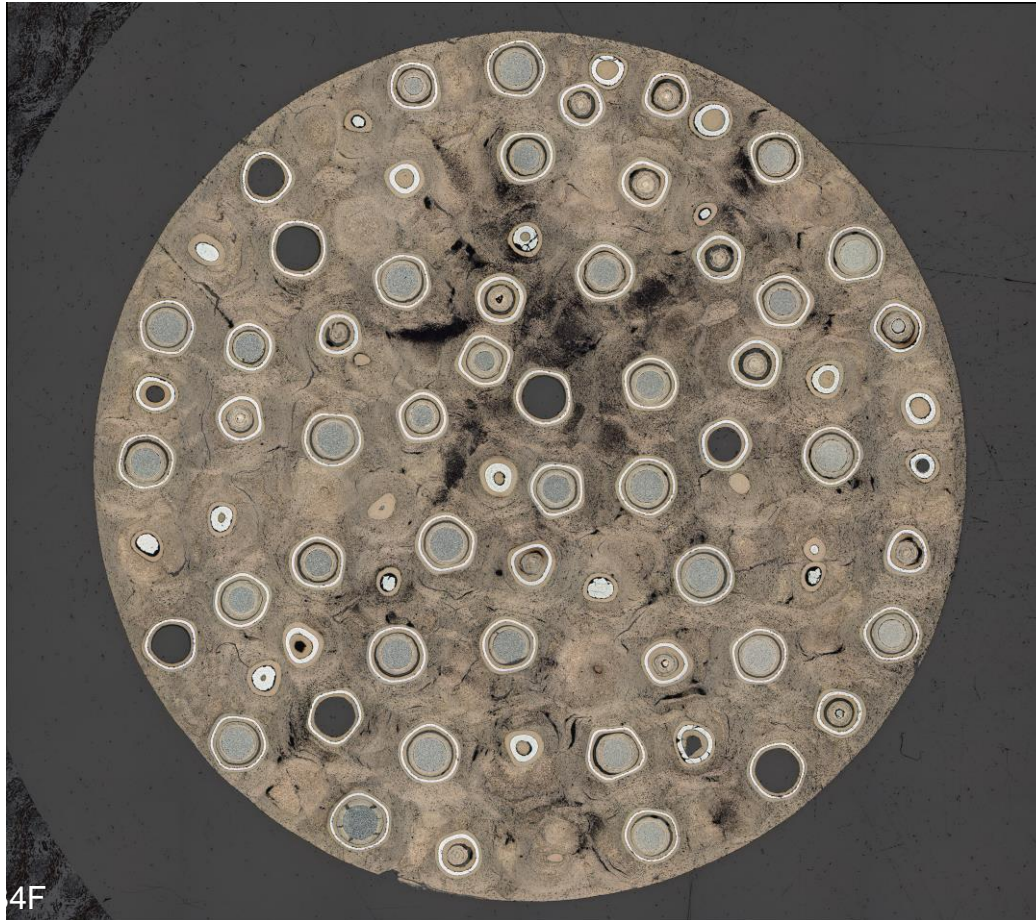
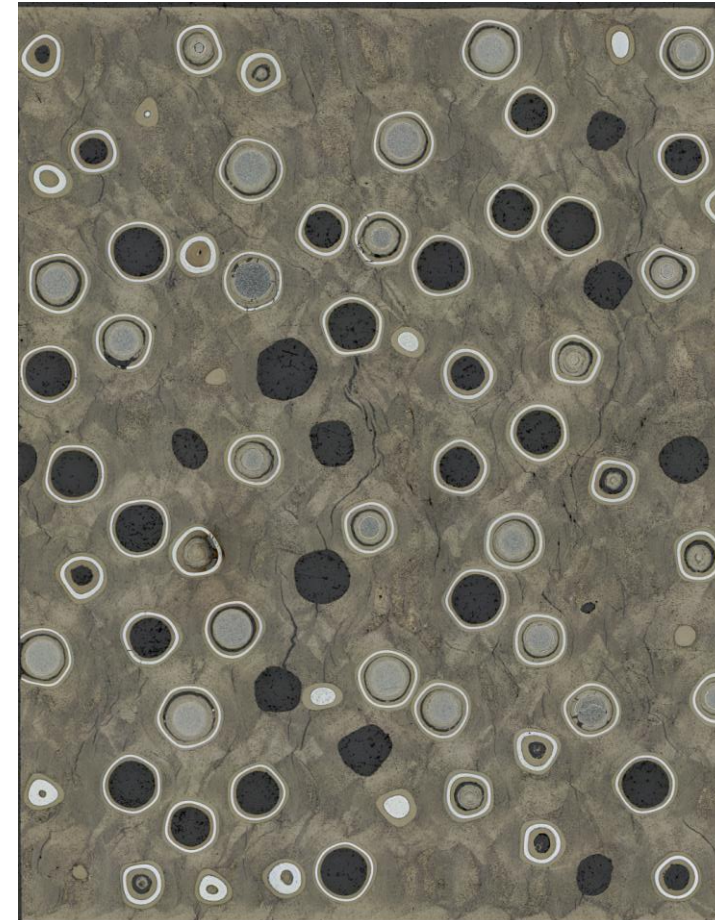
Compact 4-5-1

- Buffer fracture much less common than in Compact 2-3-3
- Very rare small IPyC tear from buffer detachment

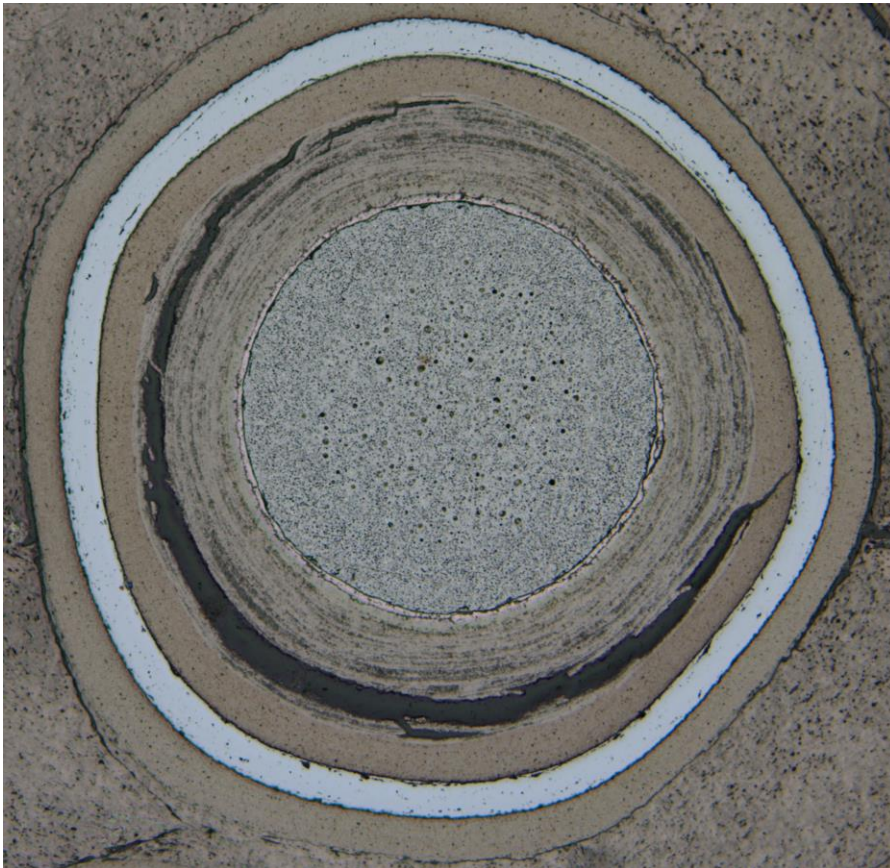
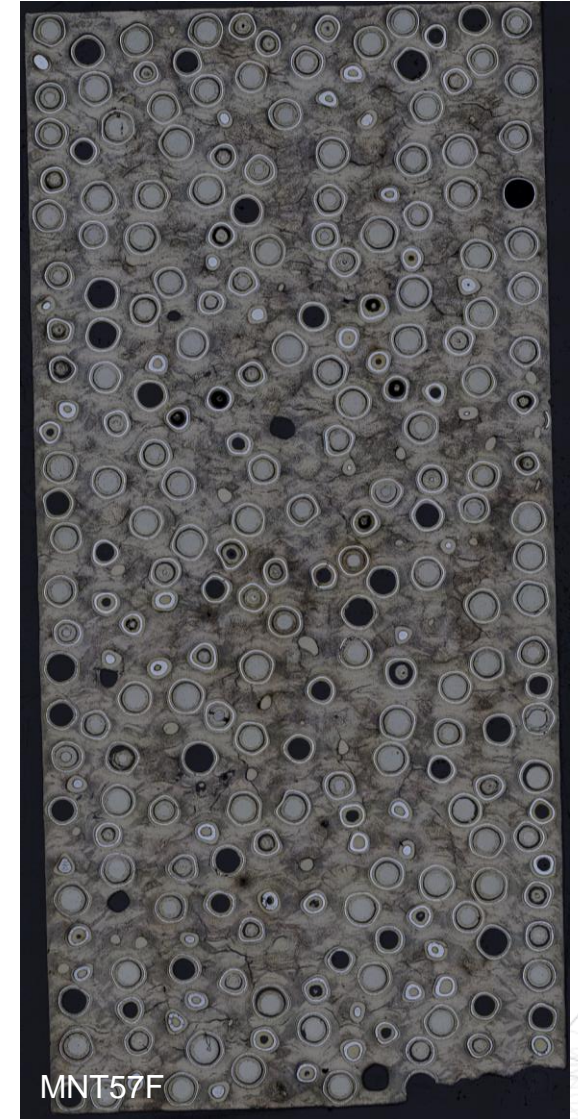
Compact 5-1-4

- Some small, incomplete IPyC tearing
- Rare IPyC cracking
- Seems to have no buffer fracture (like 4-5-1 and unlike 2-2-3)

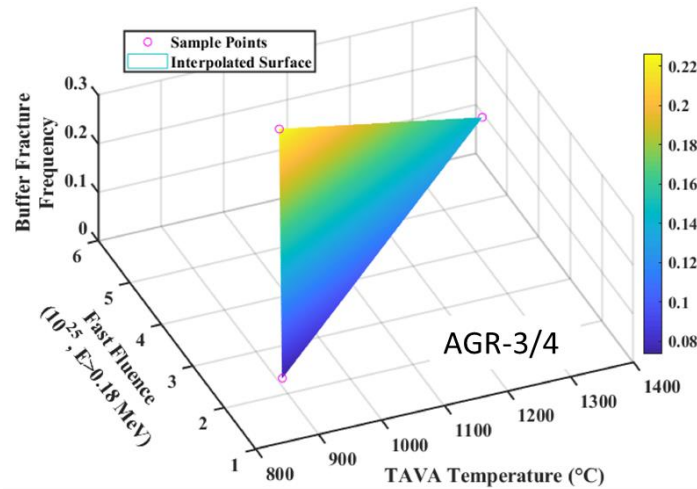
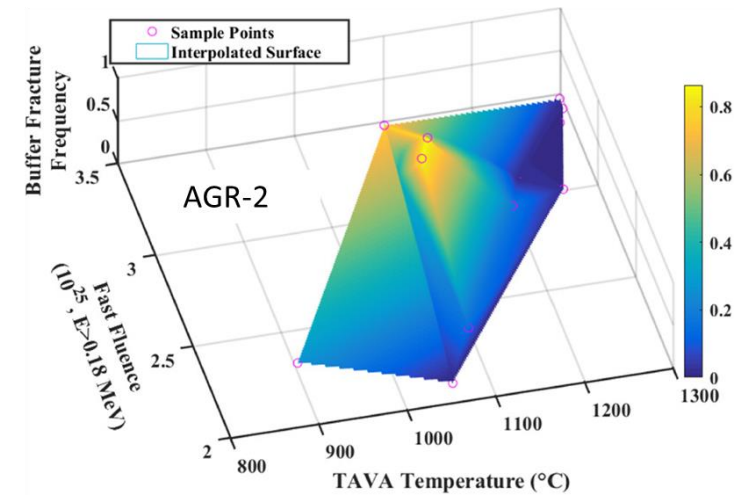
Buffer Fracture Frequency

- Observed previously to be a function of temperature and neutron fluence

- Not surprising to see a qualitative difference in buffer fracture among the lower temperature AGR-5/6/7 fuel

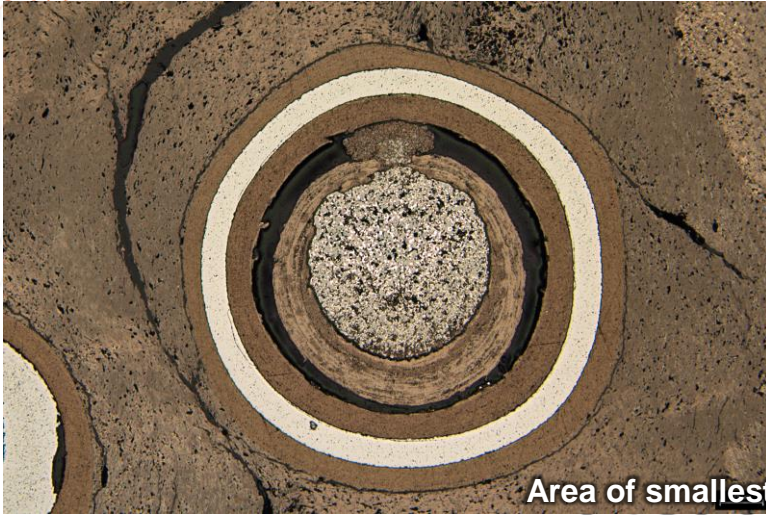
Kernel Migration? Compact 3-2-3 MNT74F

Area of smallest or no buffer-IPyC gap is coolest. Calculations suggest 15-20°C cooler. Kernel moves up the temperature gradient.

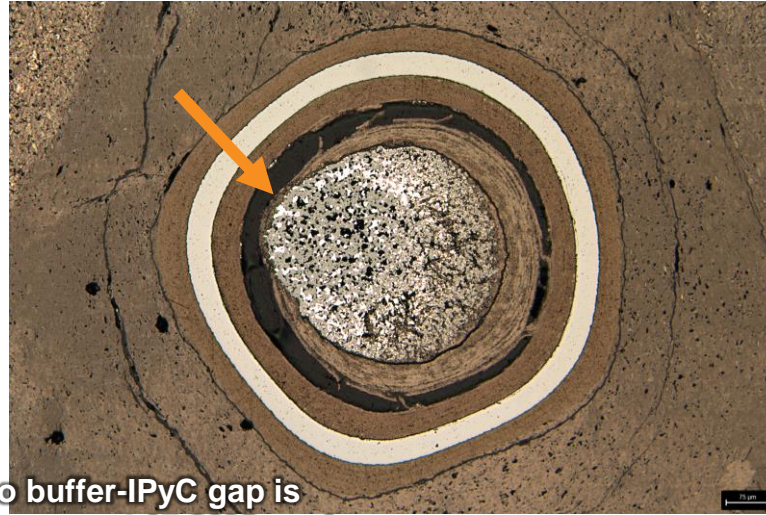
Buffer thinning at hot side of particle.
