John Stempien, PhD

TRISO Fuel PIE Technical Lead
Idaho National Laboratory

2023 AGR-5/6/7 Compact Cross-Section Microscopy

DOE ART Gas-Cooled Reactor (GCR) Review Meeting

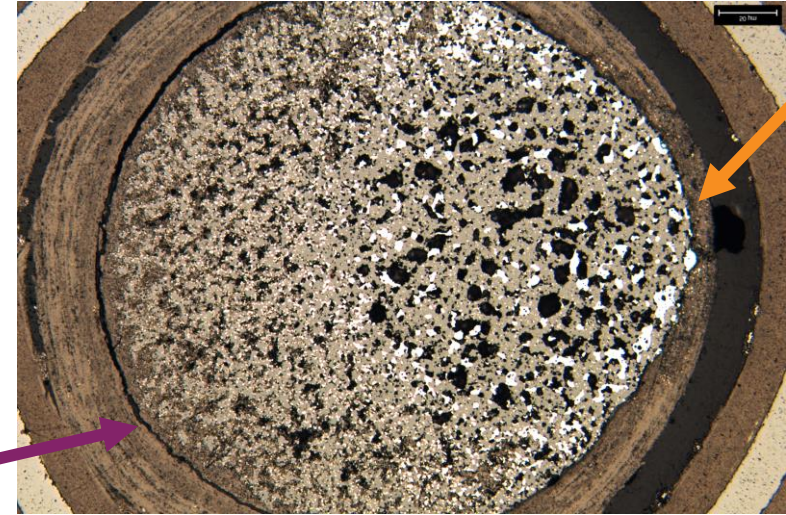
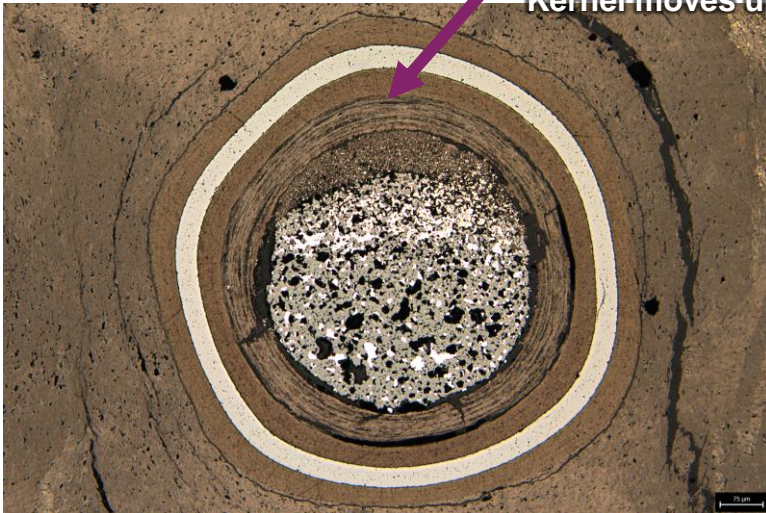
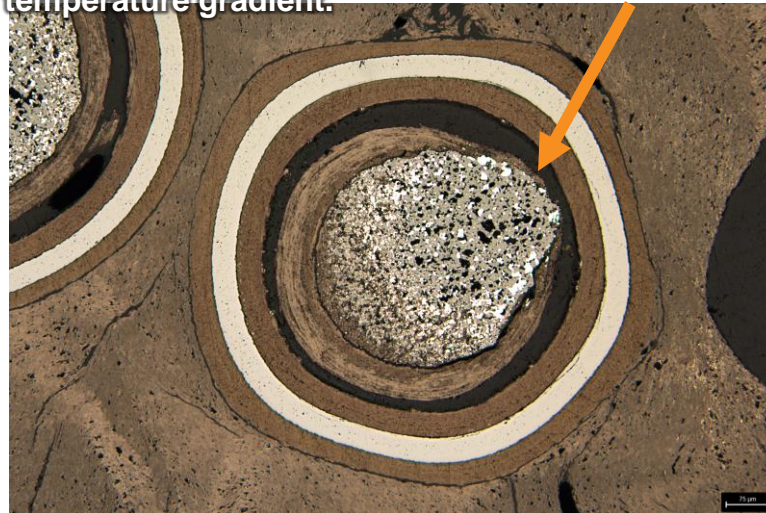
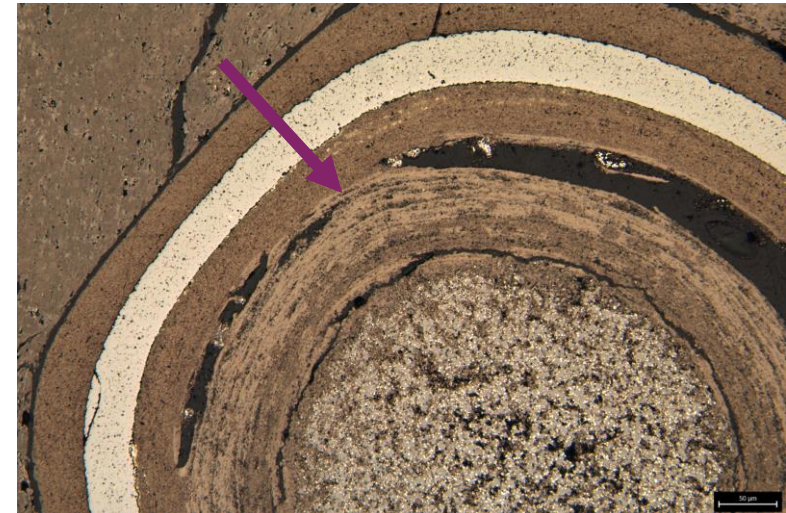
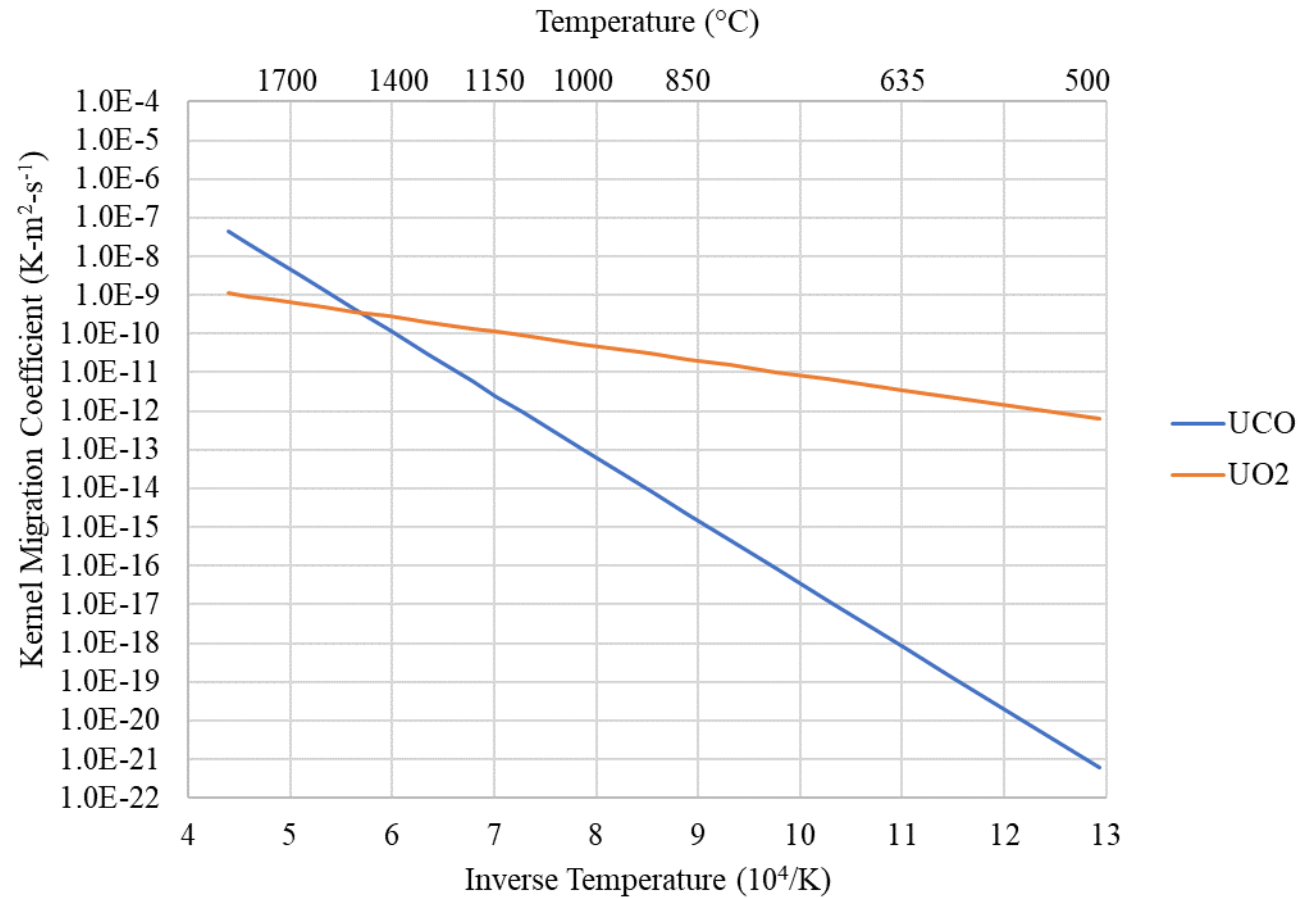
Some amount of UCO kernel migration is not unreasonable at higher temperatures $\gtrsim 1300^{\circ}\text{C}$

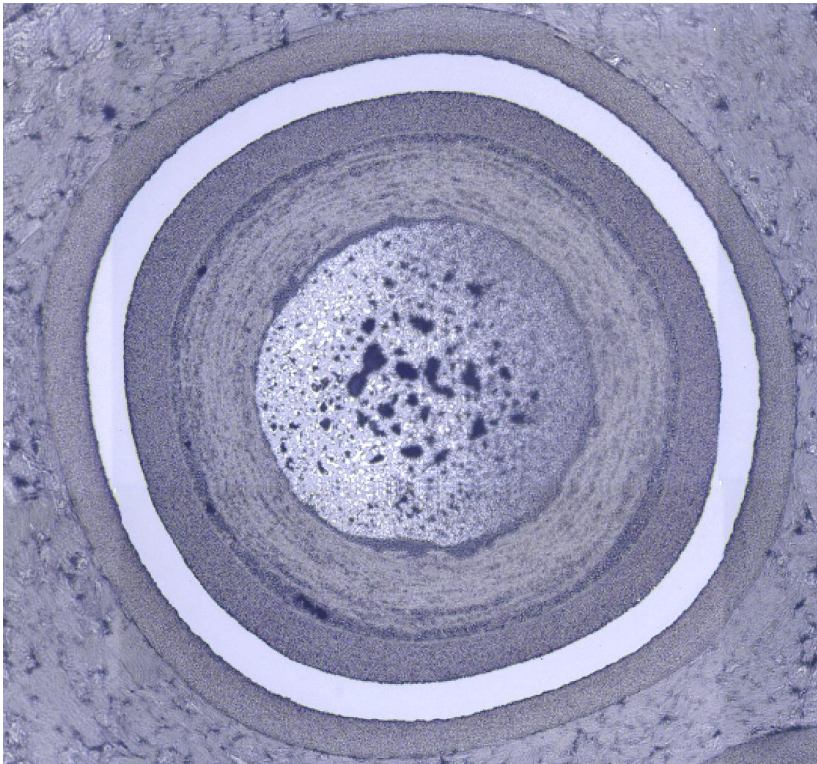
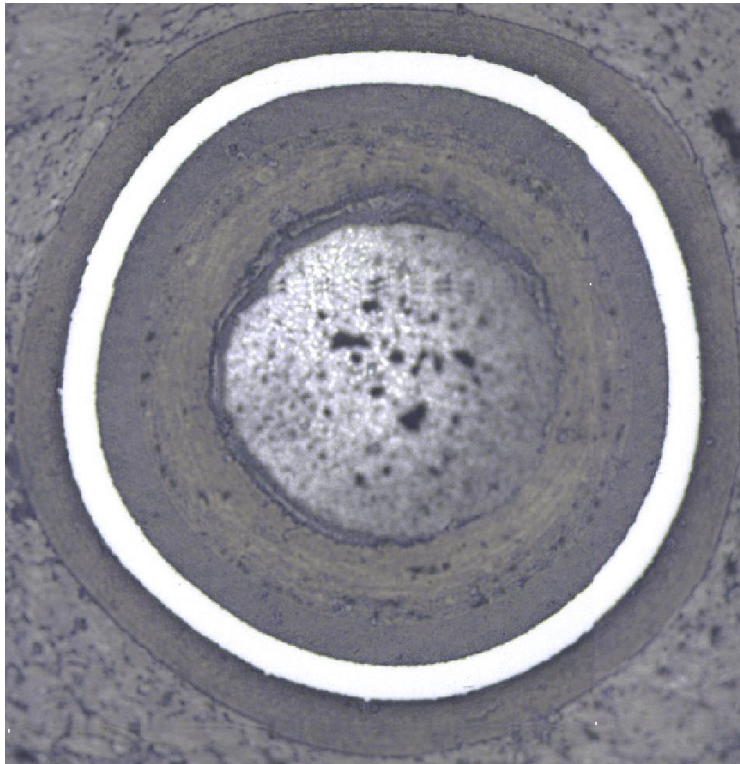
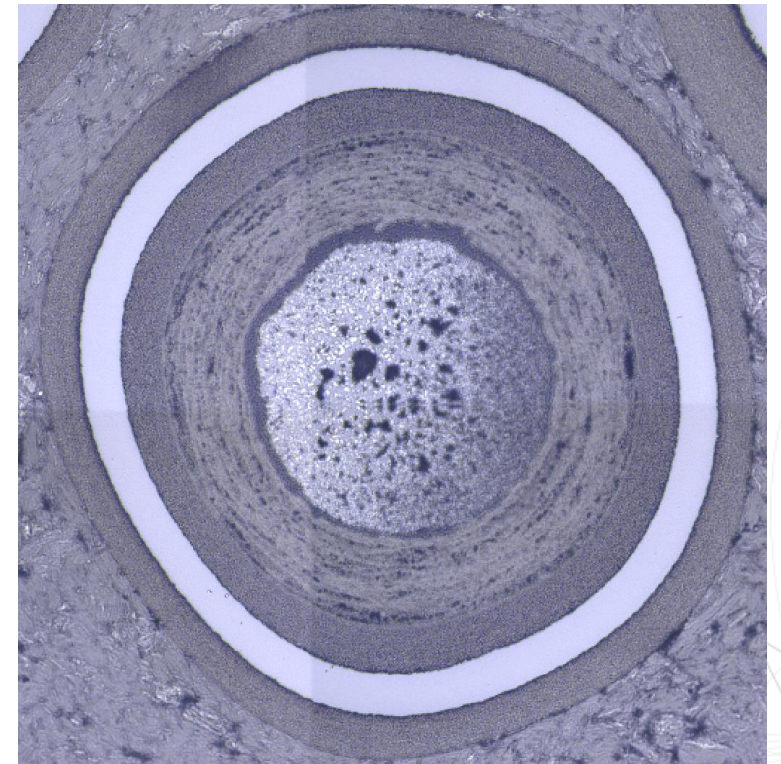
Similar Kernel Morphology Seen in AGR-3/4 Compact 7-2 (TAVA 1375°C, TA Peak 1417°C, 15.0% FIMA)

- Evidence of kernel migration in hot AGR-3/4 fuel
- Generally, not as pronounced as in AGR-5/6/7 Capsule 3

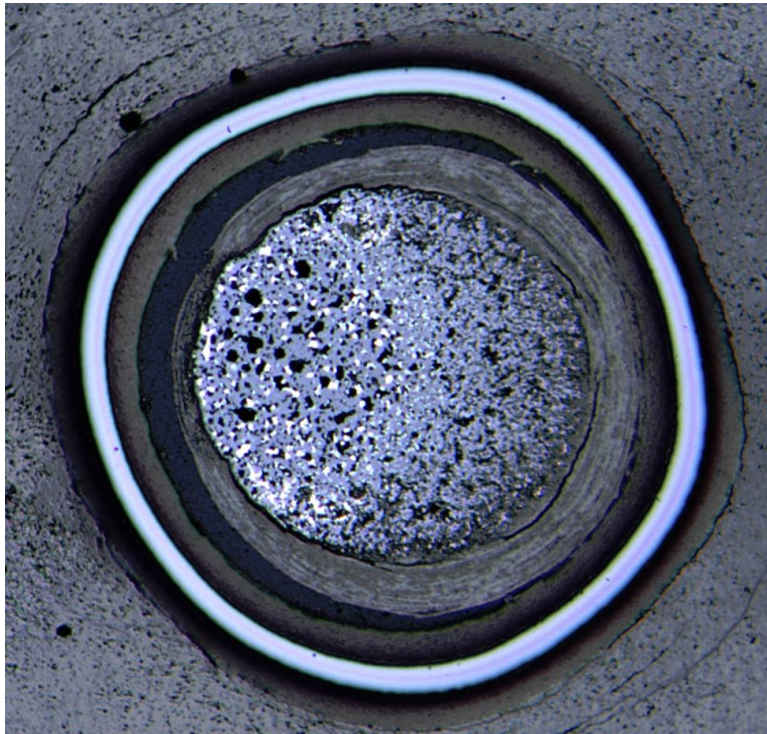
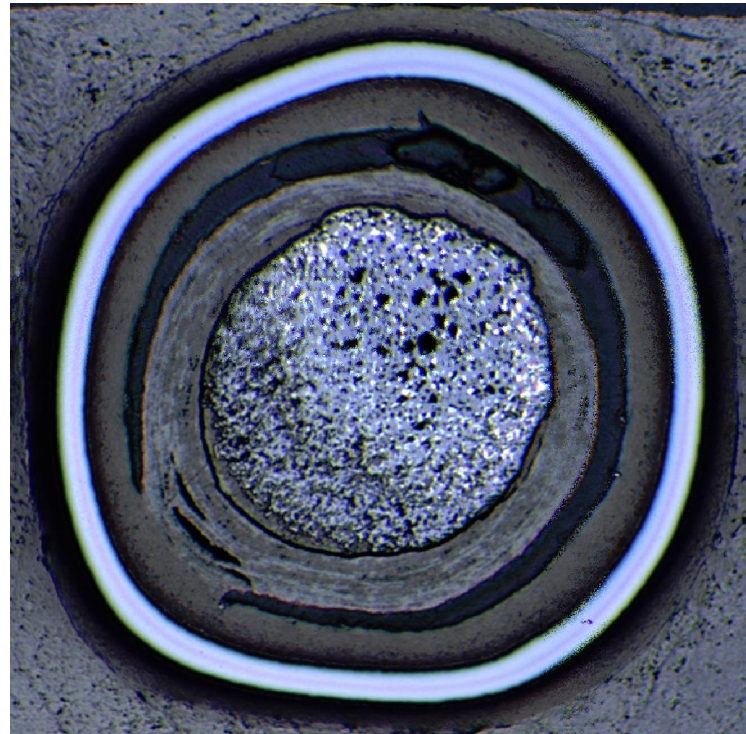
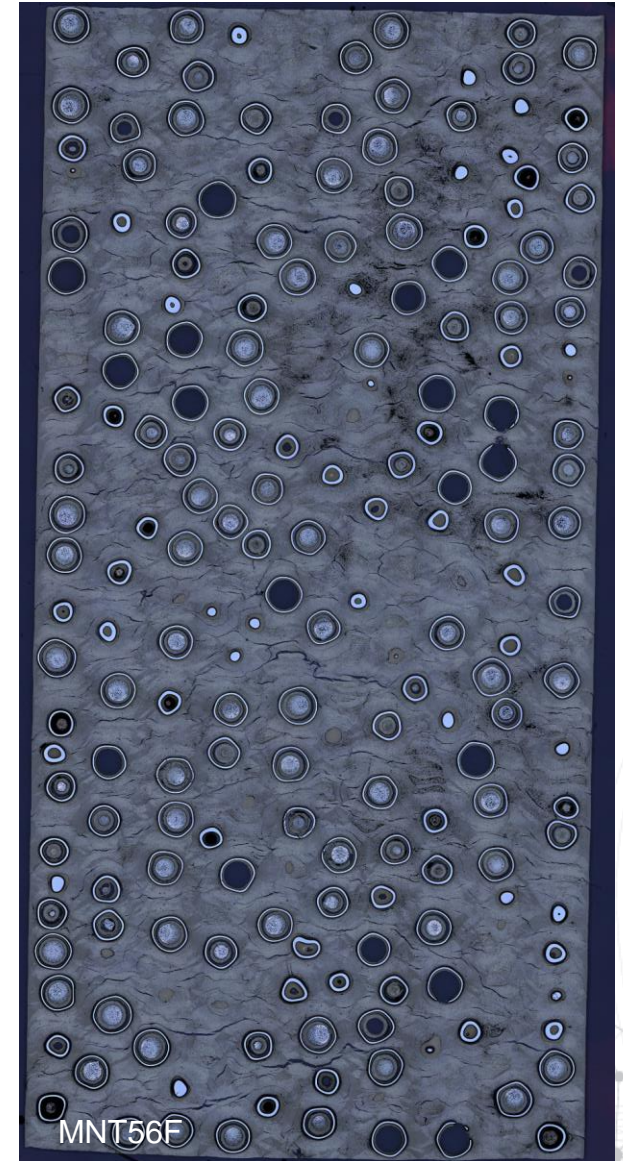
Compact 3-4-1 Appearance Similar to 3-2-3

- Some apparent kernel migration
- A little IPyC tearing

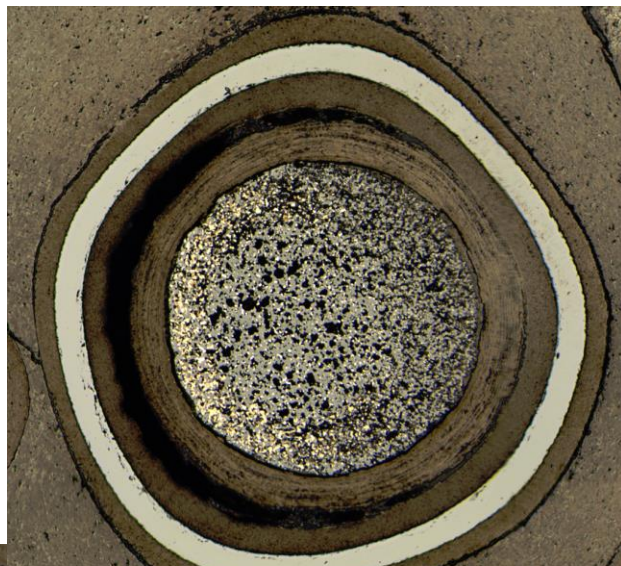
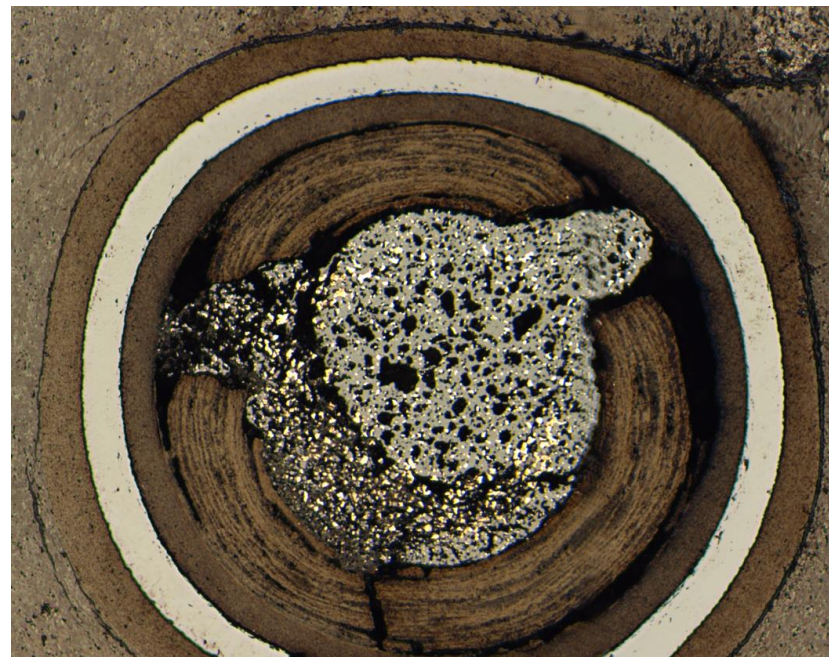
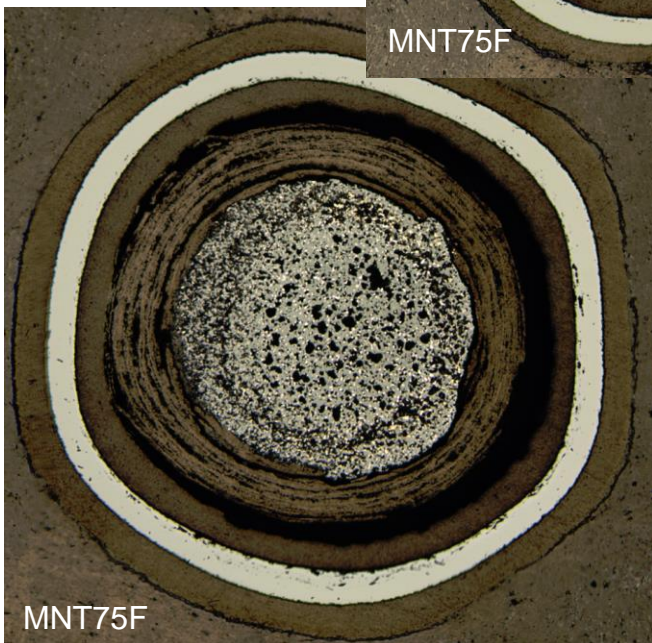
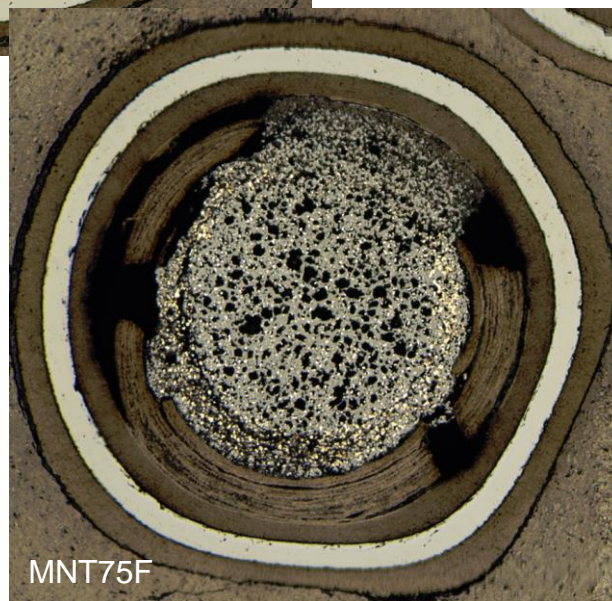
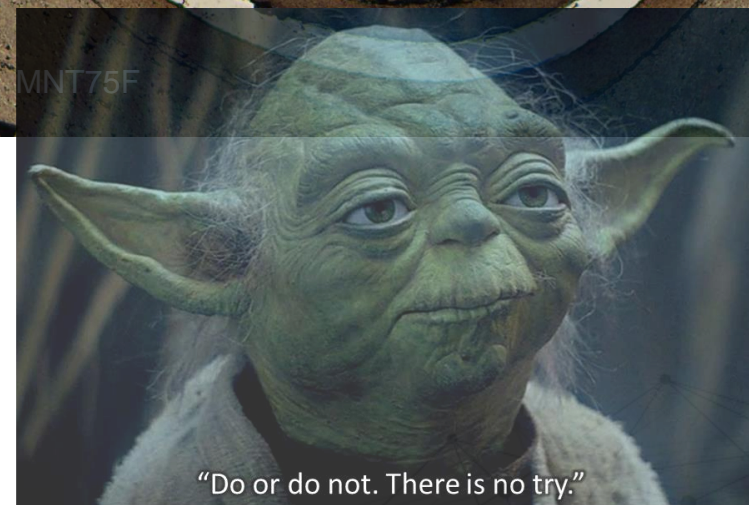
MNT75F

Compact 1-7-6 Incipient Kernel Migration
