# Initial results from electron microscopy from AGR-5/6/7 Capsule 1 fuel and applications of other microanalysis techniques to irradiated TRISO fuel

**DOE ART Gas-Cooled Reactor (GCR) Review Meeting**

# Background and Motivation – Capsule 1

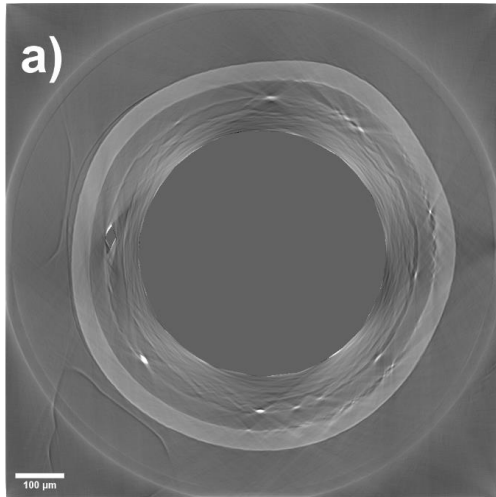
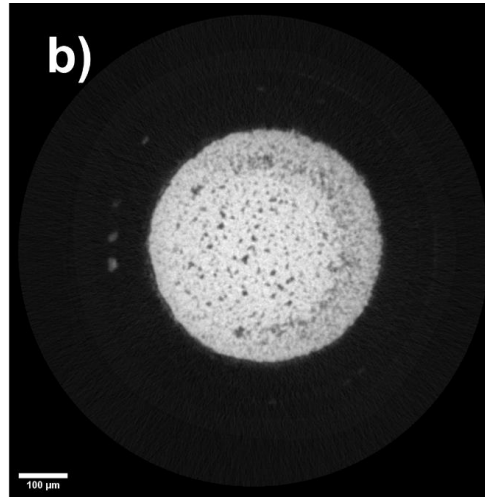
Particle A

- Low energy (a) and high energy (b) XCT scans through the particle center
- Each of three particles particle has an intact SiC layer.
- The IPyC layers appear well adhered to the SiC layer.
- The IPyC and buffer layers appear to have separated over the majority of the volume of each particle.
- A number of dense features are observed within the TRISO layers.

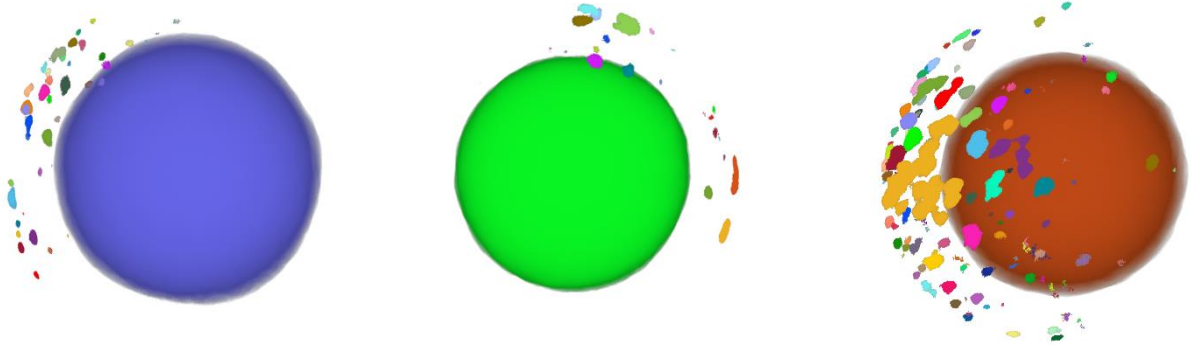
3D- renderings of dense features surrounding the kernels of Particles A, C, and D

- The dense features are primarily observed in large clusters along the IPyC side of the IPyC/Buffer interface where the two layers have separated. These features appeared to be nonuniformly distributed within particles.

- SiC degradation was observed in Particle B with XCT. Non-uniform dense features were observed in large clusters along the IPyC side of the IPyC/Buffer interface where the two layers have separated in the other three particles.
- SEM/EDS results confirmed the presence of nickel in the SiC layer co-located with fission products along SiC/IPyC interface. This finding supports the hypothesis that particle failures were caused by the overheated thermocouples.
- We are currently working on characterizing the cross-section of Compact 1-6-9 with SEM EDS to observe evidence of nickel in the fuel matrix.

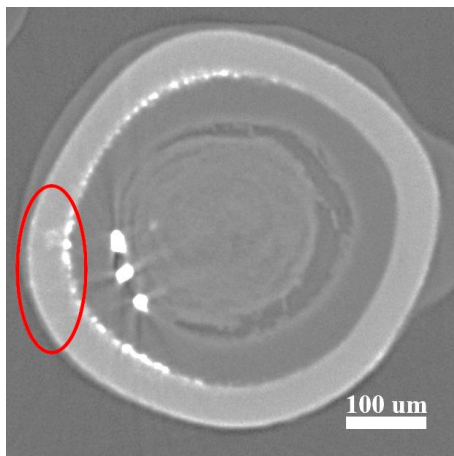
Particle C

- A lot of materials deposited on the SiC/IPyC interface.
- A small quantities of material deposited on the SiC exterior surface (circled in red).

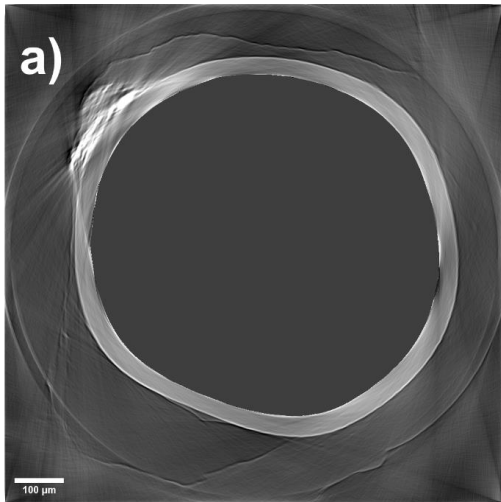
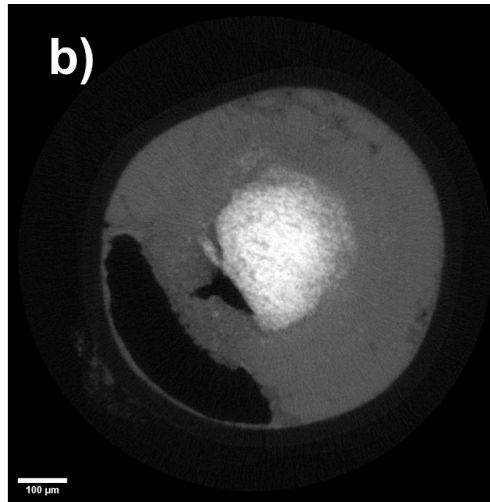
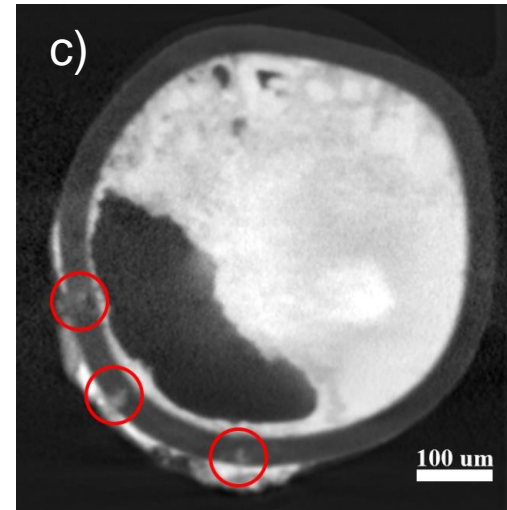
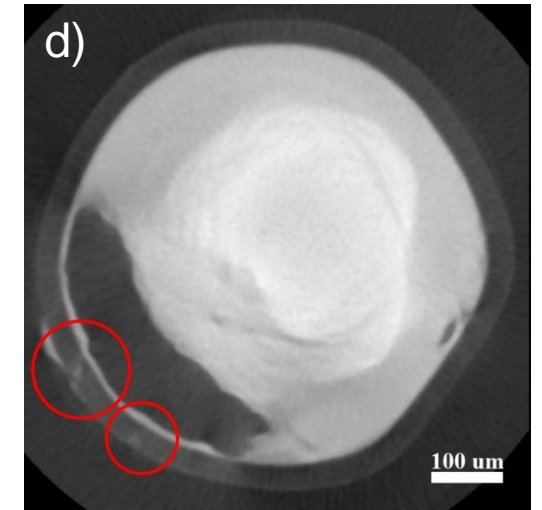
Particle B: no buffer nor IPyC

- Low energy (a) and high energy (b) XCT scans through the particle center, indicating no evidence of buffer nor IPyC. Dense material appeared dispersed throughout the interior of the SiC layer.
- (c) and (d) shows several locations on the SiC exterior surface where the unknown material appears to penetrate into the SiC layer.
- May be an example of a particle originally located near the Compact 1-7-9 surface attacked by nickel.

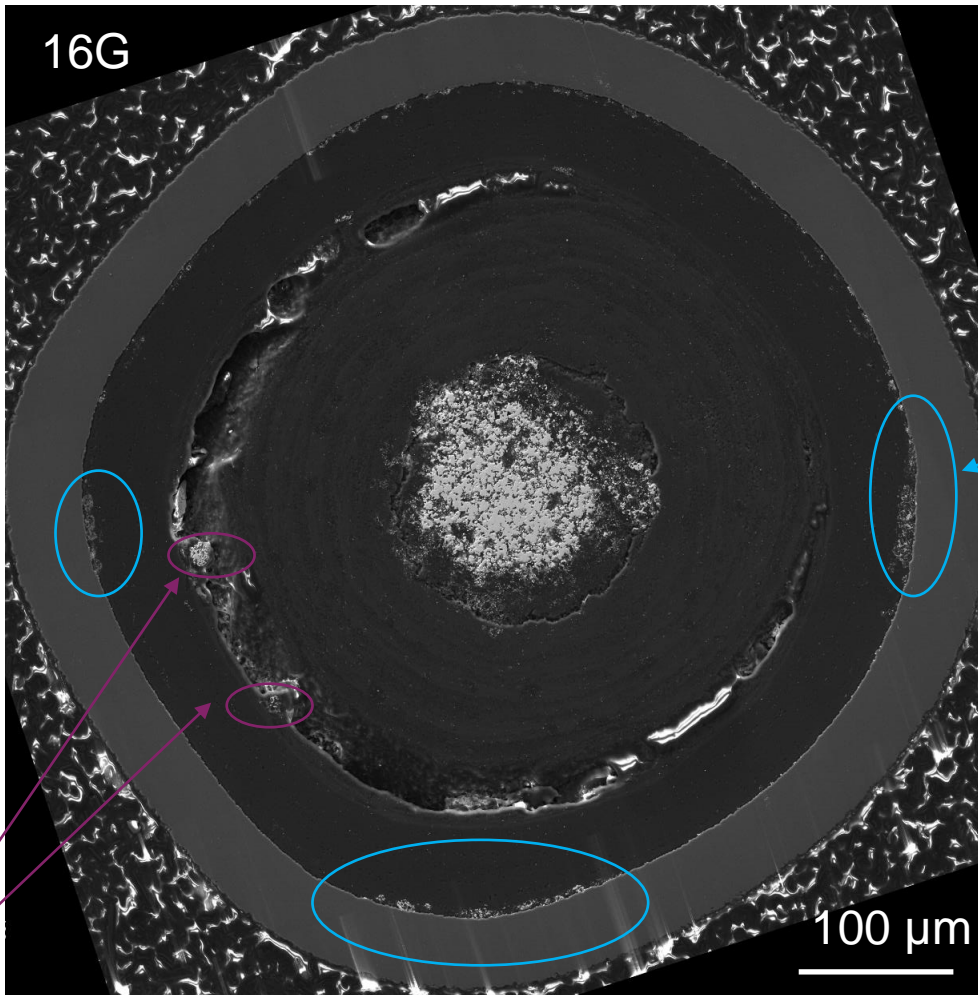
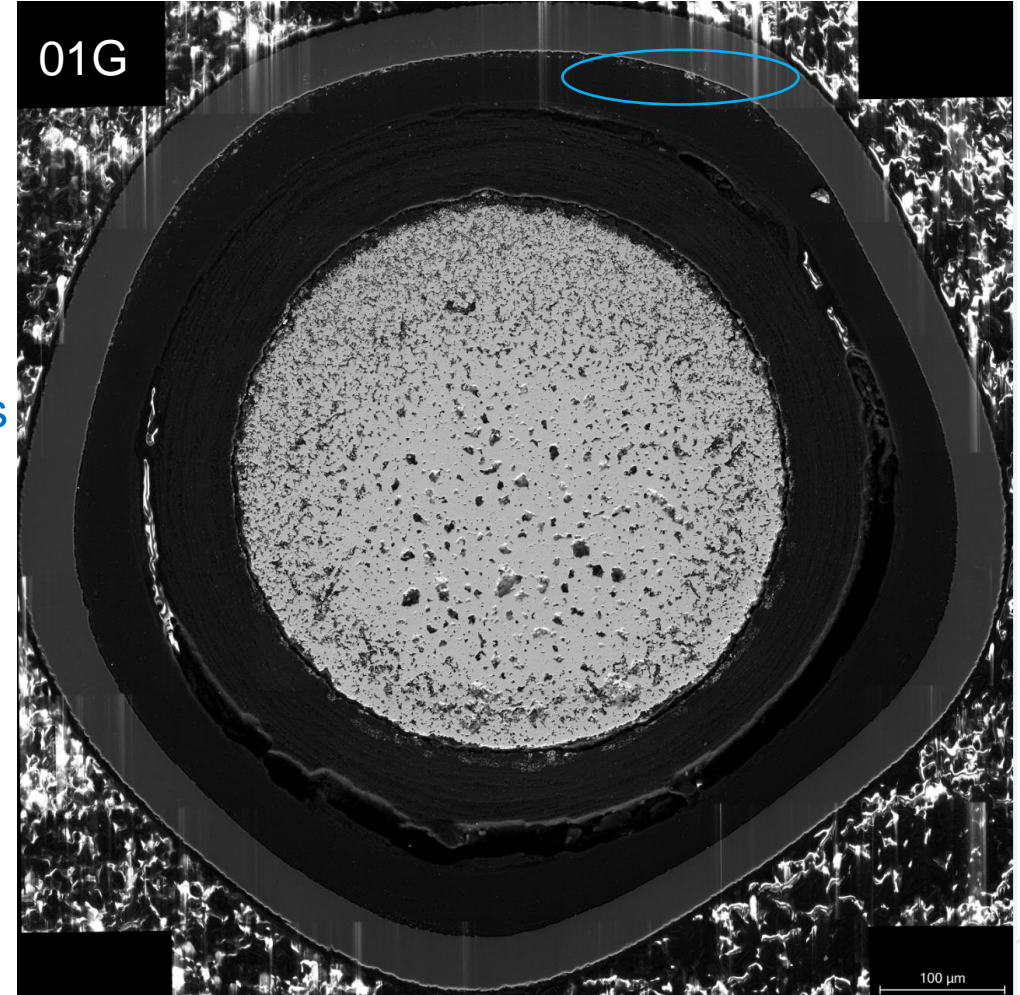
# MNT-16G and MNT-01G (Compact 1-7-9)

Cluster of high Z materials

High Z materials were also observed at the IPyC side of the IPyC/Buffer interface where the two layers have separated, consistent with the XCT observation.

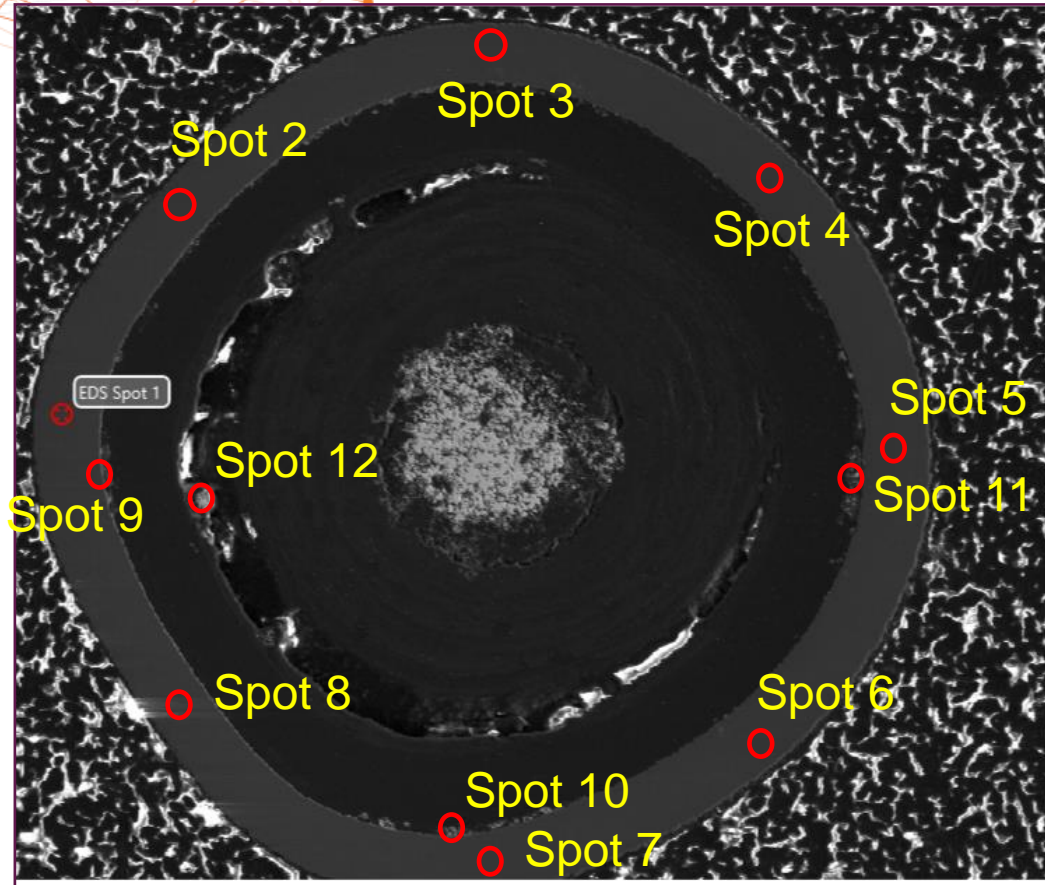
# MNT-16G (Compact 1-7-9)

Spot	Location	Ni (wt%)
1	SiC	0.9
2	SiC	N/A
3	SiC	0.3
4	SiC	0.5
5	SiC	N/A
6	SiC	N/A
7	SiC	N/A
8	SiC	N/A
9	SiC/lpyC	2.6
10	SiC/lpyC	7.7
11	SiC/lpyC	12.4
12	lpyC/gap	N/A

Ni is detected in some parts of the SiC layer as well as on the fission product deposits between SiC and IPyC interface.

Note: Ni percentage is semi-quantitative. Si has much stronger EDS peaks than C.

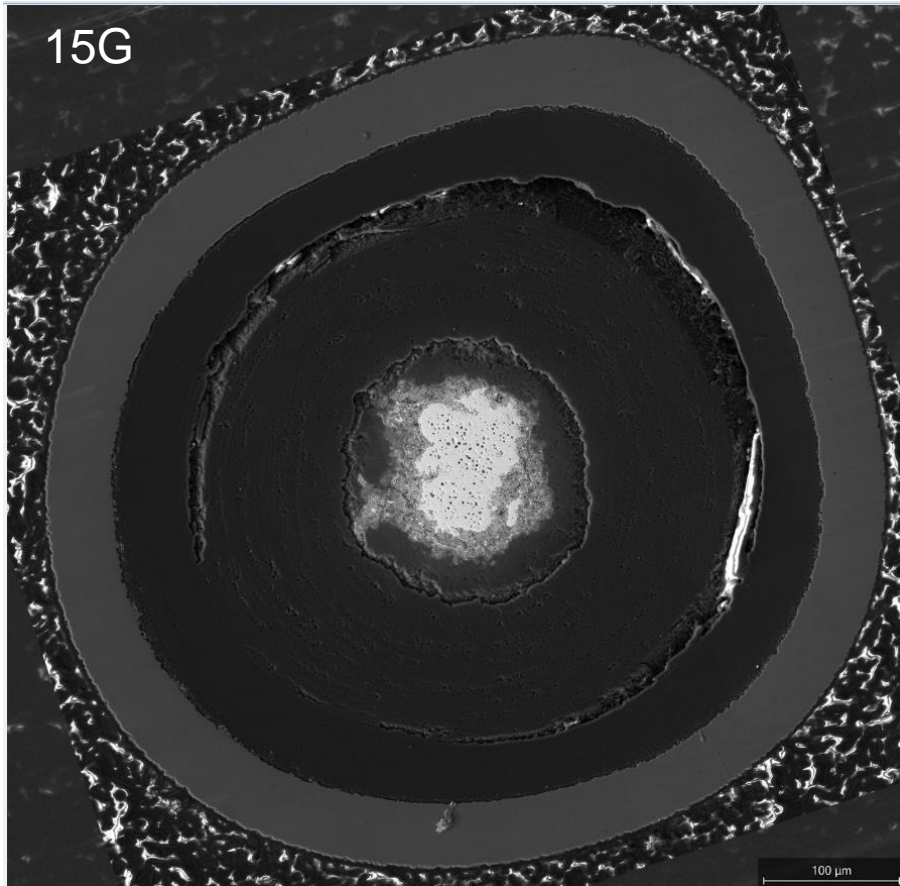
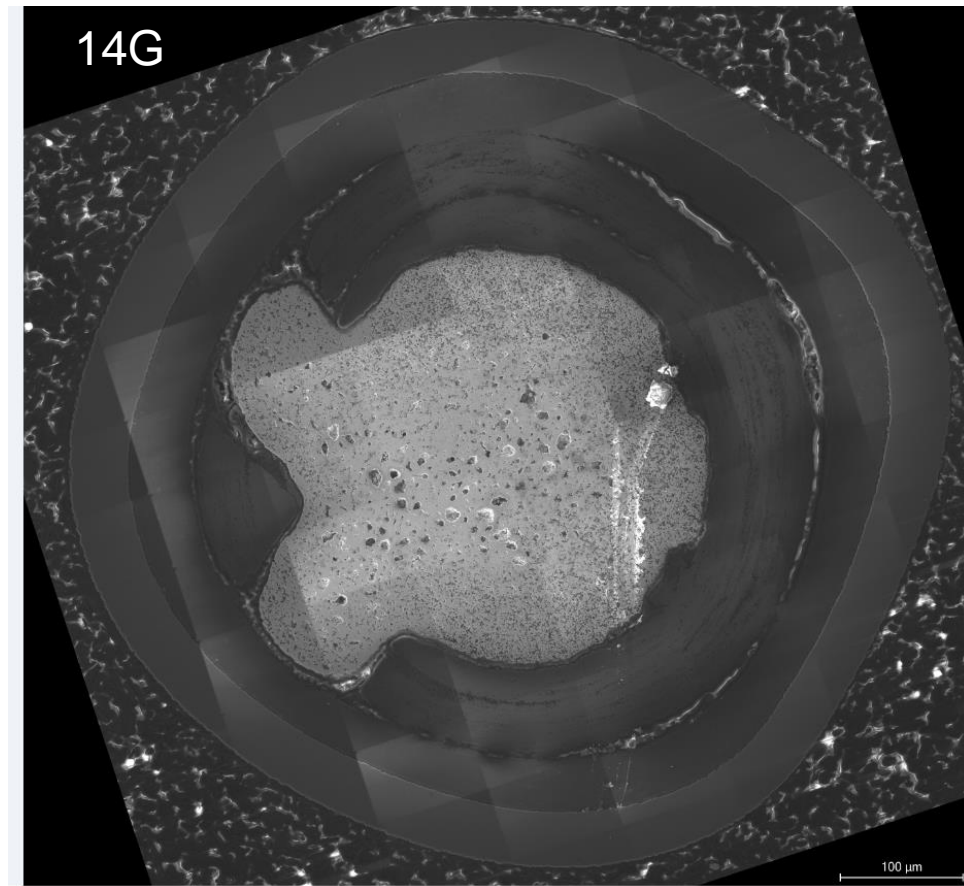
## Particles from Compact 1-7-4

- Visibly less high Z materials deposits at SiC/IPyC
- No detection of Nickel

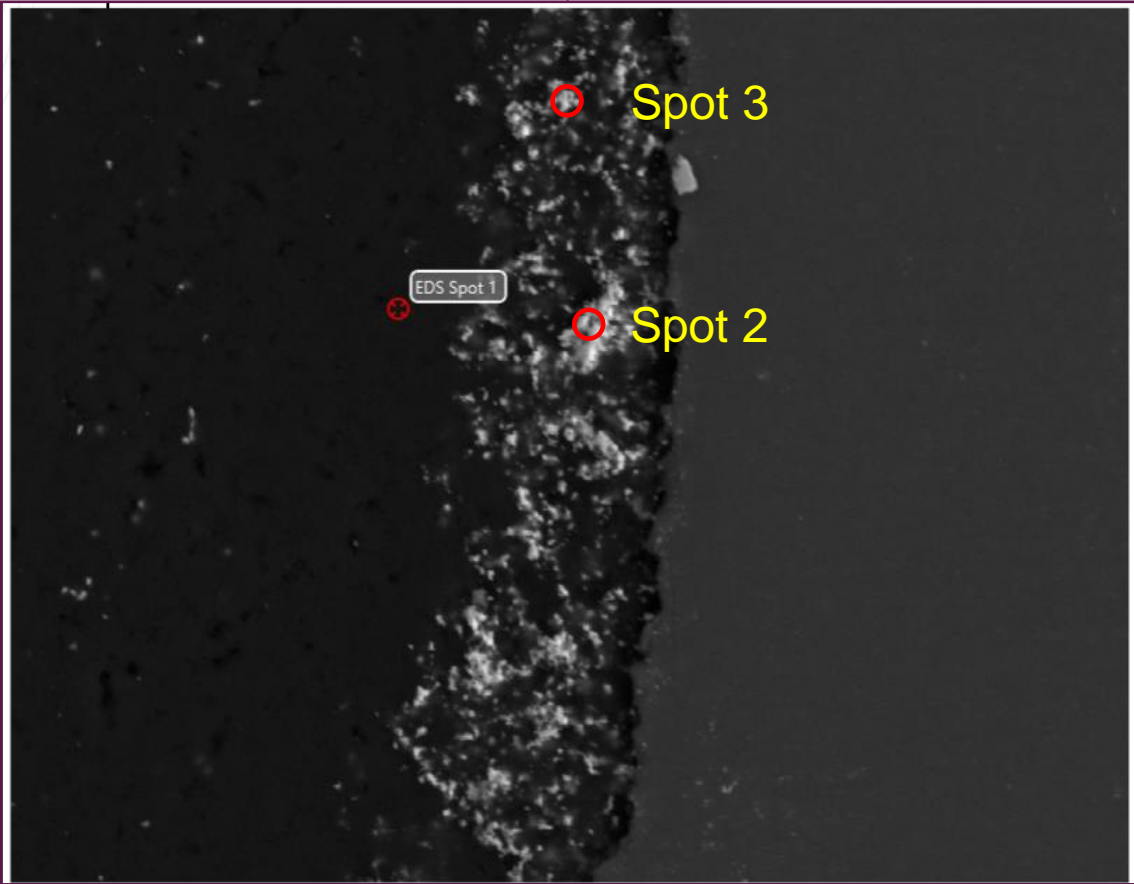
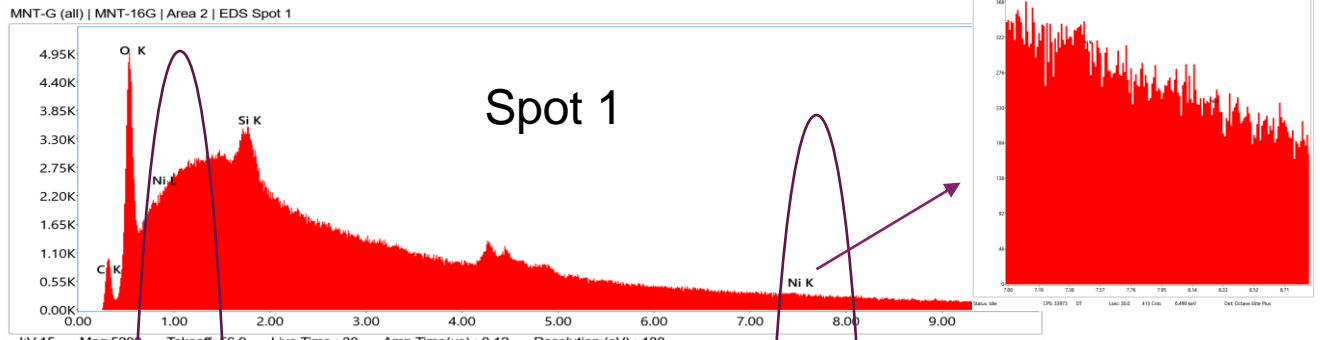
# MNT-16G (Compact 1-7-9)

No Ni peak at Spot 1.

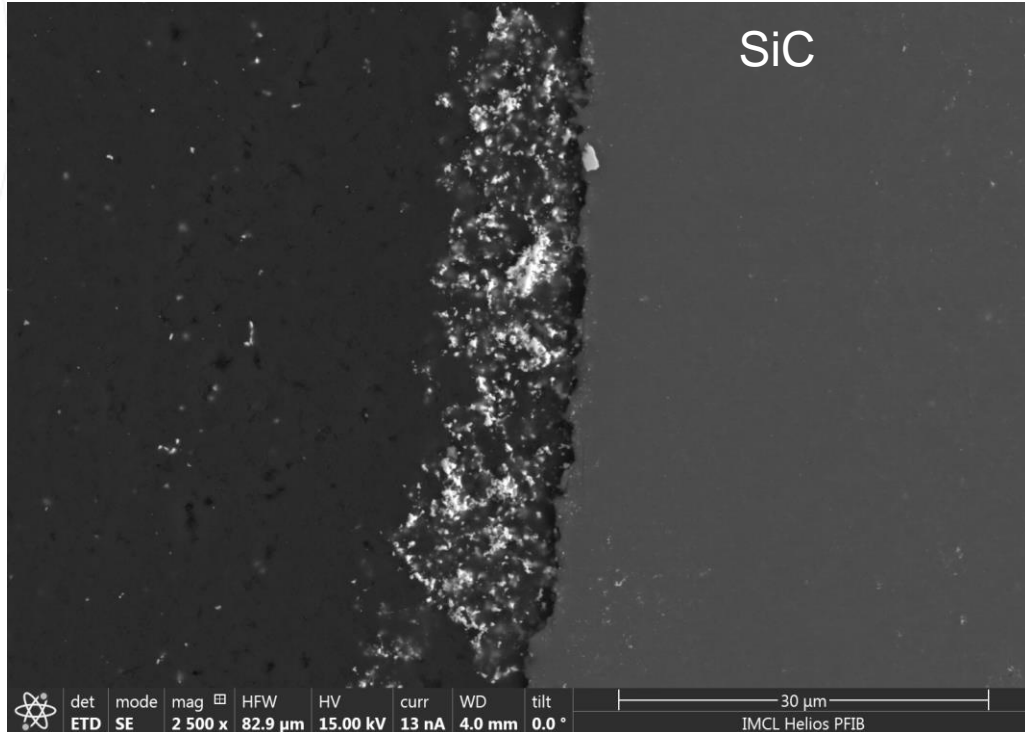
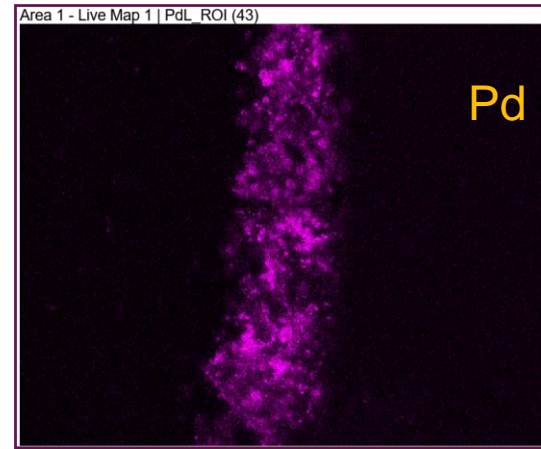
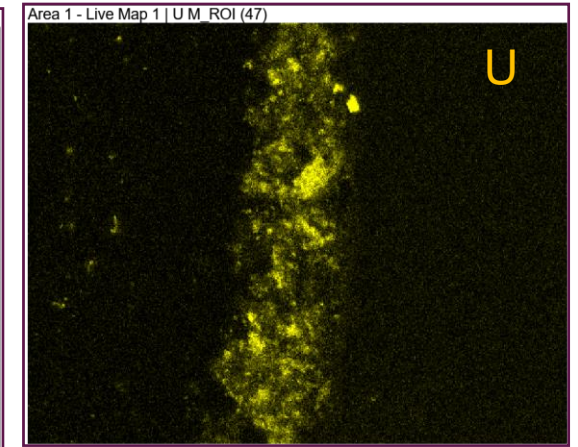
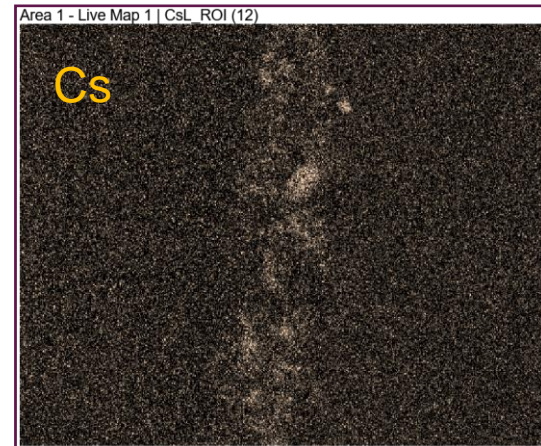
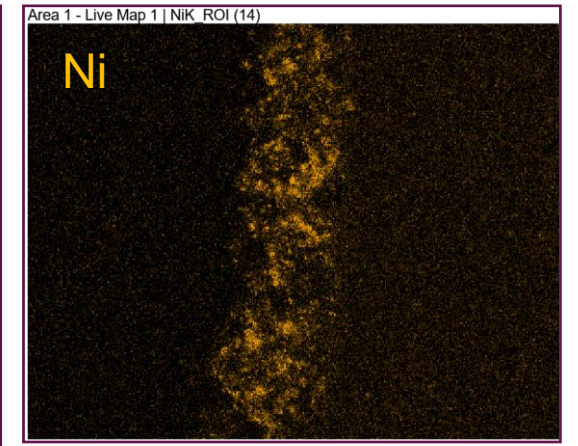
# MNT-16G (Compact 1-7-9)

Fission products accumulated at the interface of SiC/IPyC. Ni is detected in these fission products.

Element	Weight %	Error %
O K	1.7	10.8
Si K	69.5	3.9
Ni K	1.2	6.2
Pd L	5.7	4.8
Ag L	0.4	15.8
Cs L	2.3	4.4
U M	4.1	4.7
Pu M	7.5	4.1

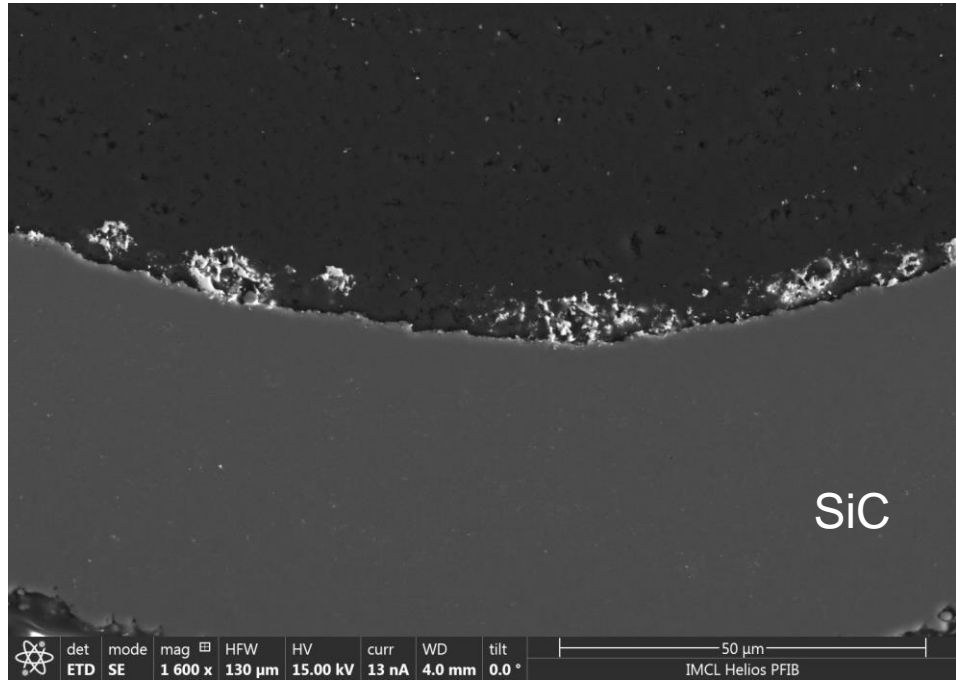
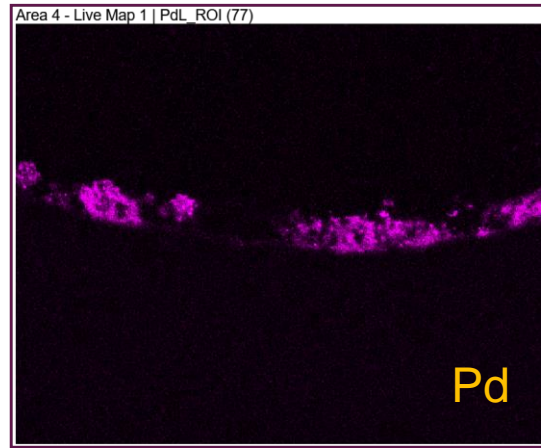
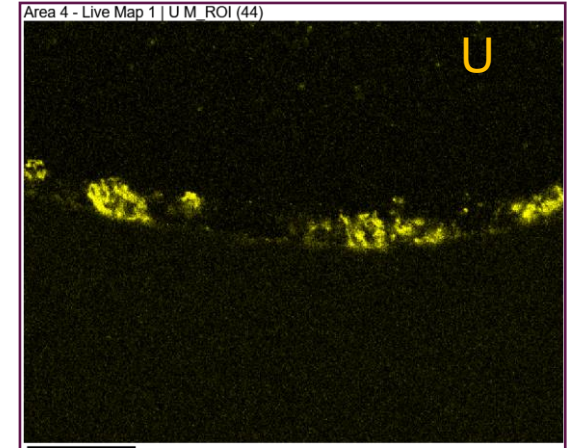
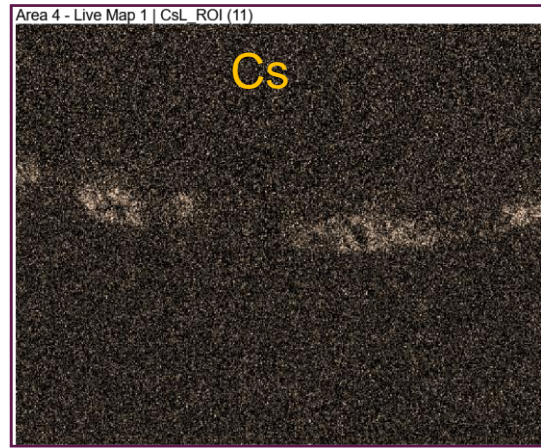
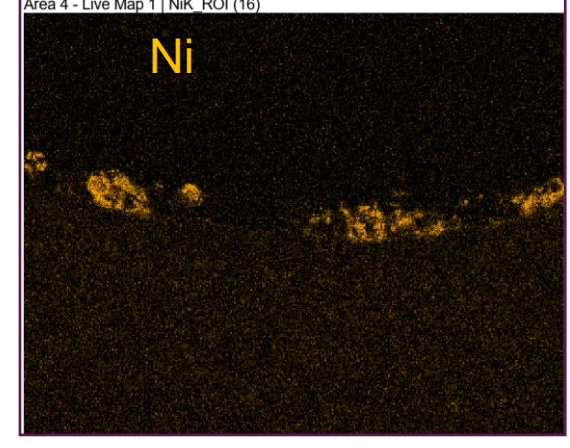
# MNT-16G (Compact 1-7-9)

Element	Weight %	Error %
O K	1.9	10.5
Si K	81.9	3.6
Ni K	0.8	9.2
Pd L	3.3	5.1
Cs L	2.1	5.2
Ce L	0.9	11.5
U M	2.9	4.3
Pu M	6.3	4.3

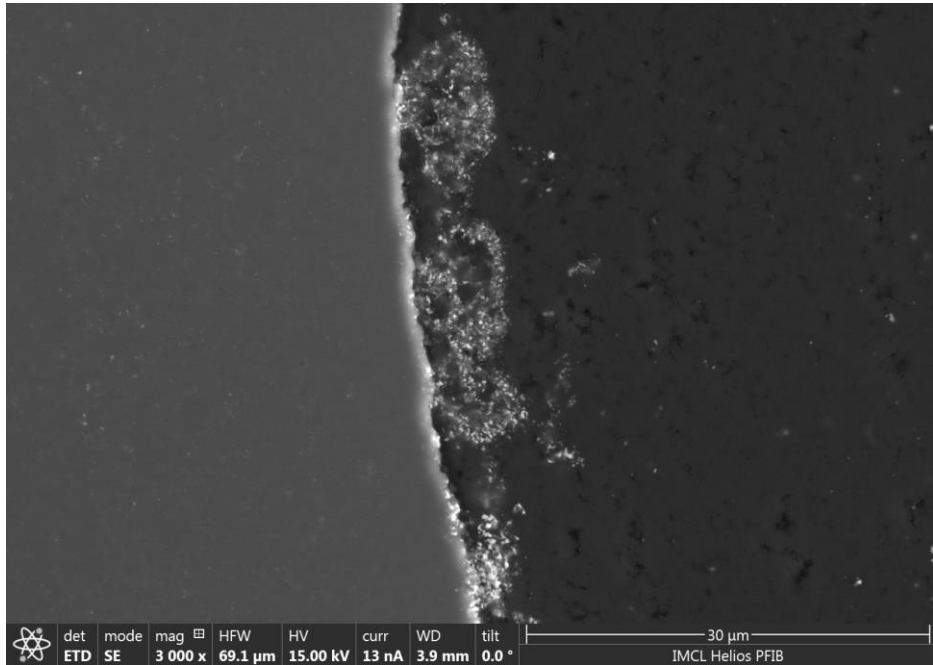
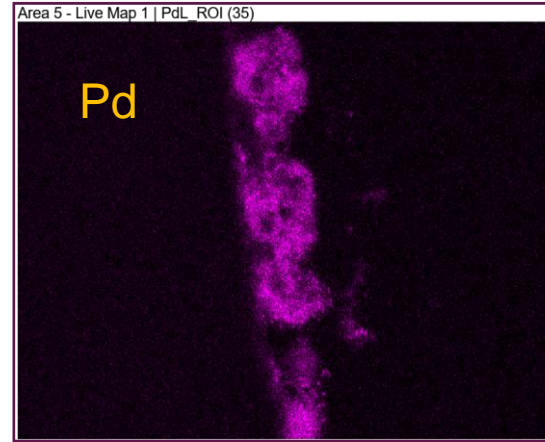
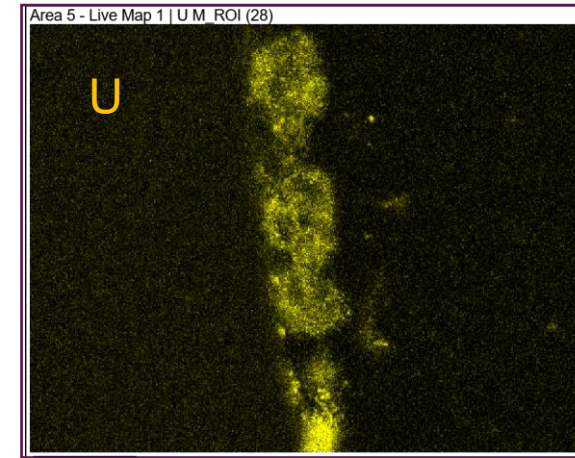
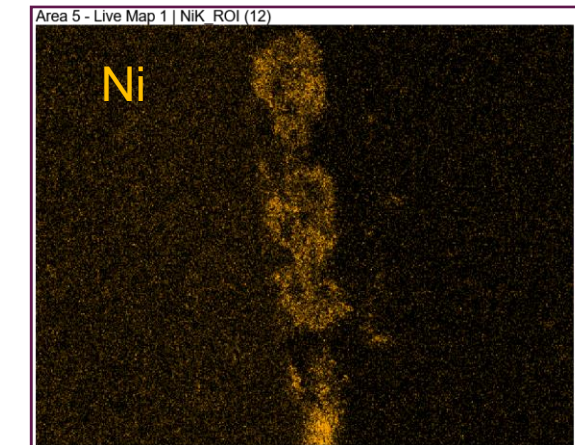
# MNT-16G (Compact 1-7-9)

Element	Weight %	Error %
O K	2.6	10.1
Si K	71.9	3.9
Ni K	1.0	5.6
Pd L	4.8	4.8
Ce L	2.5	4.5
U M	3.4	4.4
Pu M	6.5	4.1

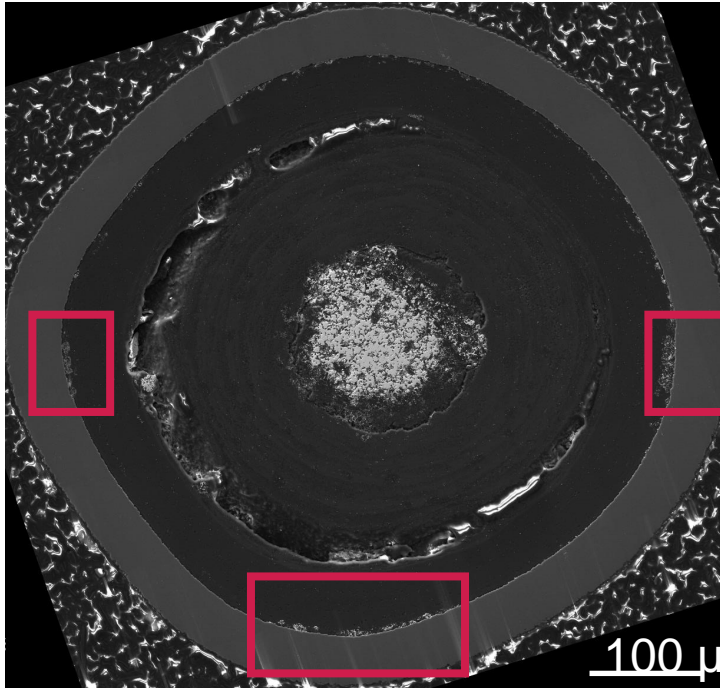
MNT-16G (Compact 1-7-9)

Looks like the nickel attack from inside out  
→ Ni penetrated from another plane

Nickel appears inside the particle with the cluster of fission products.

- is Ni penetrated the SiC in some other plane that we can't see here?
- Or is Ni diffusing through the SiC and then accumulating the locations?

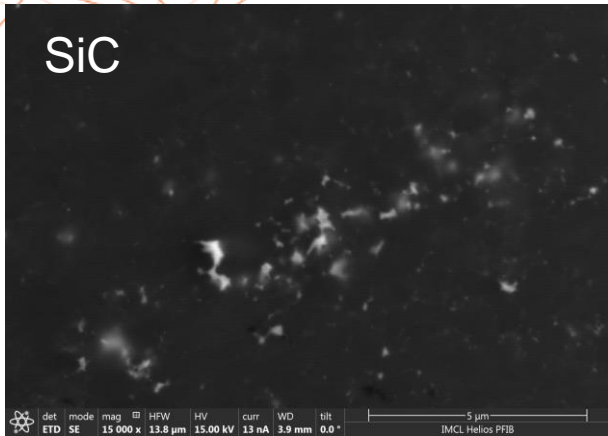
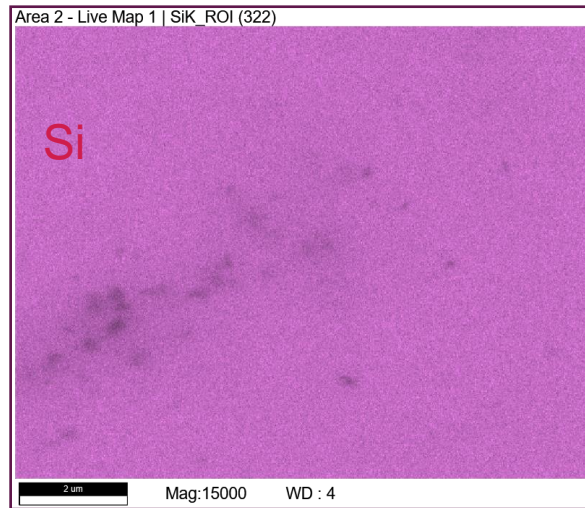
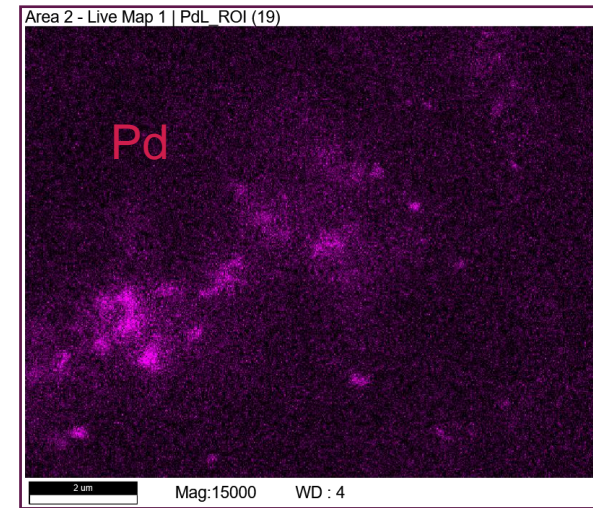
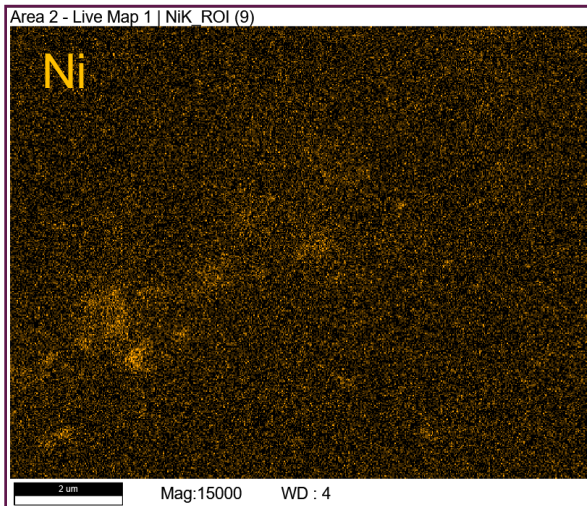
# MNT-01G (Compact 1-7-9) – Nickel on SiC

Element	Weight %	Error %
Si K	85.5	3.4
Ni K	0.4	9.9
Pd L	1.0	7.1
Cs L	0.5	10.9
Ce L	0.4	11.6
U M	1.1	6.0
Pu M	7.2	4.0

Fission products with Ni were observed on SiC.

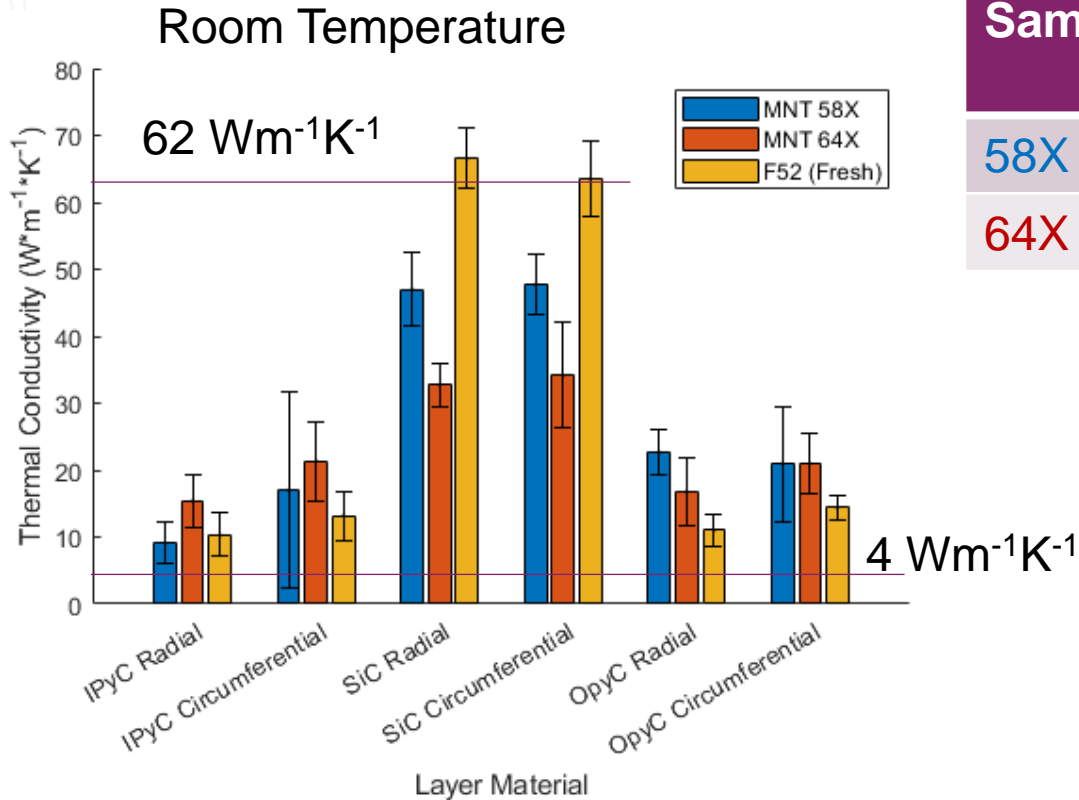
Irradiated Sample	Compact (AGR-2)	TAVA temperature (°C)	Burnup (% FIMA)	Fluence (10 <sup>25</sup> n/m <sup>2</sup> E>0.18 MeV)
58X	2-4-3	1216	11.52	3.08
64X	5-1-3	1078	11.09	3.03

- The SiC thermal conductivity from the fresh fuel matches well with that in PARFUME.
- IPyC and OPyC have a 25 to 50% **increase** in thermal conductivity after irradiation. Layers appear to densify which may improve thermal transport.
- SiC thermal conductivity **decreases** \*at least\* 30 – 50% post irradiation depending on compact which is in line with presence of irradiation induced defects.

- OPyC and IPyC thermal conductivity increases with irradiation.
- SiC thermal conductivity decreases with irradiation.
- The changes in both instances are small relative to the ranges for these properties used in the PARFUME sensitivity study.
