Ceramographic Examinations of Irradiated AGR-1 Fuel Compacts

Very High Temperature Reactor Project

INL/EXT-12-25301
Revision 1

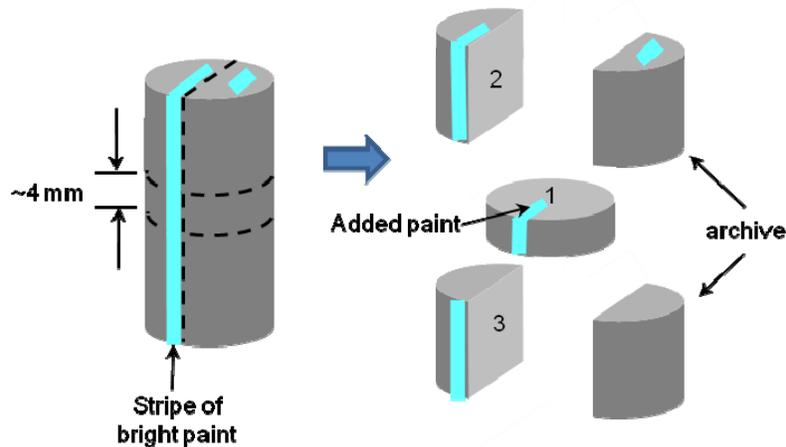
Figure 2. Cutting diagram for AGR-1 compacts, illustrating how bright paint was used to preserve orientations of discrete sections for alignment with mount reference markers.

All AGR-1 compacts were cut and marked in accordance with Figure 2, which created one transverse cross section and two longitudinal cross sections from each compact for examination. INL cutting operations were conducted in the Containment Box at the MFC Hot Fuel Examination Facility (HFEF) with a Struers Minitom saw equipped with a Buehler 15HC, 127-mm diameter diamond wafering blade. Saw speed was fixed at 200 revolutions per minute. Cutting force could be adjusted on the pivot arm holding the compact above the saw blade by sliding a counterweight with a master-slave manipulator. A nominal weight setting was established during test cuts on an unirradiated AGR-1 compact, but it was found necessary later to change the setting to compensate for blade wear (most of which occurred between batches of compacts on non-AGR samples) so that each cut took approximately 5 minutes. Preliminary cuts made dry and with water lubricant revealed no obvious advantage except wet cuts produced far less graphite dust. Several developmental modifications were made early in the sequence to fixtures that held full compacts for transverse cuts or end sections for longitudinal cuts. For example, before any irradiated AGR-1 compacts were cut, a second unirradiated compact was cross-sectioned for potential comparison to irradiated compacts. Inadequate thread length on the transverse fixture screws prevented firm clamping, so new screws had to be installed. A second longitudinal fixture with more travel also had to be built to accommodate end sections that were either longer or shorter than nominal.

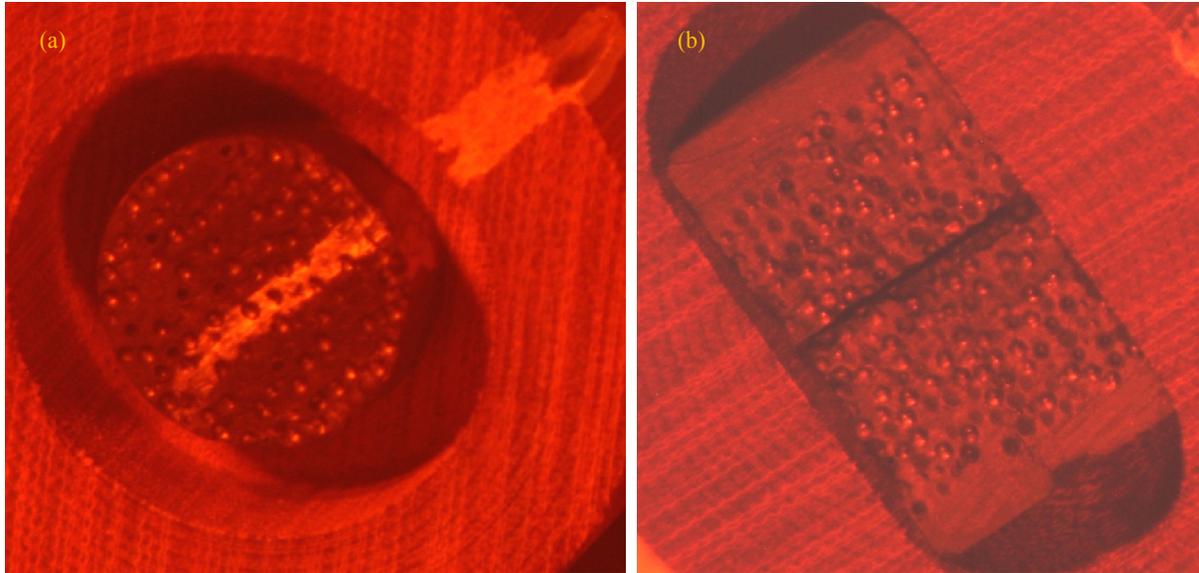
Figure 3. Periscope photos of as-cut transverse cross section of Compact 4-1-3 (a) and longitudinal cross sections of Compact 6-3-3 (b) after placing into Micarta mounts.

Compact sections were gently loaded with manipulator-held tweezers into 32-mm diameter Micarta cylinders as shown in Figure 3. Each transverse section was loaded into a 19-mm diameter flat-bottomed recess. Both longitudinal sections initially were placed into an oval-shaped recess, but it proved difficult to keep both sections at the same height as well as parallel to the Micarta surface. Later longitudinal sections were individually loaded into their own Micarta mounts. At least as many particles were damaged (buffers/kernels lost or entire particles dislodged) by the saw as cut cleanly by the saw. Some section corners and edges also broke off during saw cuts, as can be seen where the sections butt together in Figure 3(b). Despite these gross forms of saw damage, sawing did minimal damage to internal particle structures when particles were cut cleanly, as demonstrated by the bottom surface in Figure 4. Note that Particle AGR1-213-137T-058 in Figure 4 was denoted by experiment (AGR-1), by compact (2-1-3), by mount number (137T), and by order of imaging (058). All examined particles were individually identified using this format.

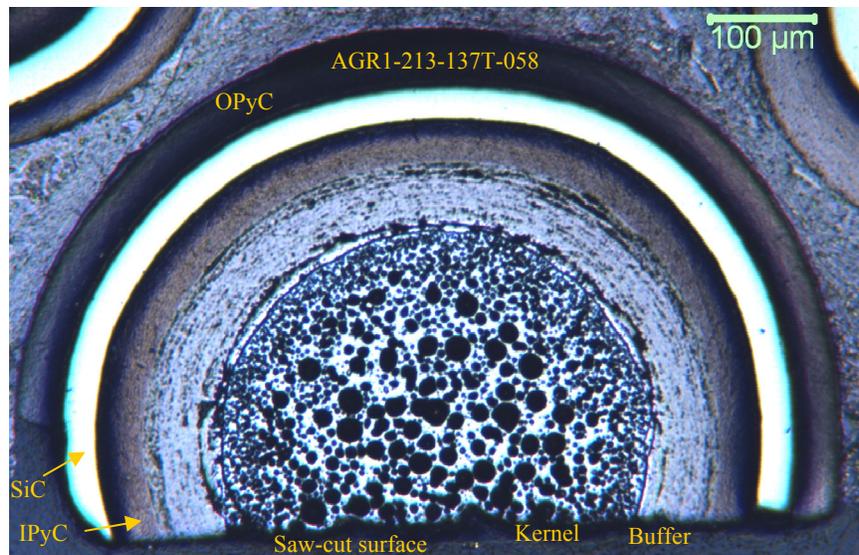
Figure 4. Cleanly cut particle at bottom end of a longitudinal cross section showing little internal damage.

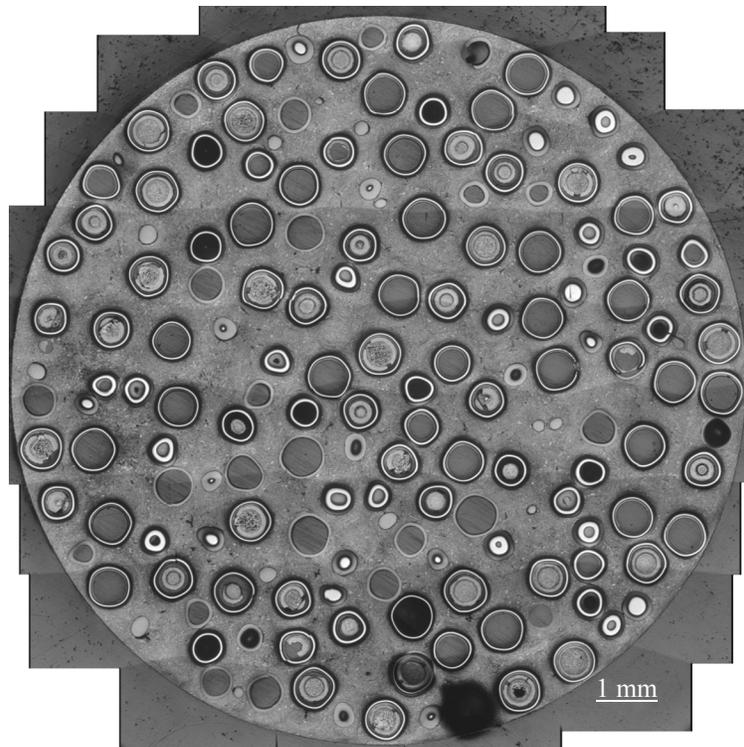
Figure 5. Representative appearance of AGR-1 mounts near saw-cut surfaces after initial grinding and polishing (here transverse cross section of Compact 3-3-3).

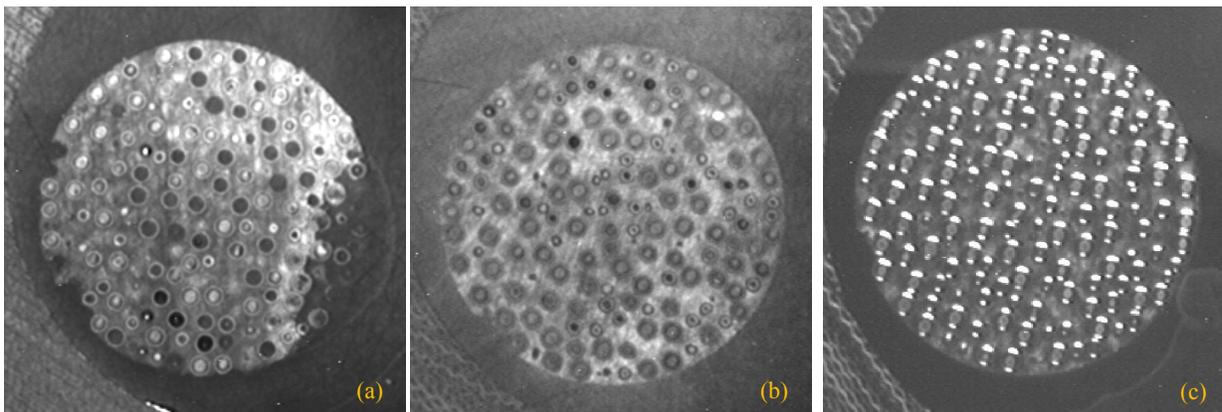
Figure 7. Cropped images of the transverse cross section of Compact 2-1-3 taken by the new Containment Box camera: (a) 600-grit surface with most saw damage still present, (b) 600-grit surface before last back-pot, and (c) after final 1- μm diamond polish.

The progression in mount appearance over the incremental grinding and back-potting process is illustrated in Figure 7. The Containment Box camera resolution was constrained to 0.4 megapixel by the available cable feedthrough. Nevertheless, the resolution was adequate to distinguish features of interest, especially the dark areas in Figure 7(b) that indicated open buffer-IPyC gaps in need of back-potting before more grinding. Good retention of kernels and buffers is even more evident in the metallograph montage in Figure 8. A goal of 75% retention (losing no more than approximately 15 kernels/buffers per mount) had been established for meaningful spatial investigations, which was satisfied by all of the reground AGR-1 cross sections. However, Figure 8 demonstrates that nearly all kernels and buffers could be retained with ample time and care.

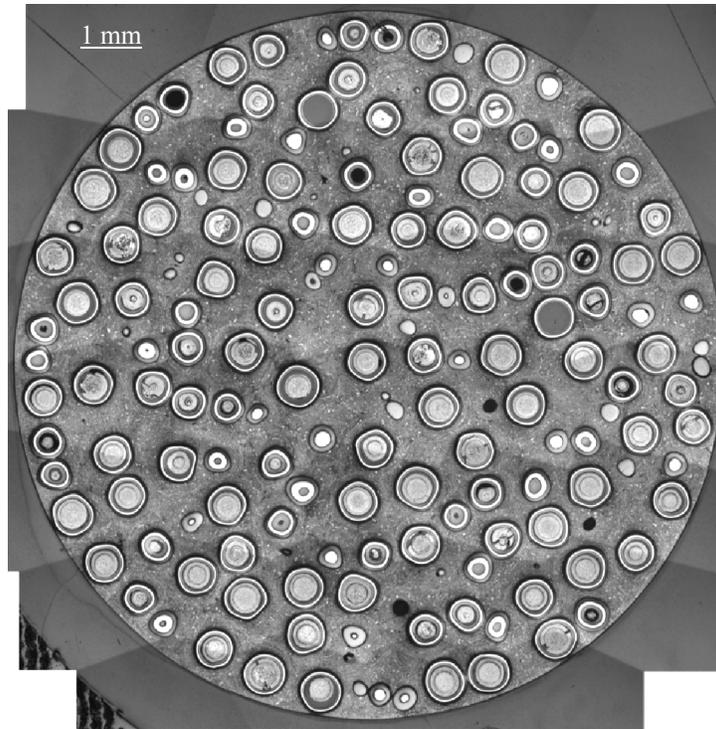
Figure 8. Montage of transverse cross section of Compact 3-3-3 after incremental grinding and back-potting. (Compare to Figure 5 to see improved retention of kernels and buffers in Figure 8.)

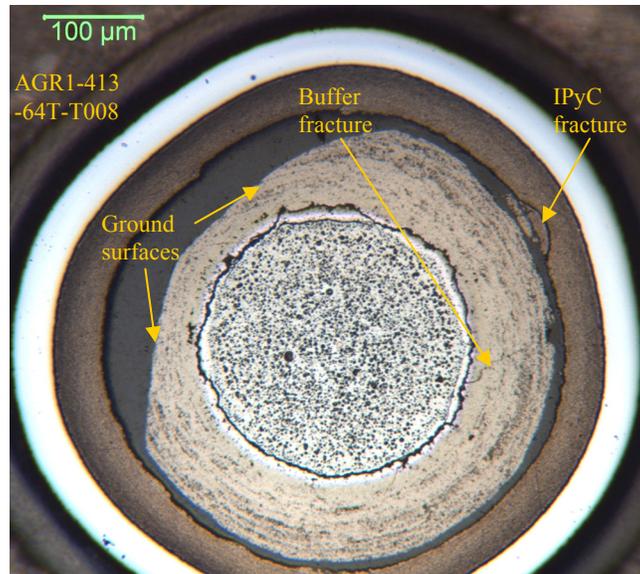
Figure 9. Grinding damage before internal structures were stabilized by back-potting.

Despite the dramatic improvement in retention of kernels and buffers from frequent back-potting, isolated particles with minor amounts of grinding damage could still be found. Figure 9 provides one example where the buffer and kernel rotated several times inside the IPyC layer while being ground before being stabilized by back-potting. A lenticular IPyC fracture apparently also occurred where the buffer rotated against the IPyC layer, and hairline fractures may have occurred in the buffer at the same time. Although most buffer-IPyC gaps were impregnated with epoxy before the buffer was contacted by the grinding disc, one or two such lopsided buffers were typically found in each of the compact cross sections. IPyC damage from buffer rotation was found to be extremely rare during sample preparation.

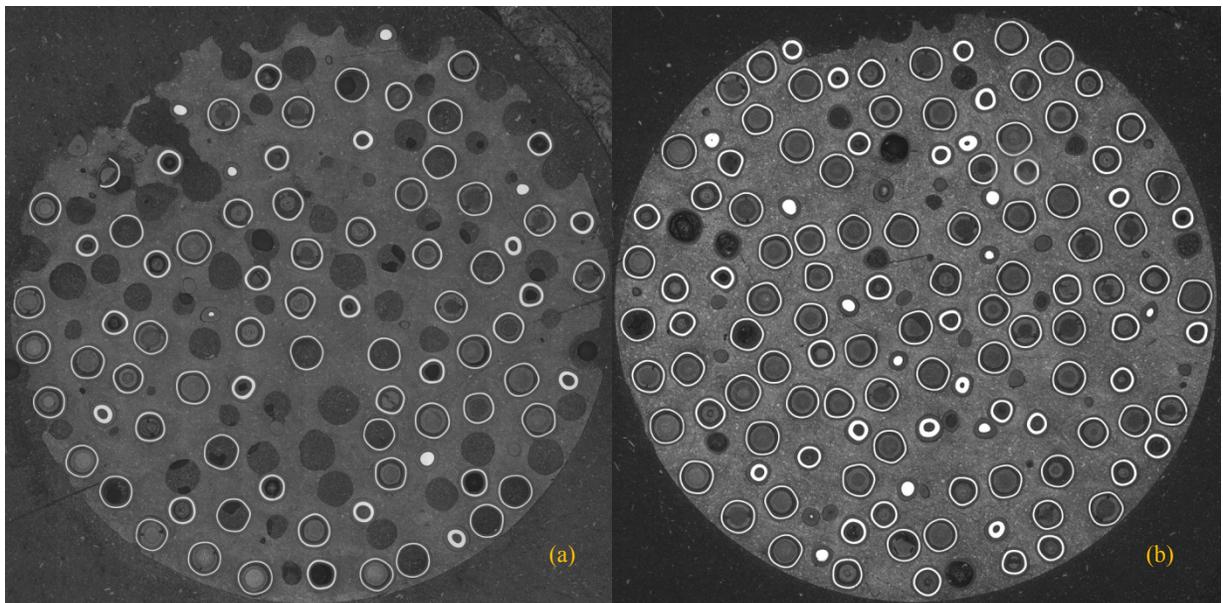
Figure 10. Polished transverse cross section of Compact 6-4-2: (a) before iterative back-potting and (b) after iterative back-potting.

Figure 10 shows the polished transverse section before and after the iterative back-potting. Without iterative back-potting, there were approximately 60 missing particles (appearing as solid gray circles where particles were removed by the saw and epoxy infiltrated during initial vacuum potting). Many of these would have been close enough to midplane for classification of kernel and layer behavior. After iterative back-potting there were only three missing particles, all too far past midplane for analysis. About 15 particles were missing the buffer and kernel in the initial polished section, compared to only two after iterative back-potting. About 10 particles in the final polished section were missing all but the OPyC layer. Seven of these were too far past midplane for analysis. Separation at the OPyC/SiC interface was enhanced in this sample because of the greater number of particles ground past midplane, but still retained in the matrix because of the iterative back-potting. The total number of particles in the transverse cross section available for analysis (see Section 3) increased from approximately 35 before iterative back-potting to 67 after. Note that some of the saw damage at the edge of the compact was also removed by grinding well past the initially cut plane.

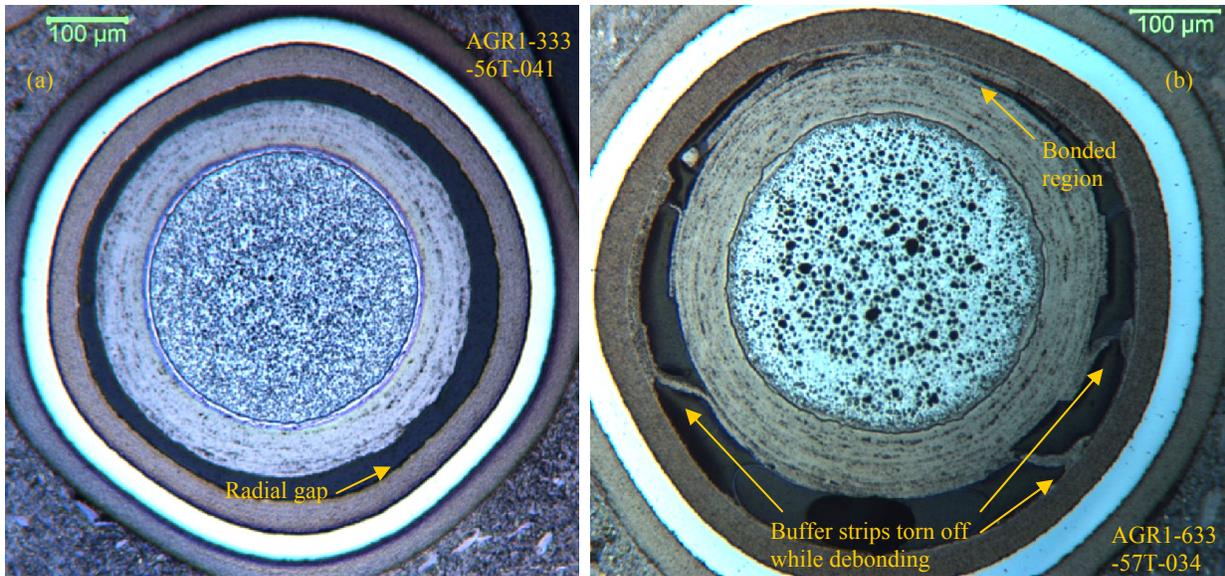
Figure 11. Continuous radial gap commonly seen in irradiated AGR-1 particle cross sections (a) and radial gap interrupted by residual buffer-IPyC bonding along the interface (b).

Several characteristic morphologies came to be recognized as the high resolution images of individual particle cross sections were examined. The most common feature was a radial gap between the buffer and IPyC layers where the buffer densified inward (outer surface moved toward kernel) during irradiation, as displayed in Figure 11(a). In some particles with inward buffer densification, such as the one shown in Figure 11(b), the radial buffer-IPyC gap was interrupted by regions where the buffer stayed firmly bonded to the IPyC layer. Many of these particles debonded along most of the interface, while debonding was much less extensive on some other particles when the AGR-1 irradiation ended. The rarest case was where a particle had no buffer-IPyC gap. In these cases, the buffer stayed bonded to the IPyC layer around the entire circumference. The buffers in these particles still evidently densified, but the inner buffer surface moved radially outward rather than the outer buffer surface moving inward. Kernels in these particles often had larger pores than seen inside kernels within inwardly densified buffers.

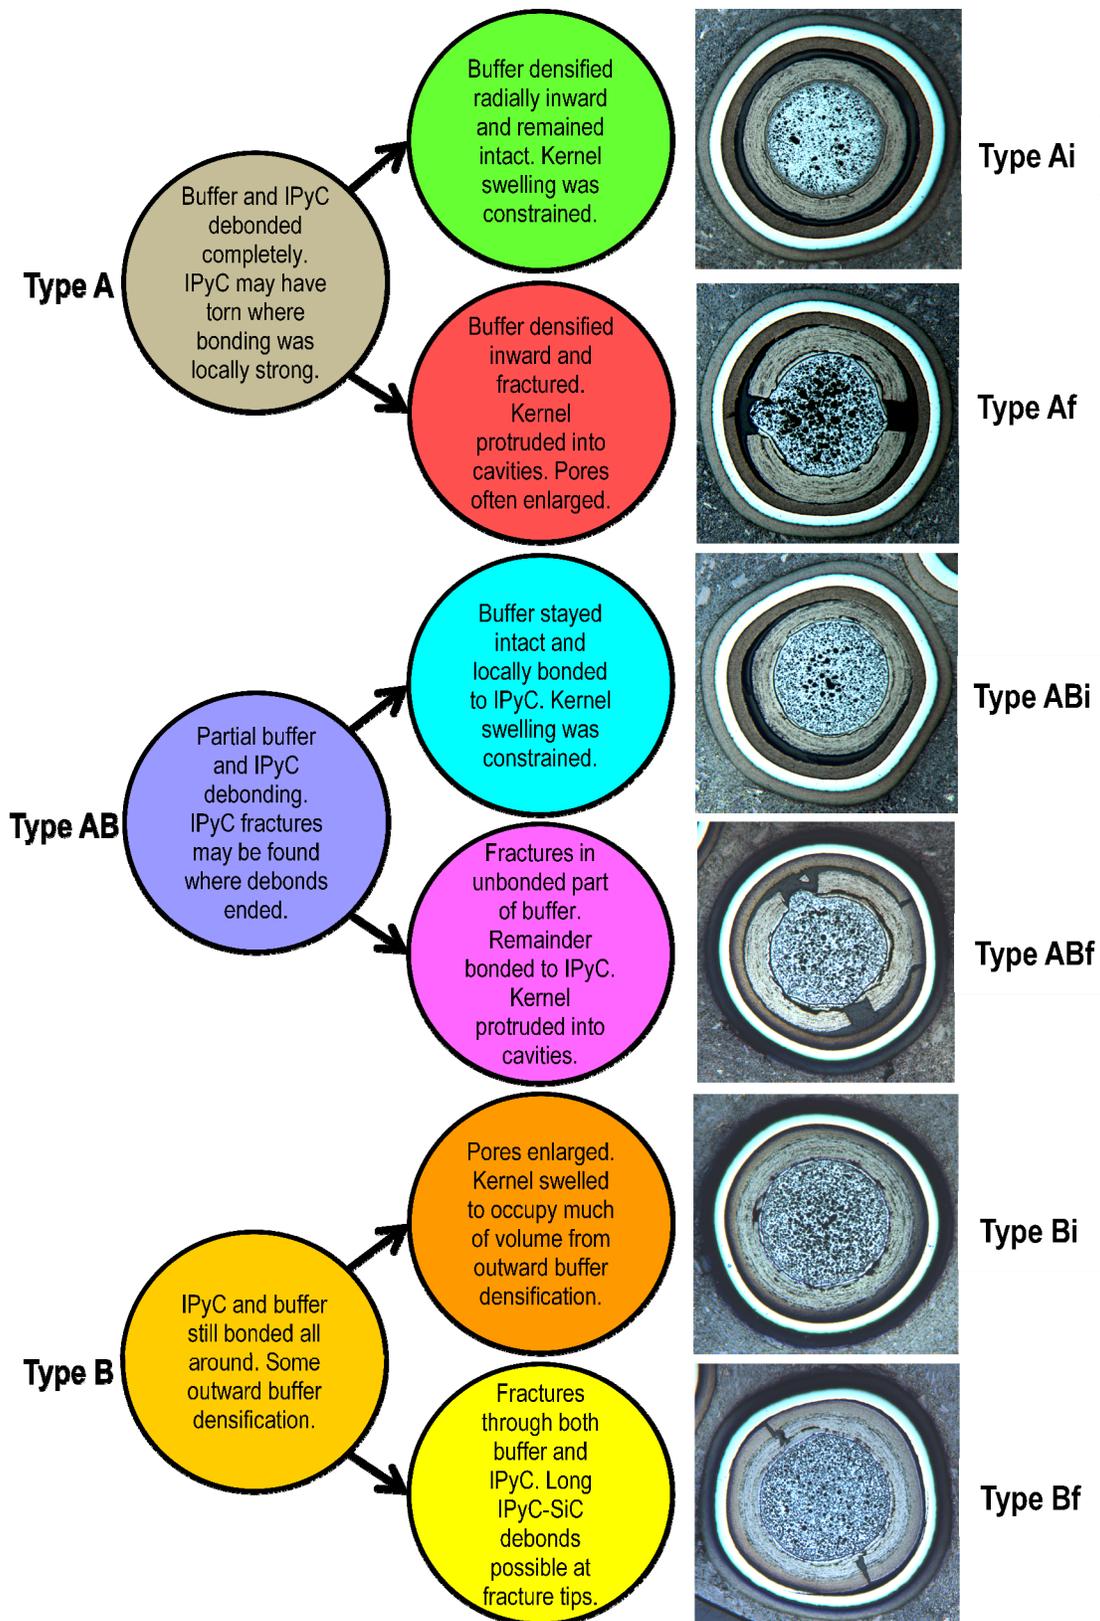
Figure 12. Characteristic end-state morphologies and associated features observed in irradiated AGR-1 fuel particles, where “i” signifies an intact buffer and “f” signifies a fractured buffer.

The colors in the middle column of Figure 12 were used to encircle the classified particles in the cross sections in order to map morphologies. An example map is provided in Figure 13, where the spatial distribution of colors appears random. This is typical of all AGR-1 transverse and longitudinal morphology maps presented in Appendix A. No obvious patterns emerged despite appreciable estimated axial and radial gradients in temperature (Hawkes 2012), some axial variation in calculated fast fluence (Sterbentz 2011), and significant axial variations in measured burnup (Harp 2011) within individual irradiated AGR-1 compacts.

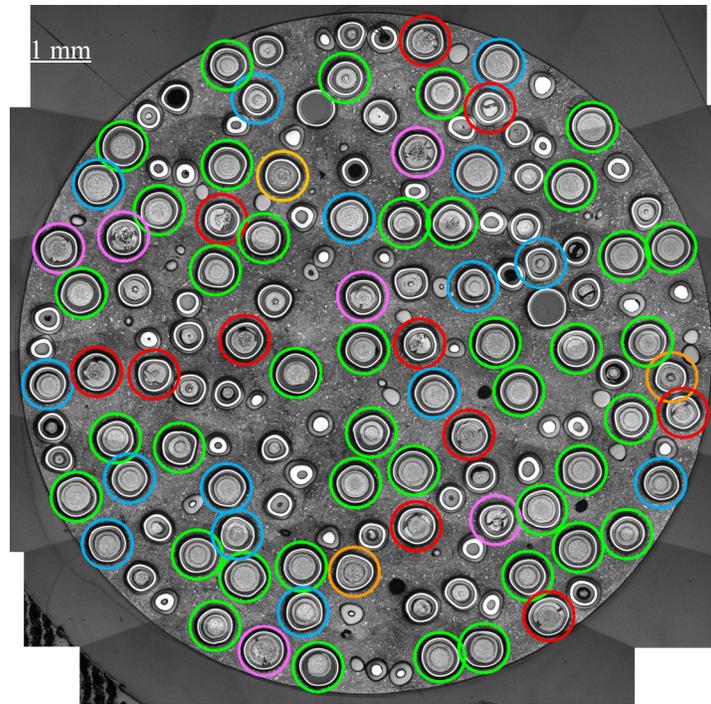
Figure 13. Particle morphology map for the transverse cross section of Compact 3-3-3.

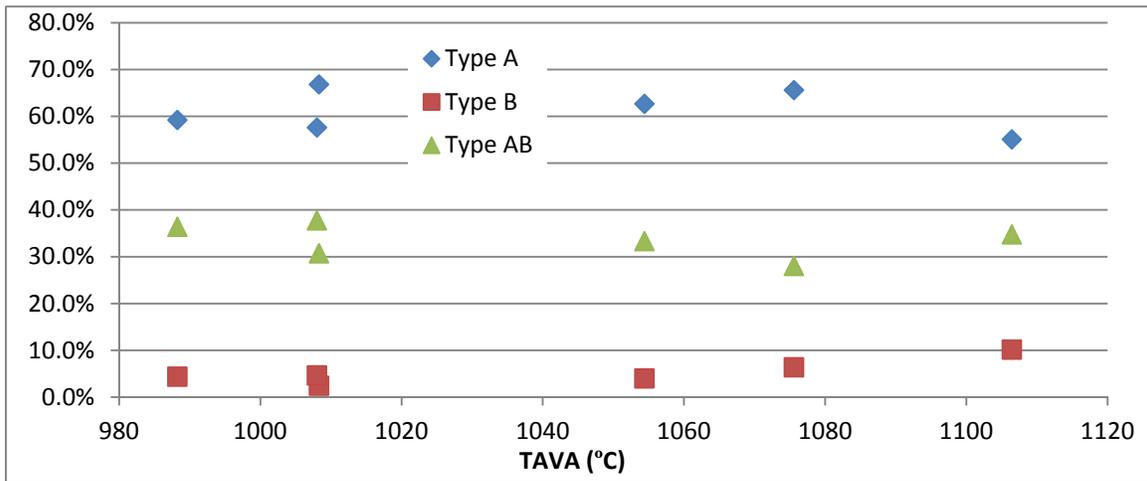
Figure 17. Frequencies of basic particle types plotted according to time-average volume-average temperature.

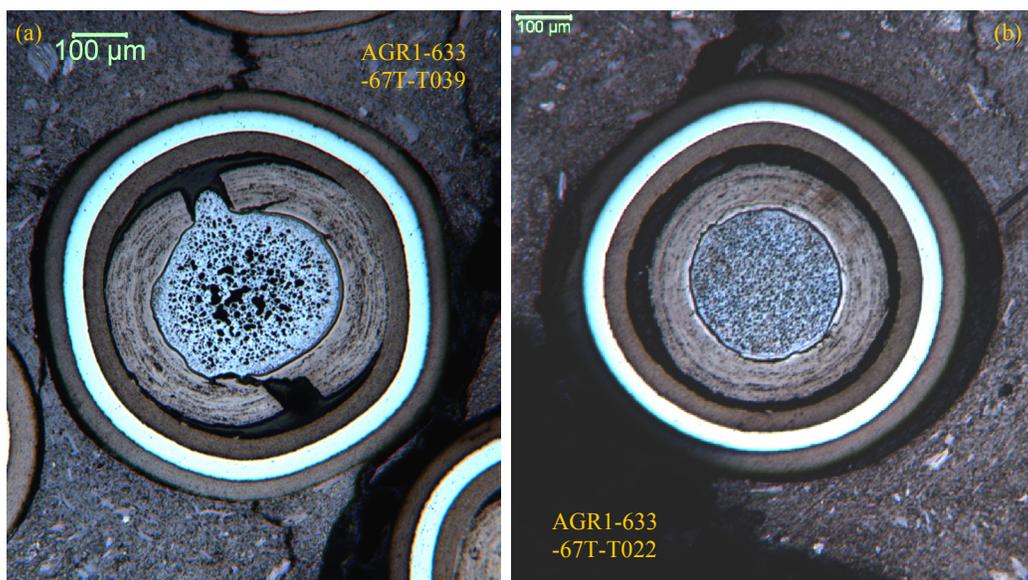
Figure 18. Matrix fracture diverted around OPyC layer (a) and matrix-OPyC delamination (b), both from sample preparation.

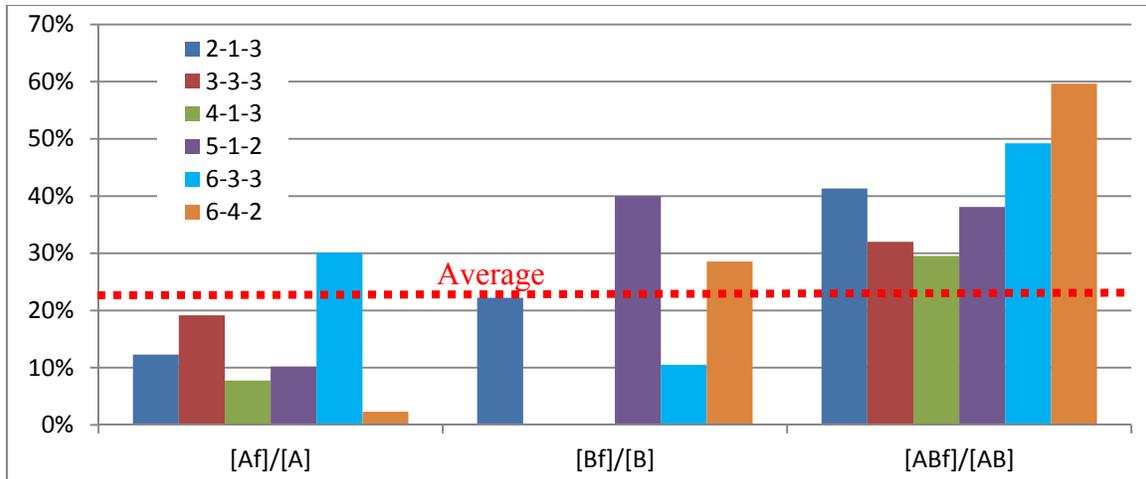
Figure 19. Frequency of fractured buffers among basic types in irradiated AGR-1 compacts.

Figure 19 shows relatively minor buffer fracture frequency differences among compacts, while the frequency differences among particle types are more striking. Although Type Bf particles were too rare for meaningful comparisons, Figure 19 reveals that buffer fractures occurred on average over three times as frequently in Type AB particles than in Type A particles. The general trend of higher frequency of fractures in Type AB particles compared to Type A particles was seen for all six compacts. The reason was not immediately apparent because buffer fractures have been thought to arise in both Type A and Type AB particles from buffer hoop stress created by the combination of inward buffer densification and outward kernel swelling.

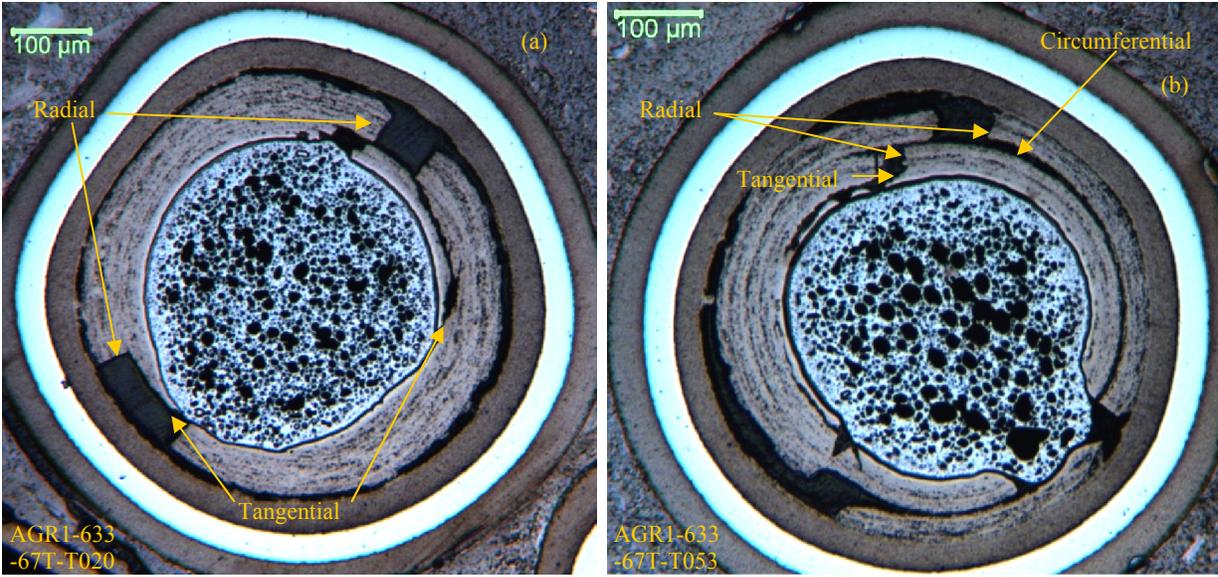
Figure 21. Jagged buffer fractures with mixtures of tangential, radial, and occasionally circumferential components.

The buffer fracture process in Figure 20 cannot explain the preponderance of buffer fractures in Type AB particles, where a second mechanism may have dominated. Figure 21 shows that buffer fractures could be more complex than in Figure 20, where the complex fractures typified in Figure 21 often appear to have initiated tangentially at the kernel interface. The initially tangential buffer fractures evidently failed in the radial direction after propagating in a variety of directions, leaving fracture surfaces with a jagged contour. Figure 18(a) shows a smooth radial fracture on the top side and a jagged contour on the bottom, so some particles exhibited both shapes of buffer fracture.

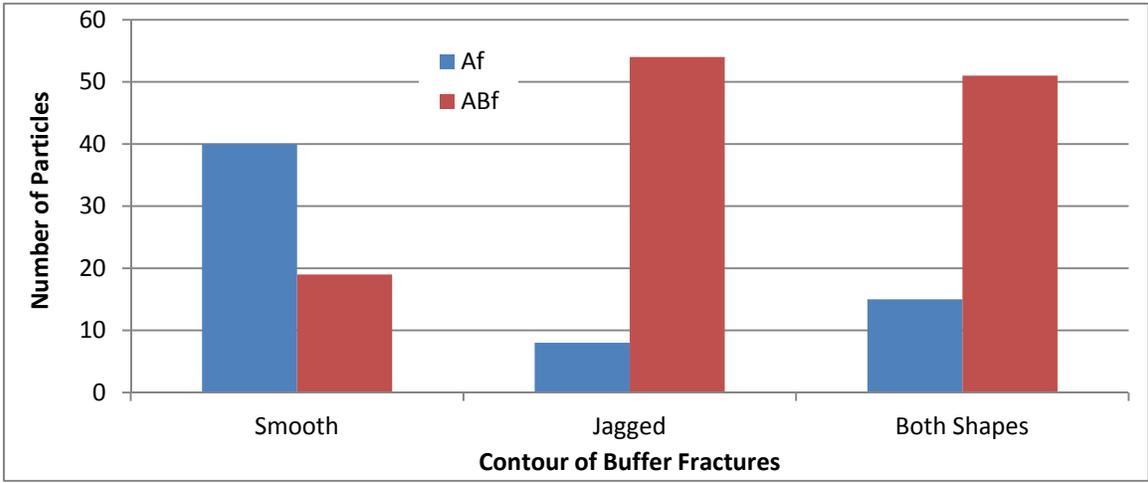
Figure 22. Different buffer fracture shapes seen in Type Af and Type ABf particles.

Figure 22 reveals that smooth radial fractures were much more common in Type Af buffers than in Type ABf buffers. Meanwhile, jagged (multidirectional) buffer fracture contours were found much more frequently in Type ABf particles than Type Af particles. Approximately one-third of the 152 particles covered in Figure 22 contained both shapes of buffer fracture, as in Figure 18(a). In addition, 16 Af particles and 18 ABf particles included in Table 2 showed too little of their buffer fractures for contours to be clearly distinguished, so they could not be included in Figure 22.

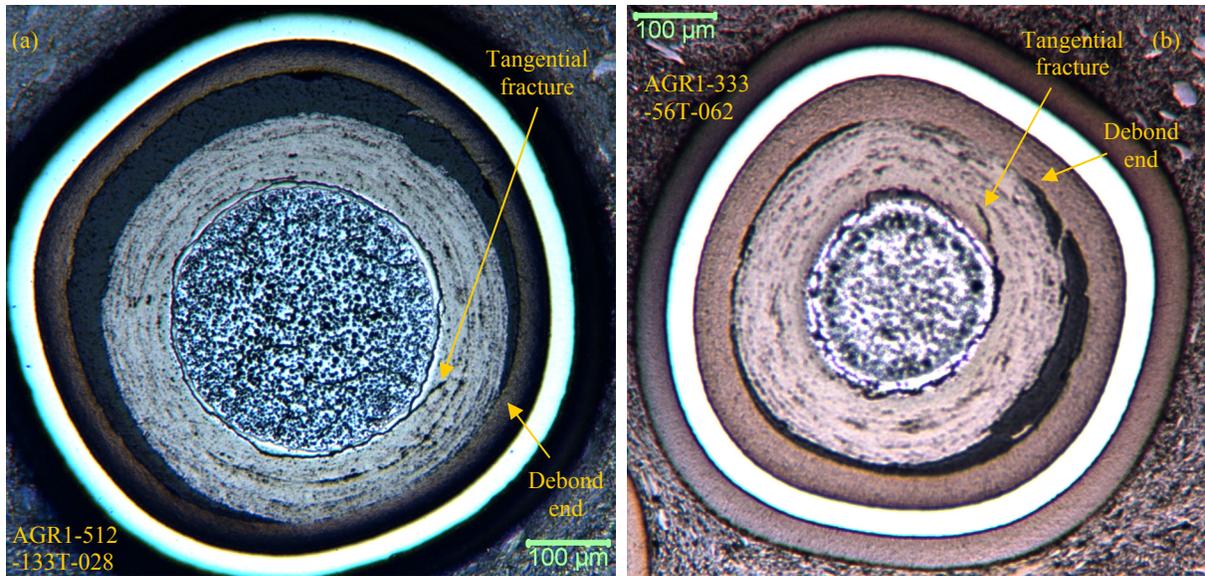
Figure 23. Apparent incipient buffer fractures that initiated tangentially near azimuths where buffer-IPyC debonds terminated.

Determining how jagged buffer fractures initiated is very difficult from end-state particle configurations. Nevertheless, several images of Type AB particles apparently contain rare incipient tangential buffer fractures. Two examples are presented in Figure 23 where the incipient tangential fractures began at the kernel interface and coincide azimuthally with the ends of buffer-IPyC debonds. The bright thickness at the kernel interface is referred to as a uranium carbide “skin” (Hunn et al. 2005). It may have had some role in initiating the tangential buffer fractures.

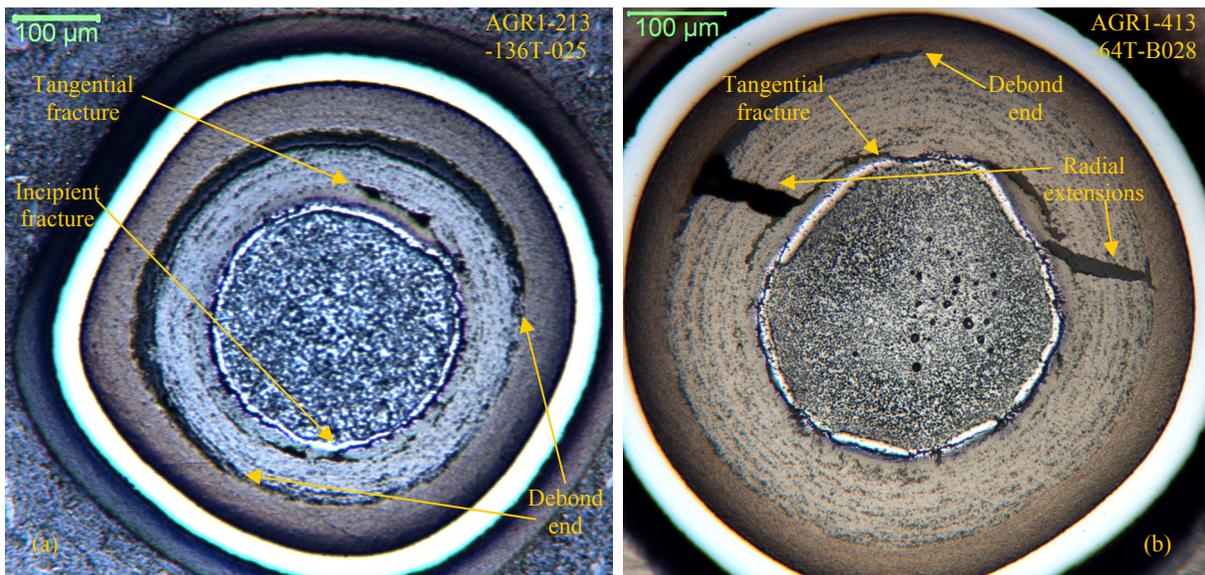
Figure 24. Tangential buffer fractures that propagated to varying extents.

Figure 24 displays two tangential buffer fractures that progressed beyond the incipient stage. In both of these examples, the tangential buffer fractures split from the kernel interface at approximately the same azimuths as the buffer-IPyC debonds ended. However, the azimuths where the buffers and IPyC layers were separating when the buffer fractures were initiated cannot be determined. Figure 24(a) also reveals an incipient buffer fracture toward the bottom. Here the fracture connected the kernel interface to an apparent concentration of buffer porosity that was circumferentially oriented. Similar circumferential pore concentrations are evident in portions of Figures 23(a) and 23(b), as well.

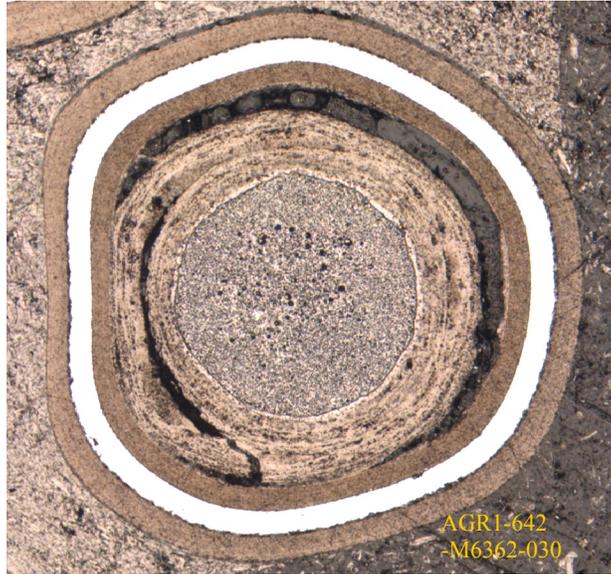
Figure 25. Isolated example where a fracture may have initiated at a buffer periphery.

For completeness, there may have been cases where buffer fractures initiated along the buffer periphery instead of at the kernel. Figure 25 provides the only example of such behavior discovered during examinations of the six AGR-1 compacts. This fracture is within the portion of buffer still bonded to the IPyC layer, so how stress would have concentrated to initiate the fracture at the periphery is not readily apparent. Therefore, a possibility exists that this buffer fracture initiated at the kernel at a different plane than exposed in Figure 25.

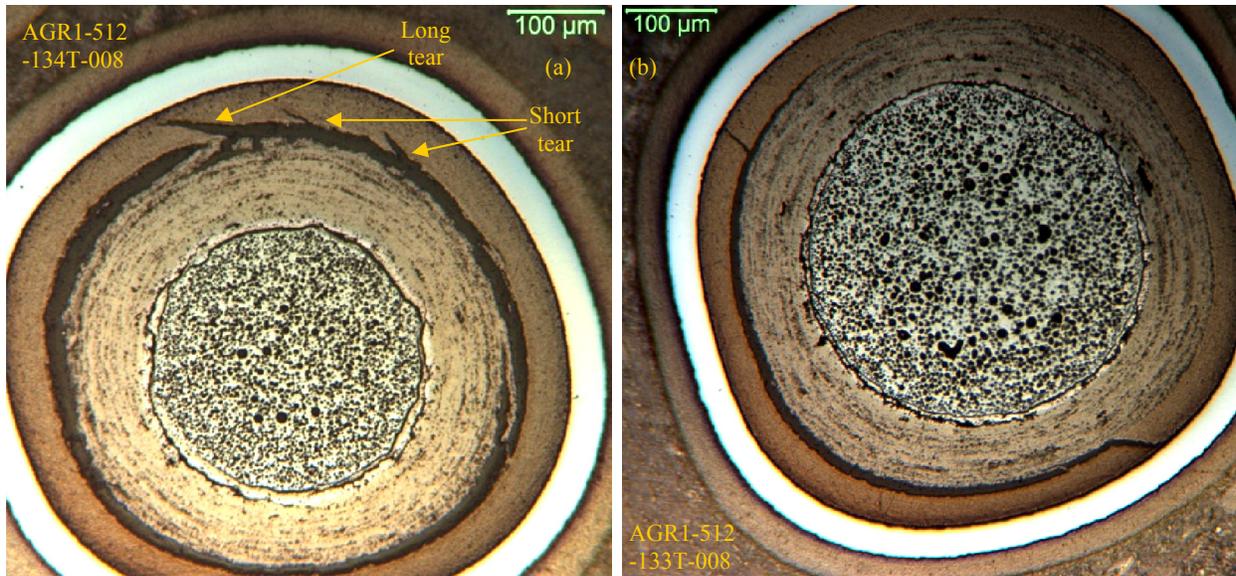
Figure 26. IPyC fractures where buffer apparently was strongly bonded to IPyC layer.

Fractures in irradiated AGR-1 IPyC layers were observed in a range of extents, from incipient to through-wall, as well as in a wide variety of circumstances. Both images in Figure 26 suggest that the IPyC layer may have torn during buffer-IPyC debonding at interfacial points where bonding was especially strong. Locally strong bonding evidently initiated the two short tears in Figure 26(a), but the bonds apparently released at both locations before these fractures penetrated the entire IPyC layer. The tear was much longer where the buffer-IPyC bond was maintained. In Figure 26(b), buffer-IPyC debonding halted at the lower IPyC fracture, but apparently resumed after starting the IPyC fracture at the upper left. These observations infer that bond strength varied considerably along the buffer-IPyC interface, at least within these two Compact 5-1-2 particles. In any case, buffer fractures clearly were not essential for IPyC fractures. Similar behavior with buffer fracturing is shown in Figure 12 for the Type ABf example, where IPyC fractures were found immediately adjacent to the circumferential region that still had a bonded buffer-IPyC interface.

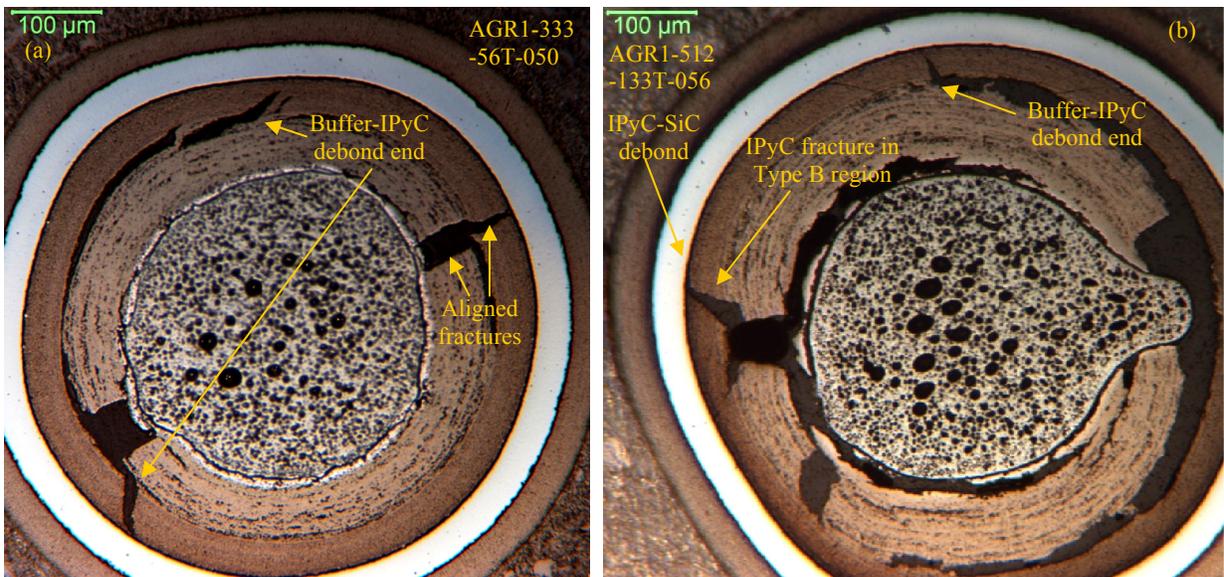
Figure 27. IPyC fractures in Type AB particles with multiple buffer fractures.

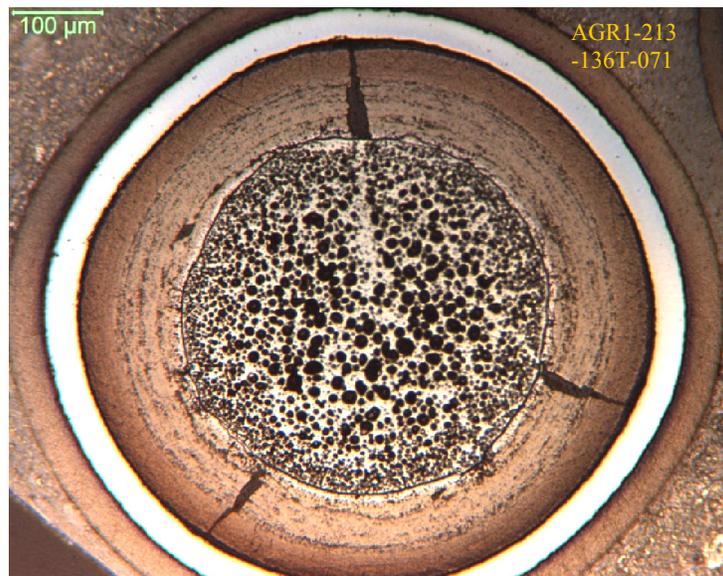
Figure 29. Extensive IPyC-SiC debonding at tips of three IPyC fractures in a Type Bf particle.

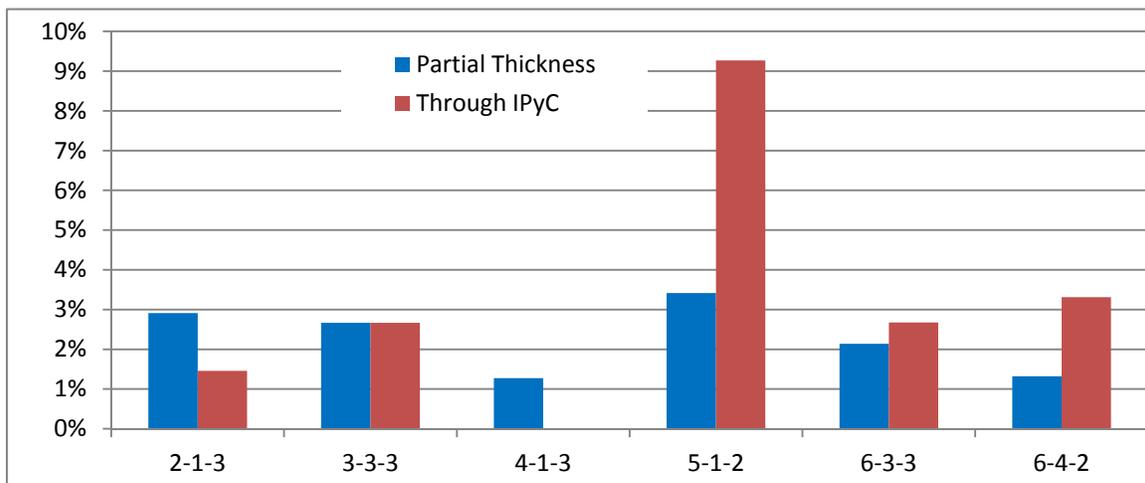
Figure 30. Percentages of particles with IPyC fractures among irradiated AGR-1 compacts.

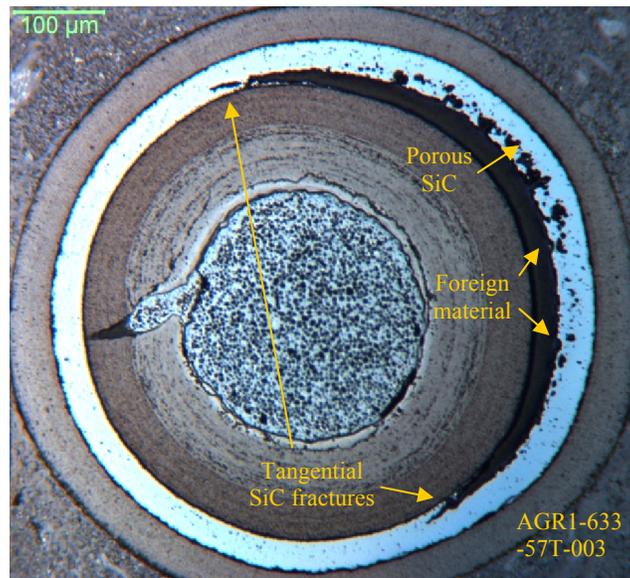
Figure 31. Tangential SiC fractures bordering a probable soot inclusion.

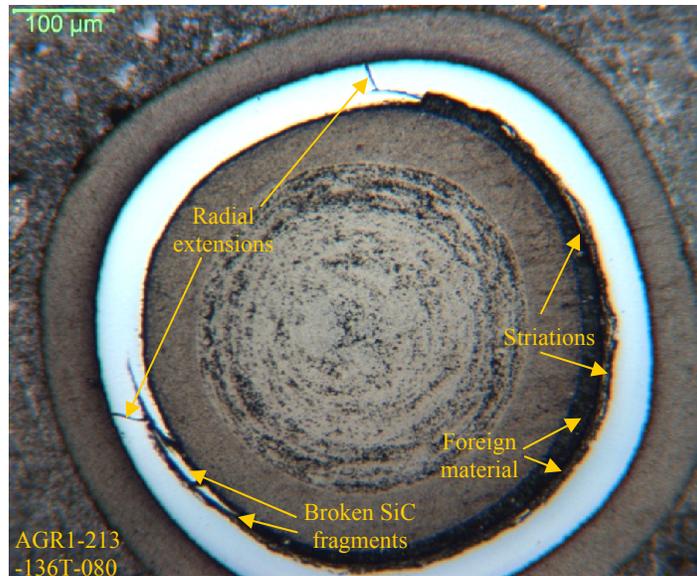
Figure 32. SiC fractures in the crown of a particle with foreign material between IPyC and SiC.

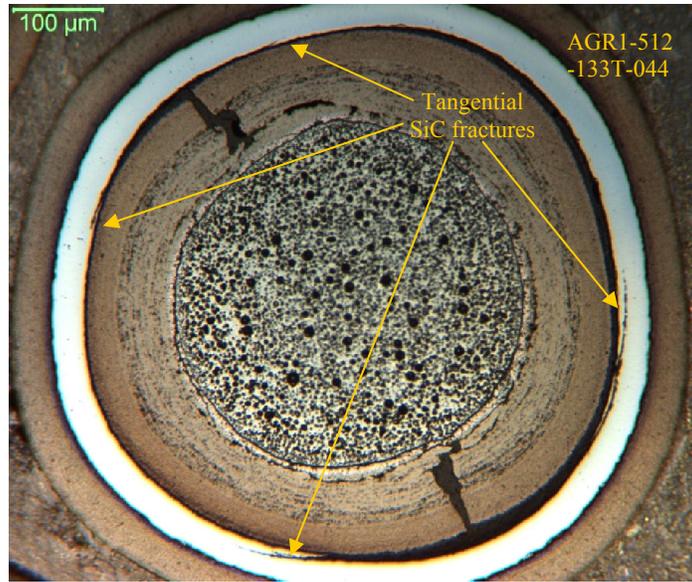
Figure 33. Pairs of SiC fractures symmetrically positioned around two buffer-IPyC fractures.

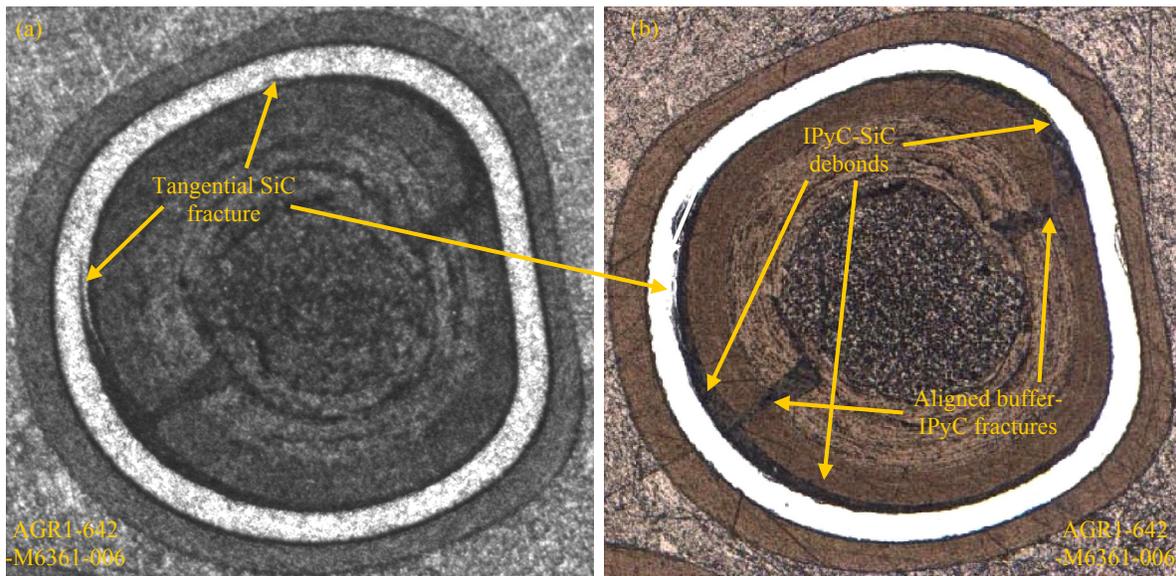
Figure 34. Tangential SiC fractures in an aspherical Type Bf particle earlier (a) and later (b) in the grinding and polishing sequence.

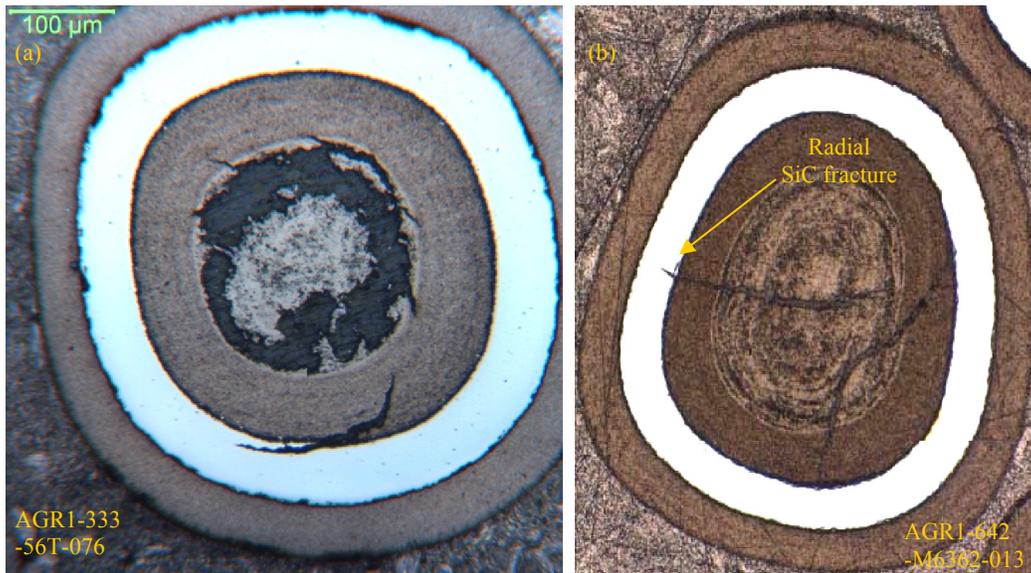
Figure 36. SiC fractures in two particles whose cross sections are located far from midplane.

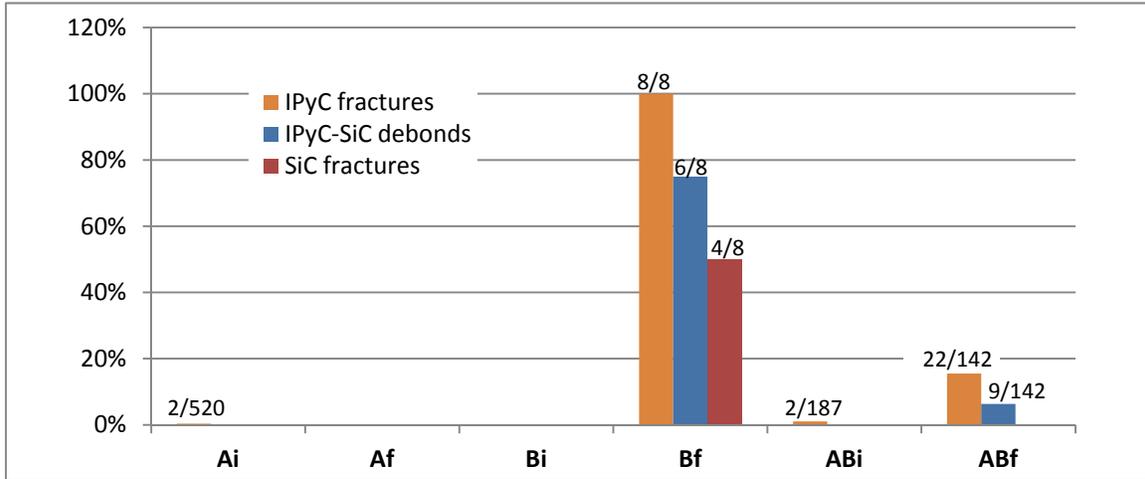
Figure 37. Frequencies of IPyC fractures, IPyC-SiC debonds, and SiC fractures by type among the 981 classified AGR-1 particles.

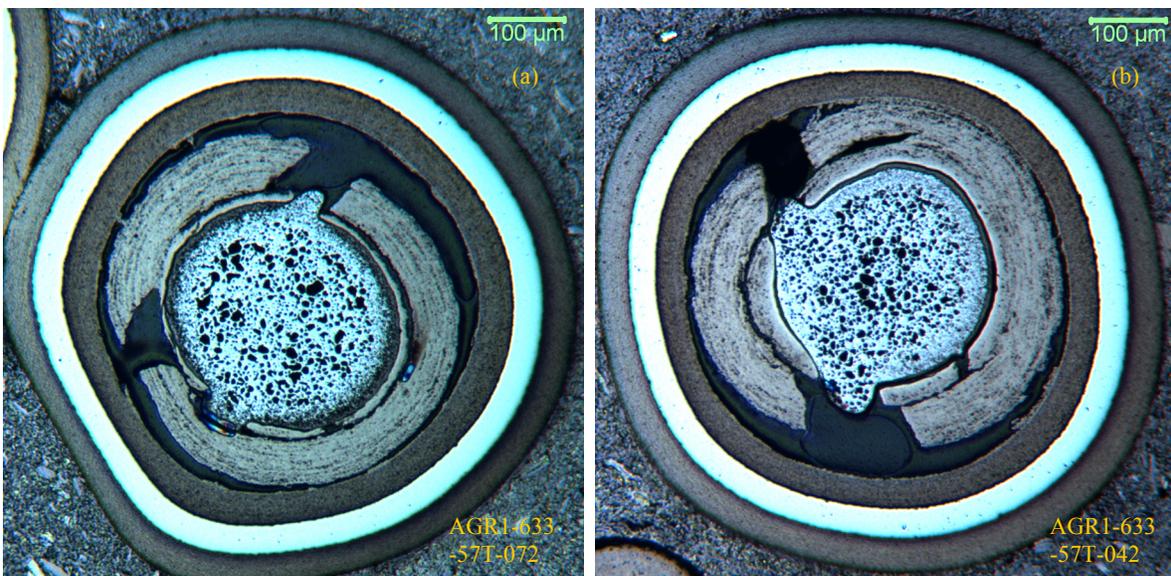
Figure 39. Kernels inhibited from protruding into buffer cavities by buffer fragments.
