Ceramographic Examinations of Irradiated AGR-1 Fuel Compacts

Very High Temperature Reactor Project

INL/EXT-12-25301
Revision 1

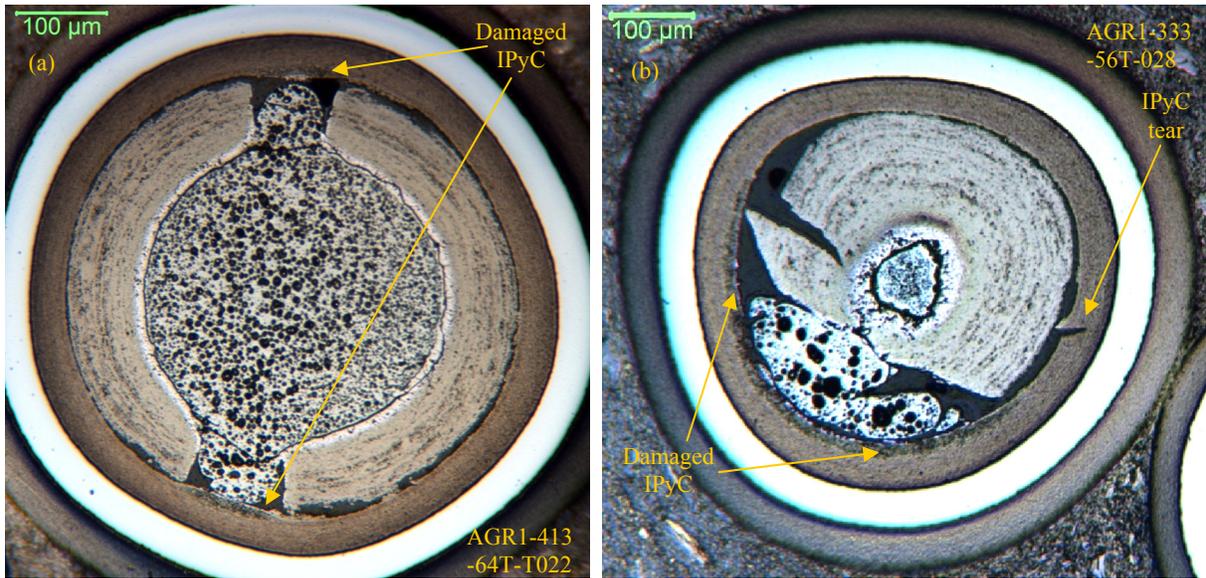
Figure 40. IPyC interiors damaged by kernel growth through fractured buffer cavities.

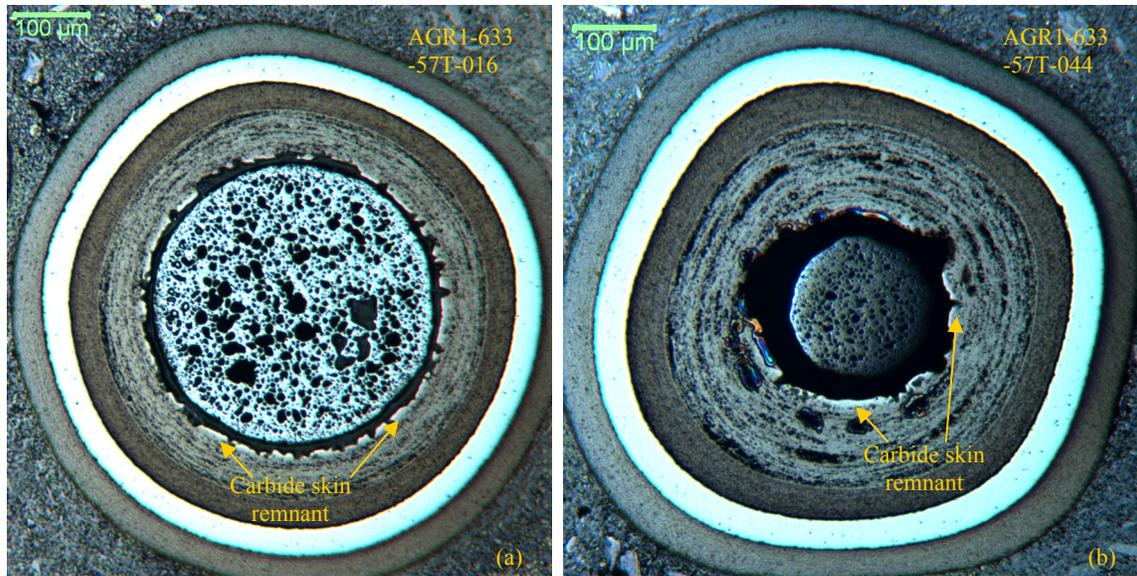
Figure 41. Apparent radial gap between kernel and buffer in two Type B particles from Compact 6-3-3.

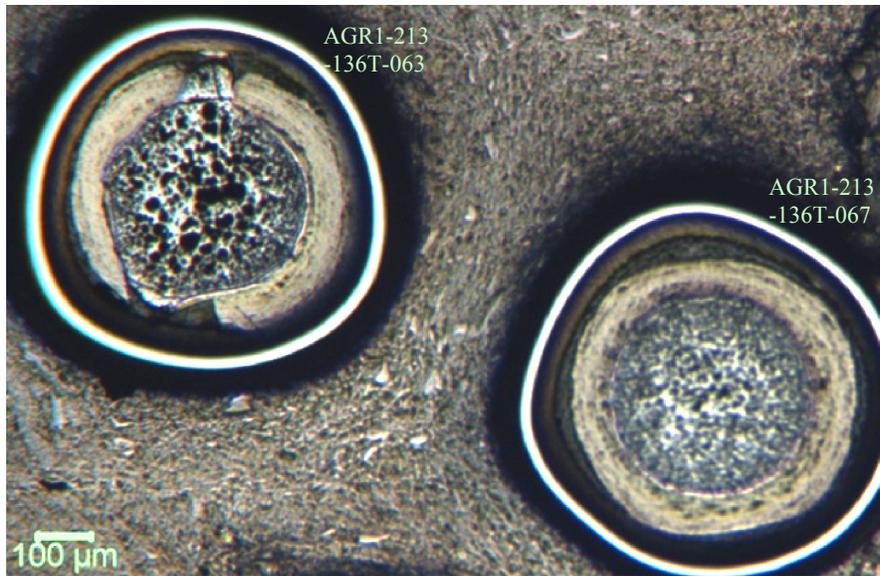
Figure 42. Larger kernel pores inside a fractured buffer than in a nearby kernel inside an intact buffer.

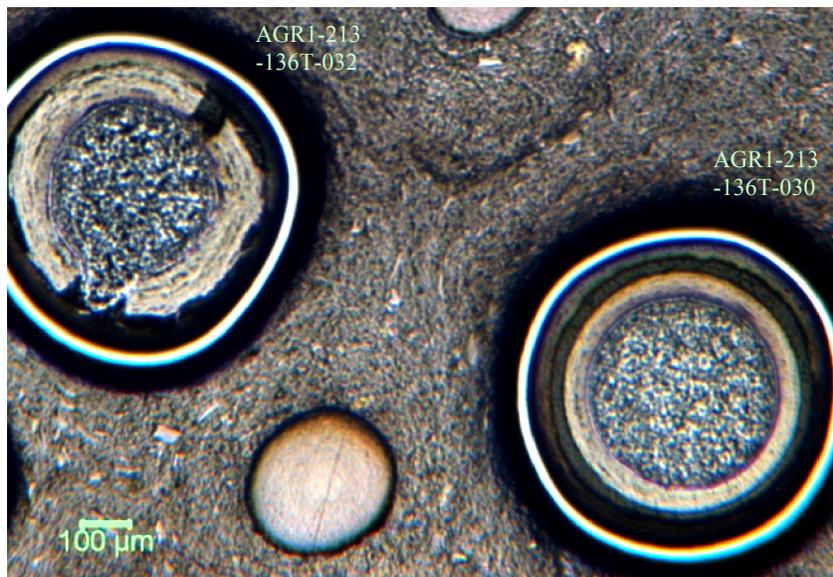
Figure 43. Kernel pores within a fractured buffer that were only slightly larger than inside an intact buffer.

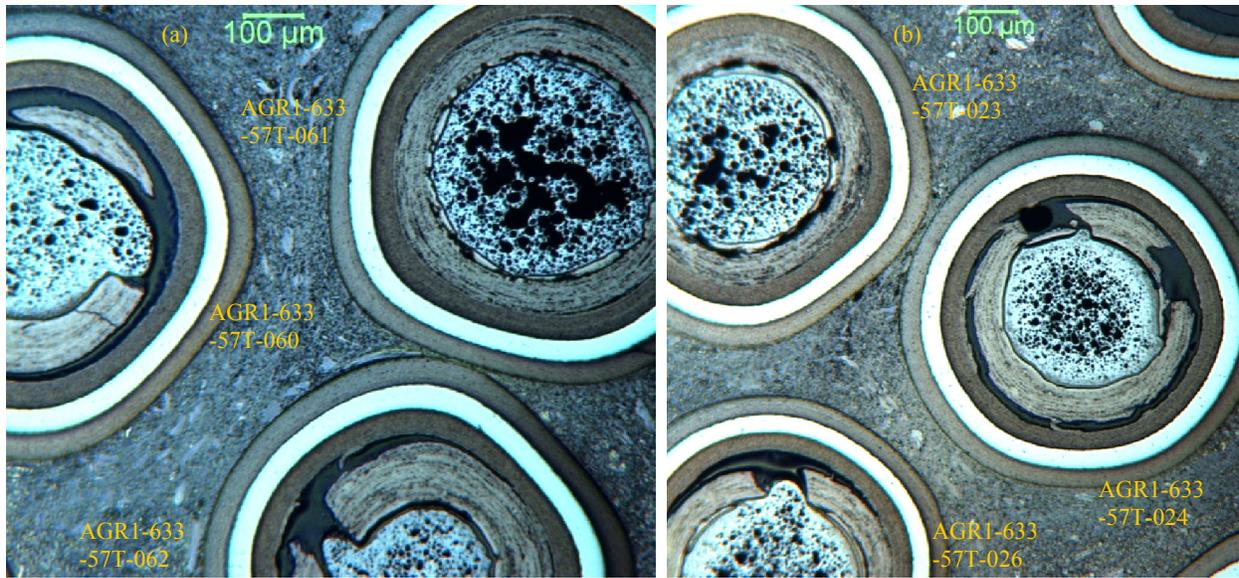
Figure 44. Larger pores in Type Bi Particles 061 and 023 than in nearby particles with fractured buffers.

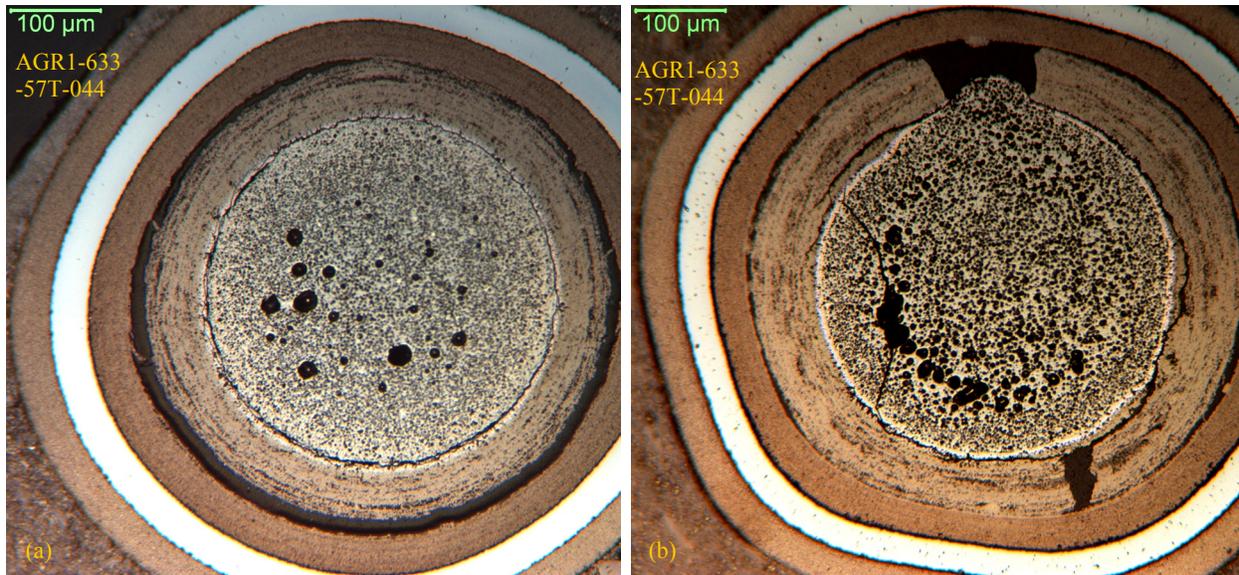
Figure 45. Two examples of spatial variations in pore enlargement.

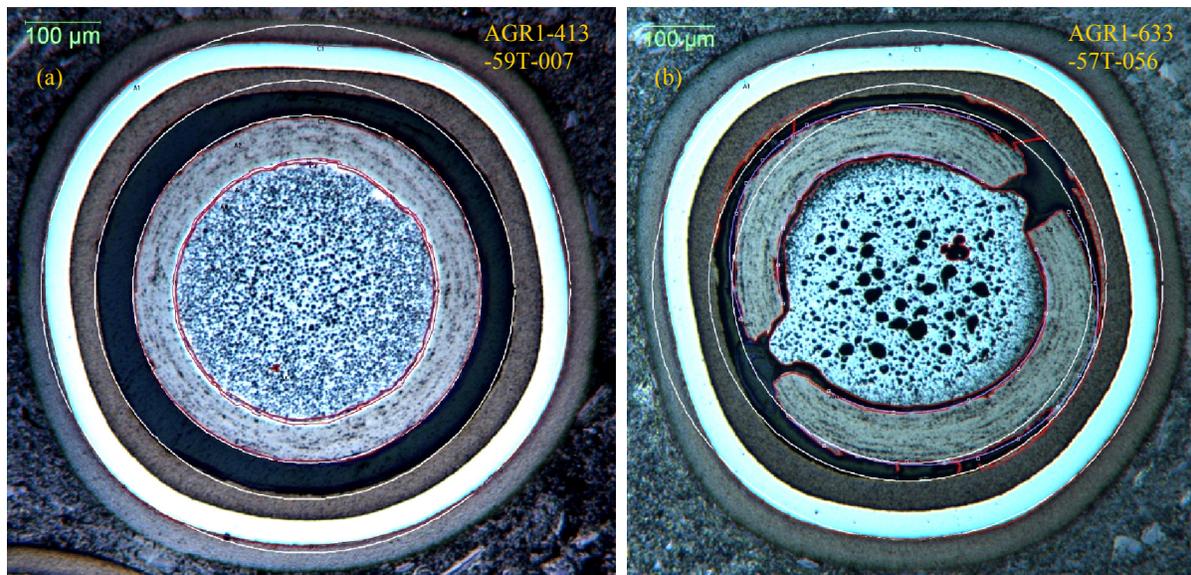
Figure 46. Circles (white), polygons (red), and arcs (blue) fit to particles without (a) and with (b) a fractured buffer for dimensional measurements.

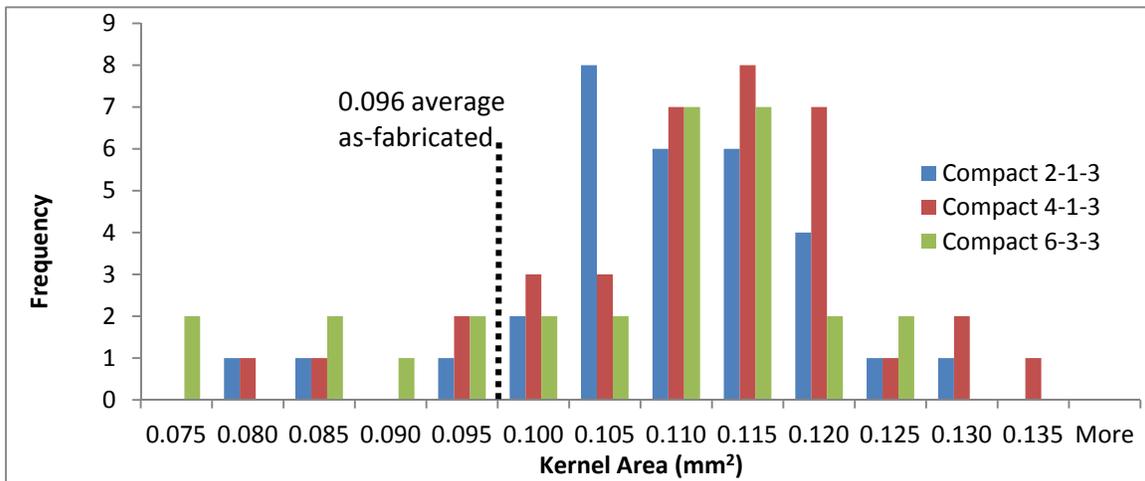
Figure 47. Histogram of 95 irradiated cross-sectional kernel areas.

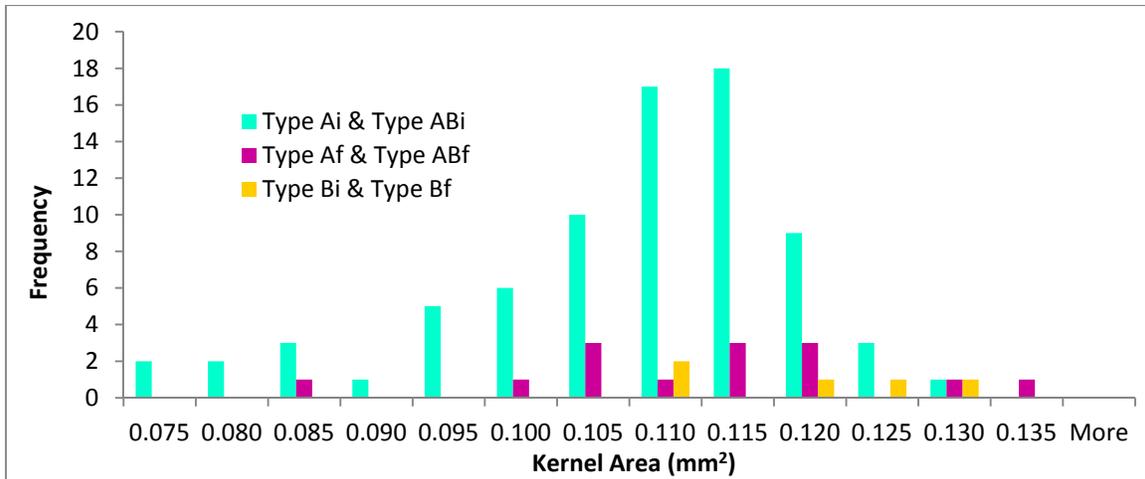
Figure 48. Kernel areas grouped according to buffer-imposed constraint on kernel swelling.

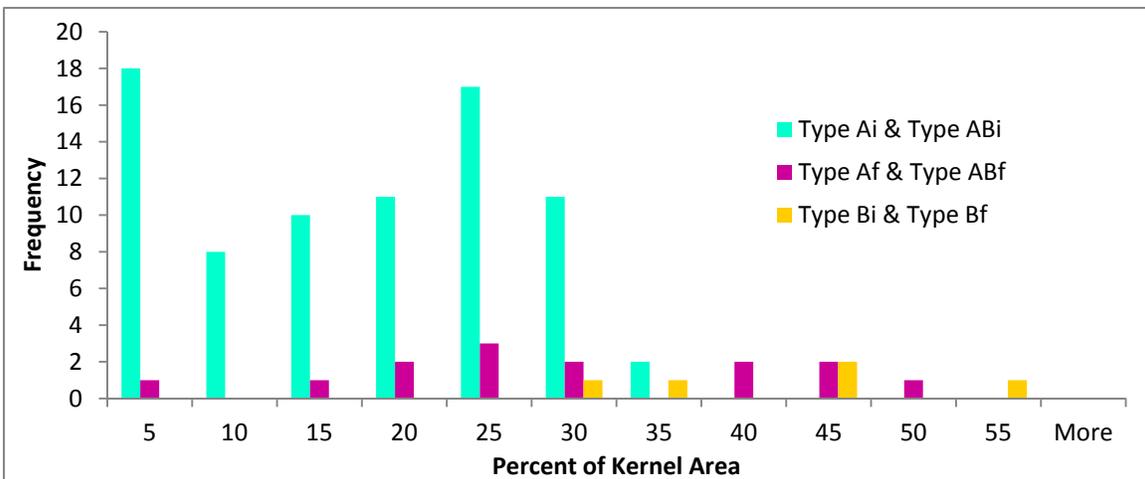
Figure 49. Pore area percentages in kernels according to buffer-imposed constraint on kernel swelling.

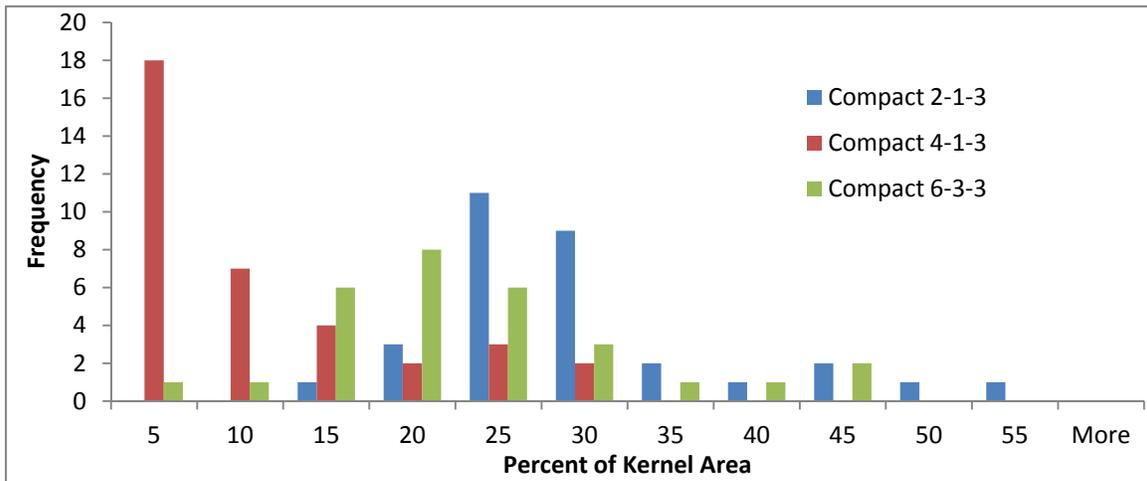
Figure 50. Kernel pore area percentages grouped by compact.

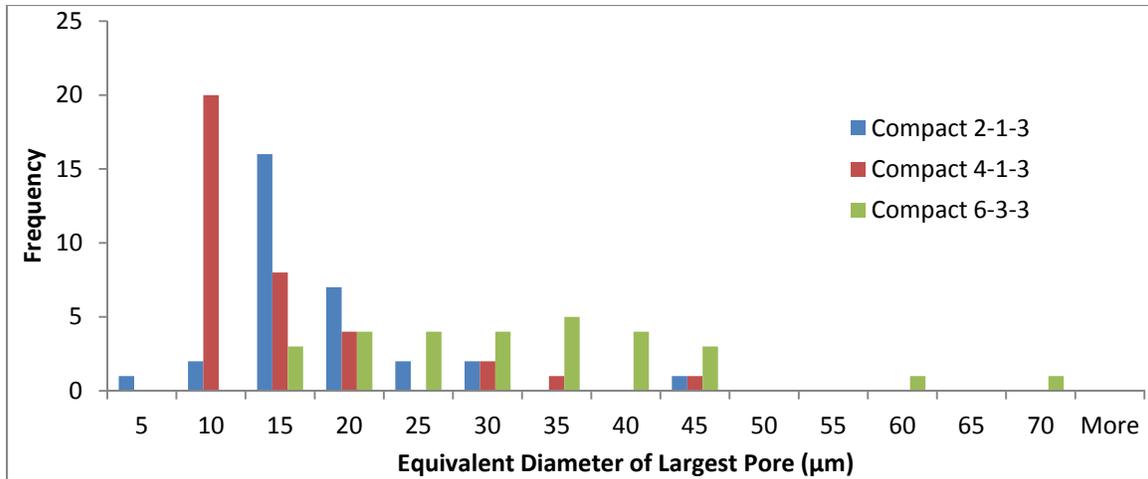
Figure 51. Size of largest pore in each kernel grouped by compact.

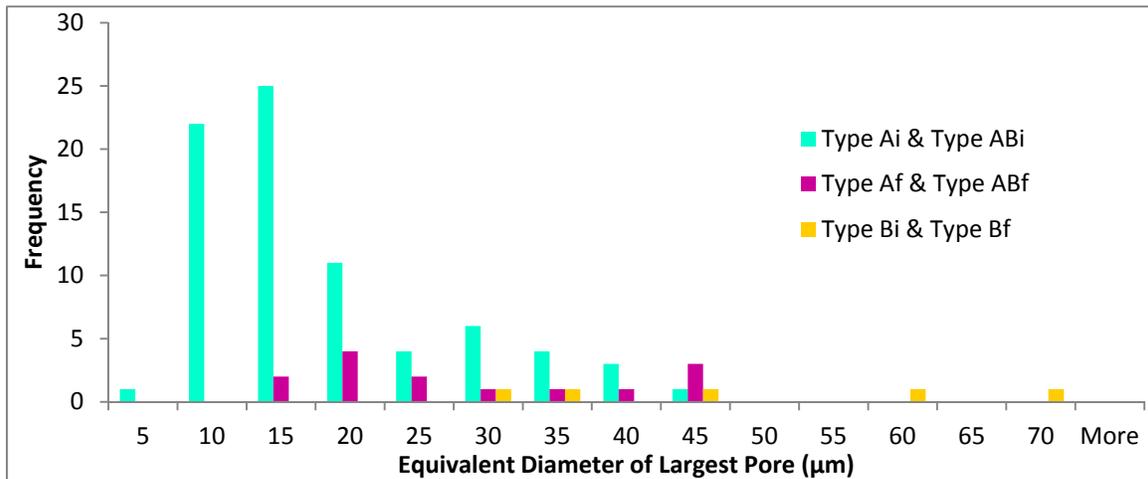
Figure 52. Largest kernel pore sizes grouped according to buffer-imposed constraint on kernel swelling.

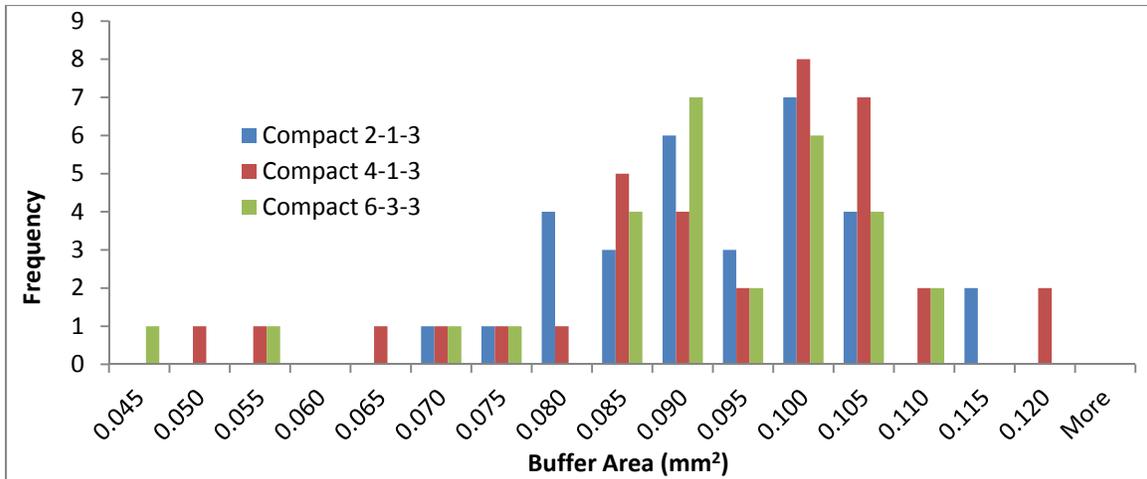
Figure 53. Buffer cross-sectional areas grouped by compact.

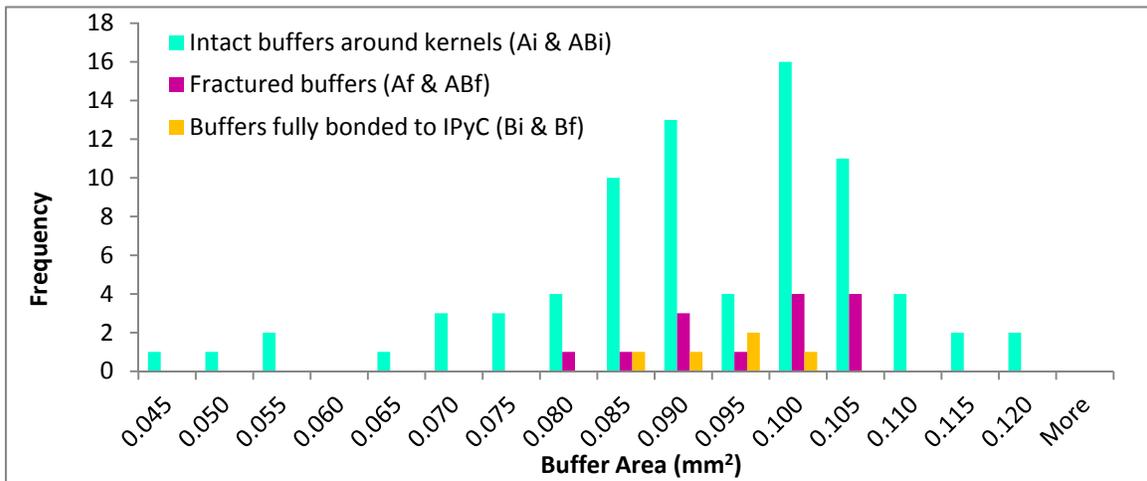
Figure 54. Buffer cross-sectional areas grouped according to buffer bonding and fracturing behavior.

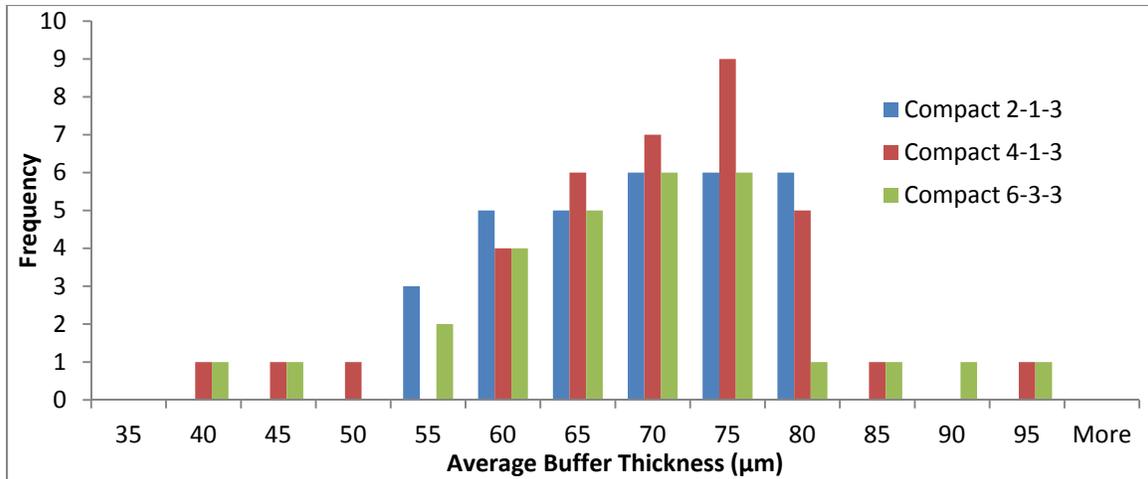
Figure 55. Buffer thicknesses grouped by compact.

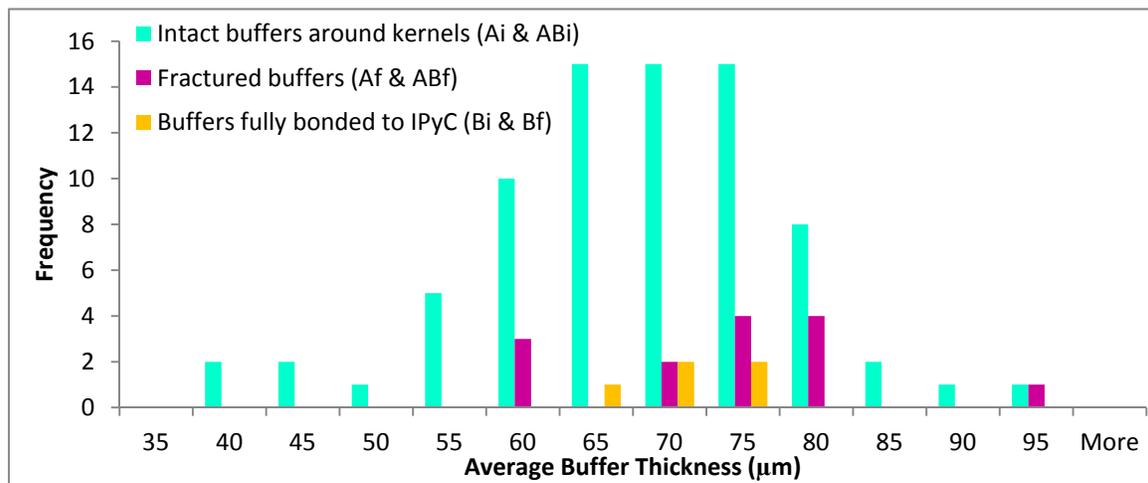
Figure 56. Buffer thicknesses grouped by buffer bonding and fracturing behavior.

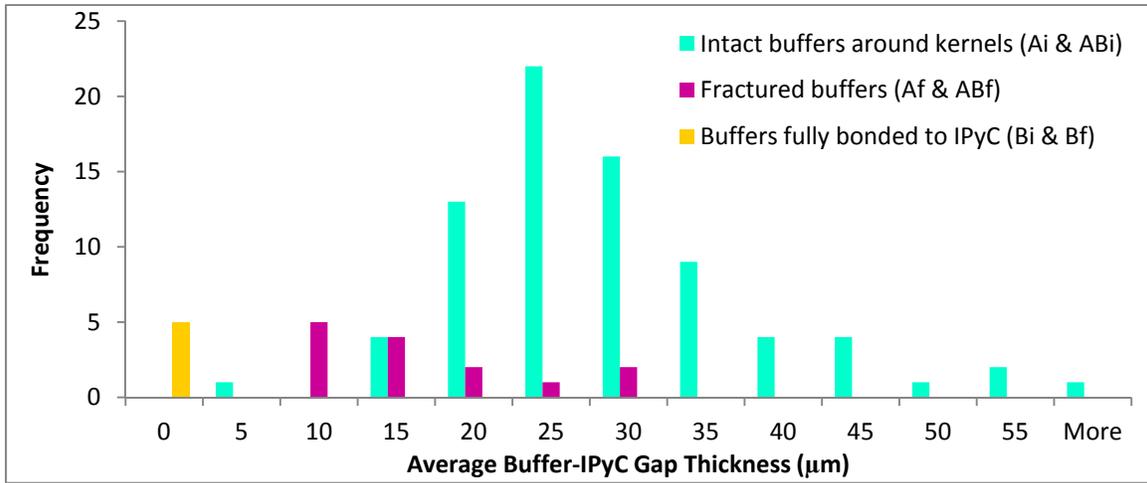
Figure 57. Average buffer-IPyC gaps grouped by buffer densification and fracturing behavior.

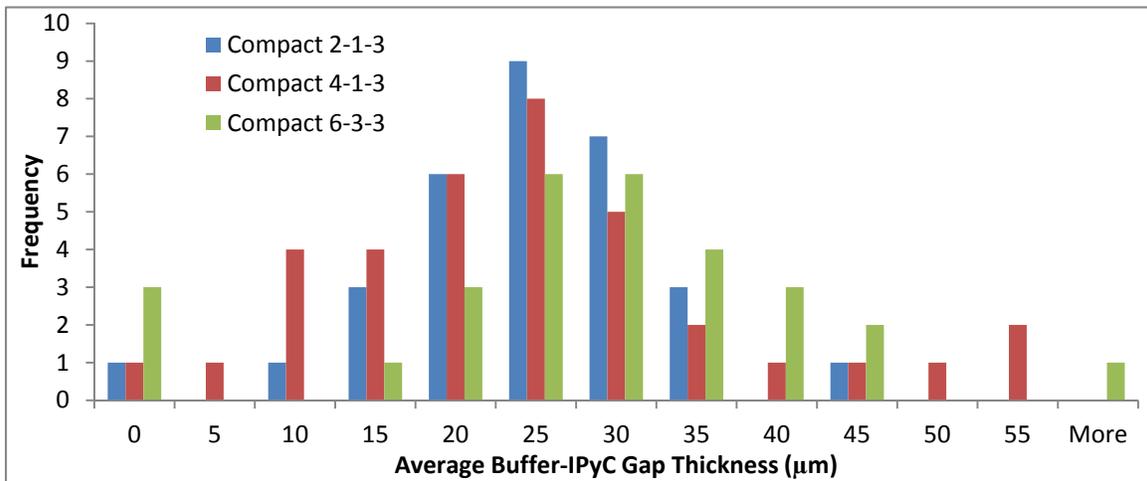
Figure 58. Average buffer-IPyC gaps grouped by compact.

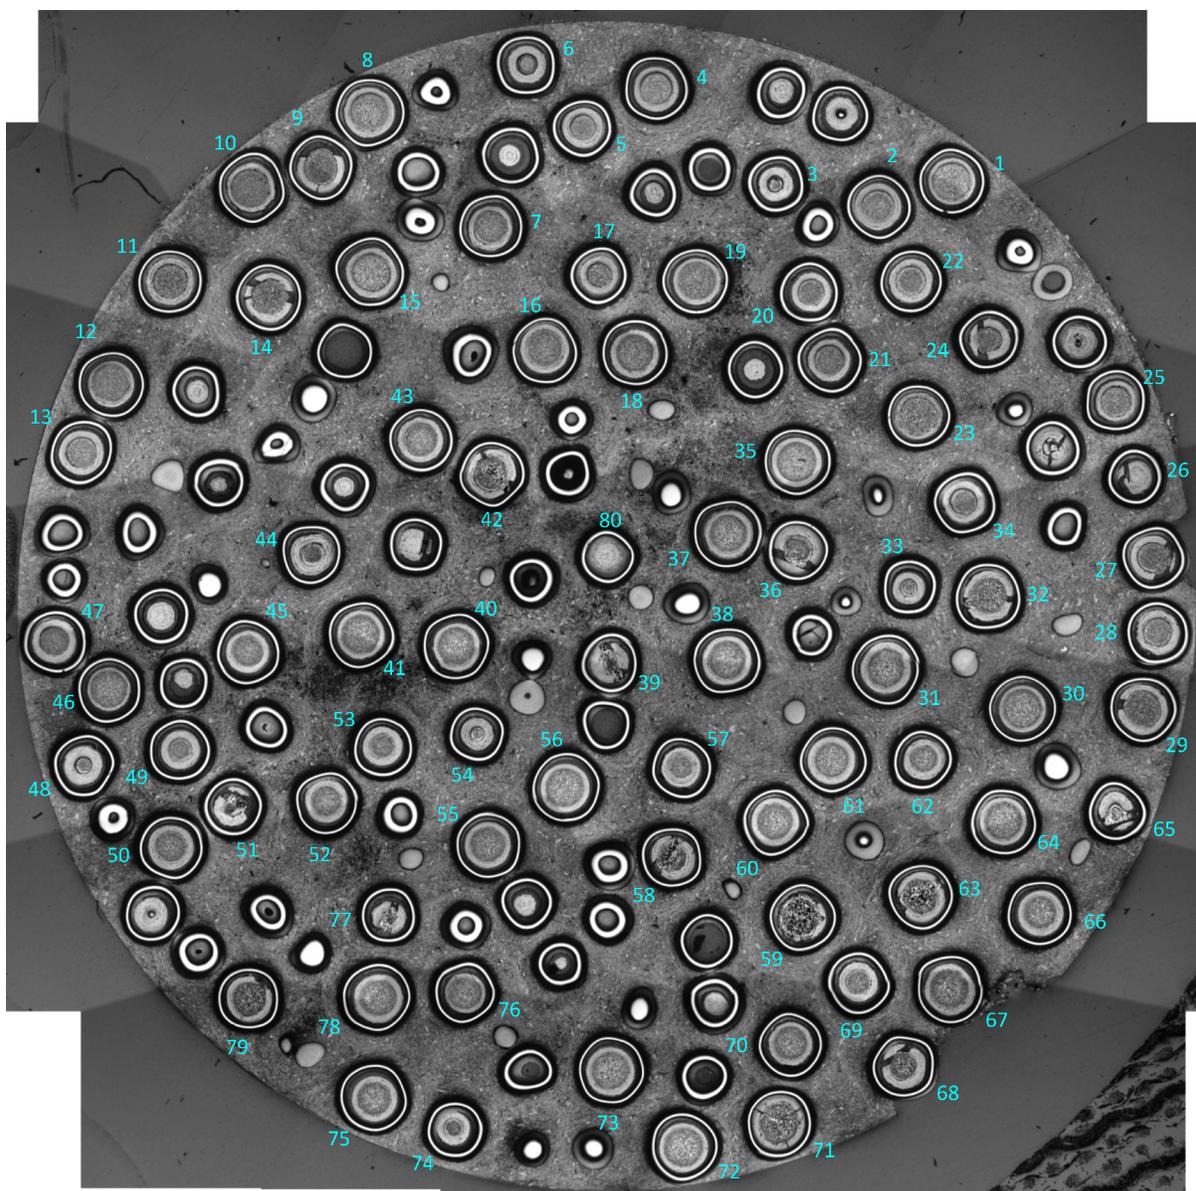
Figure A-1. Transverse cross section through middle of Compact 2-1-3 (Mount 136T) with particle identifiers.

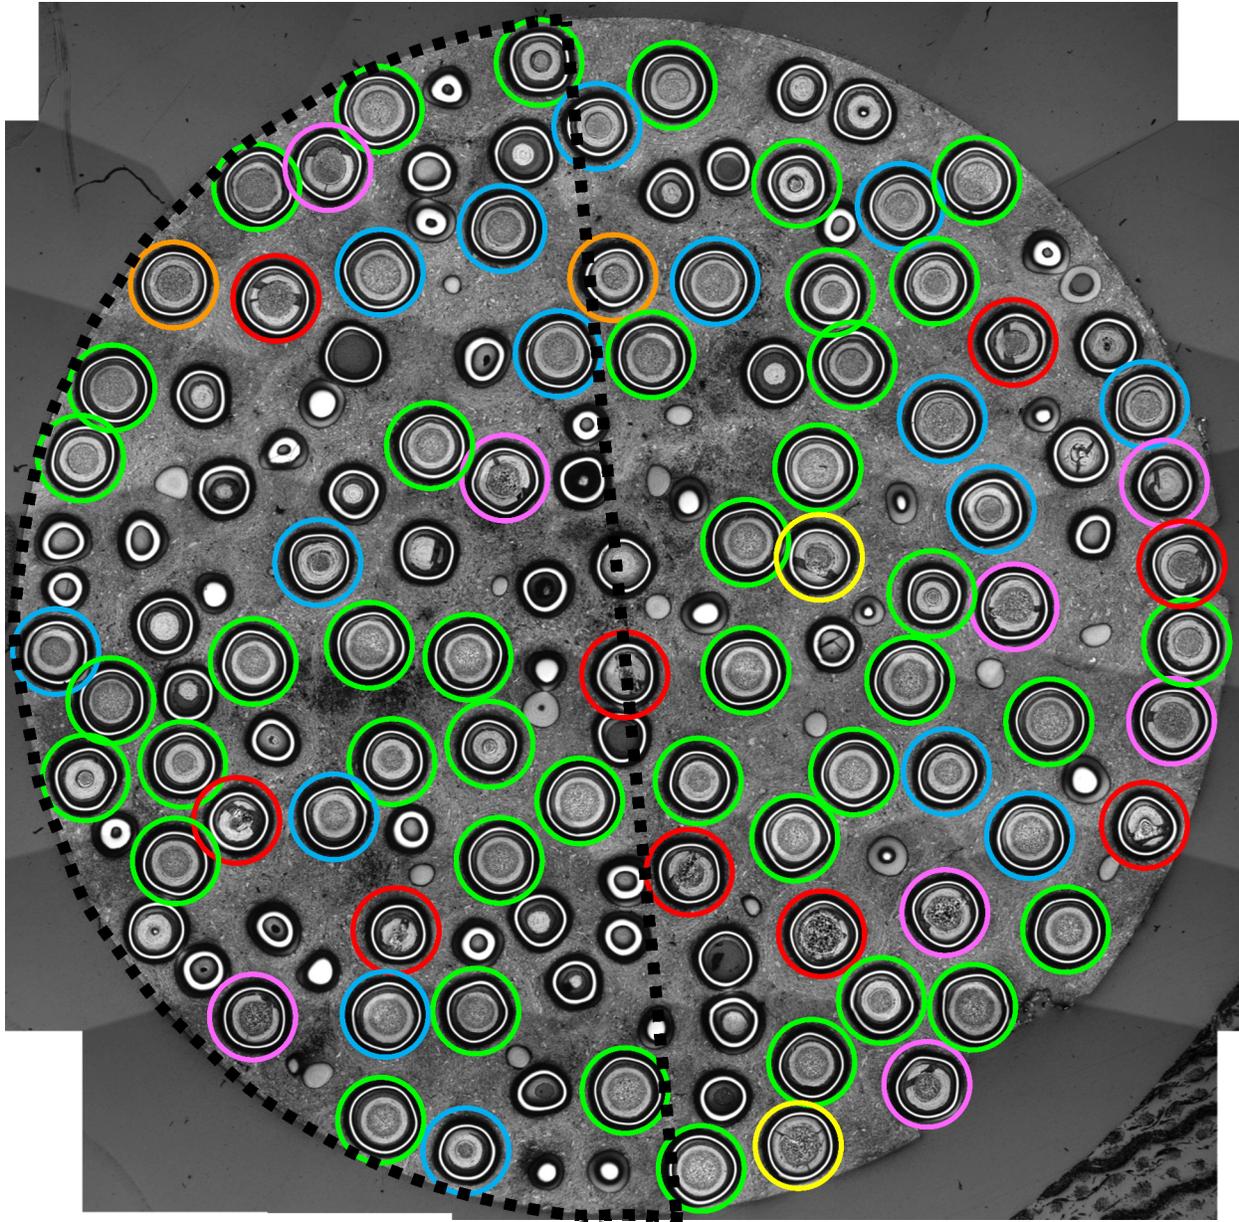
Figure A-2. Spatial distribution of particle morphologies across Compact 2-1-3 (Mount 136T).

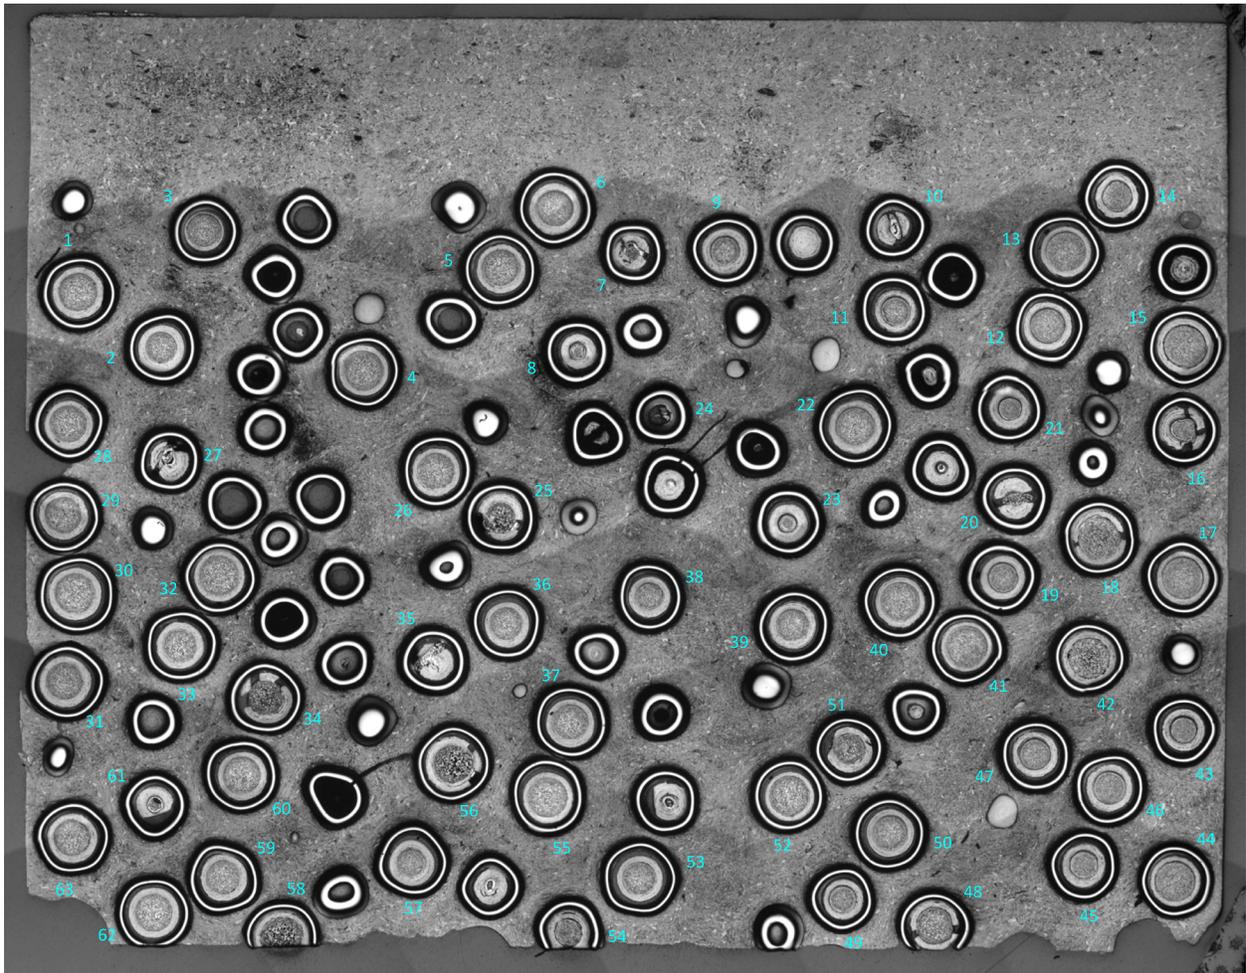
Figure A-3. Longitudinal cross section through top portion of Compact 2-1-3 (Mount 137T) with particle identifiers.

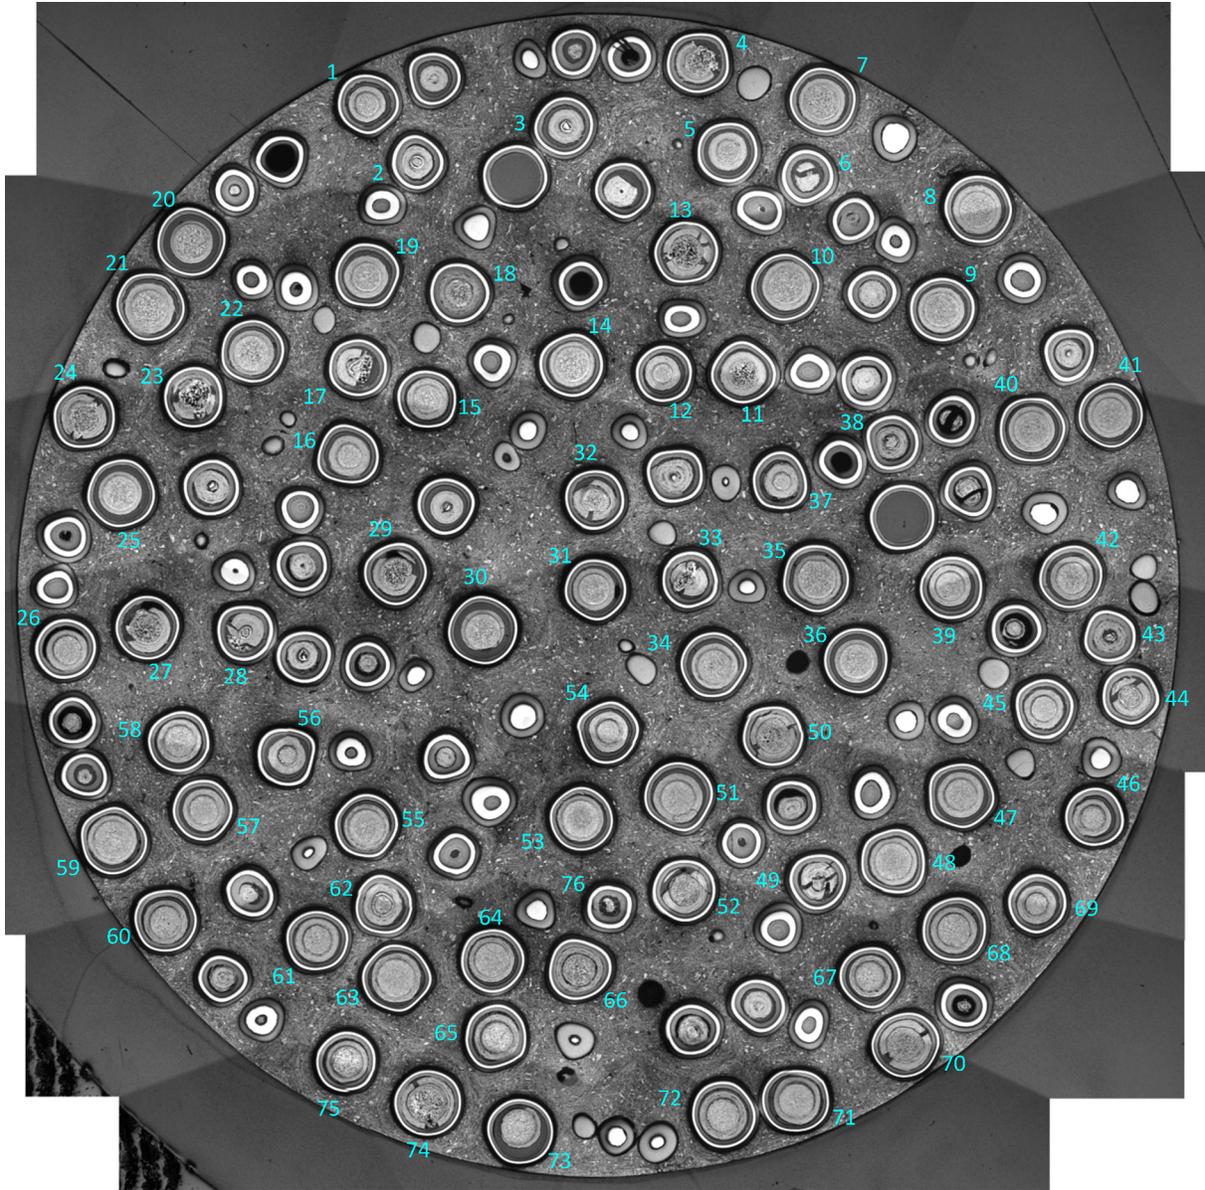
Figure A-7. Transverse cross section through middle of Compact 3-3-3 (Mount 56T) with particle identifiers.

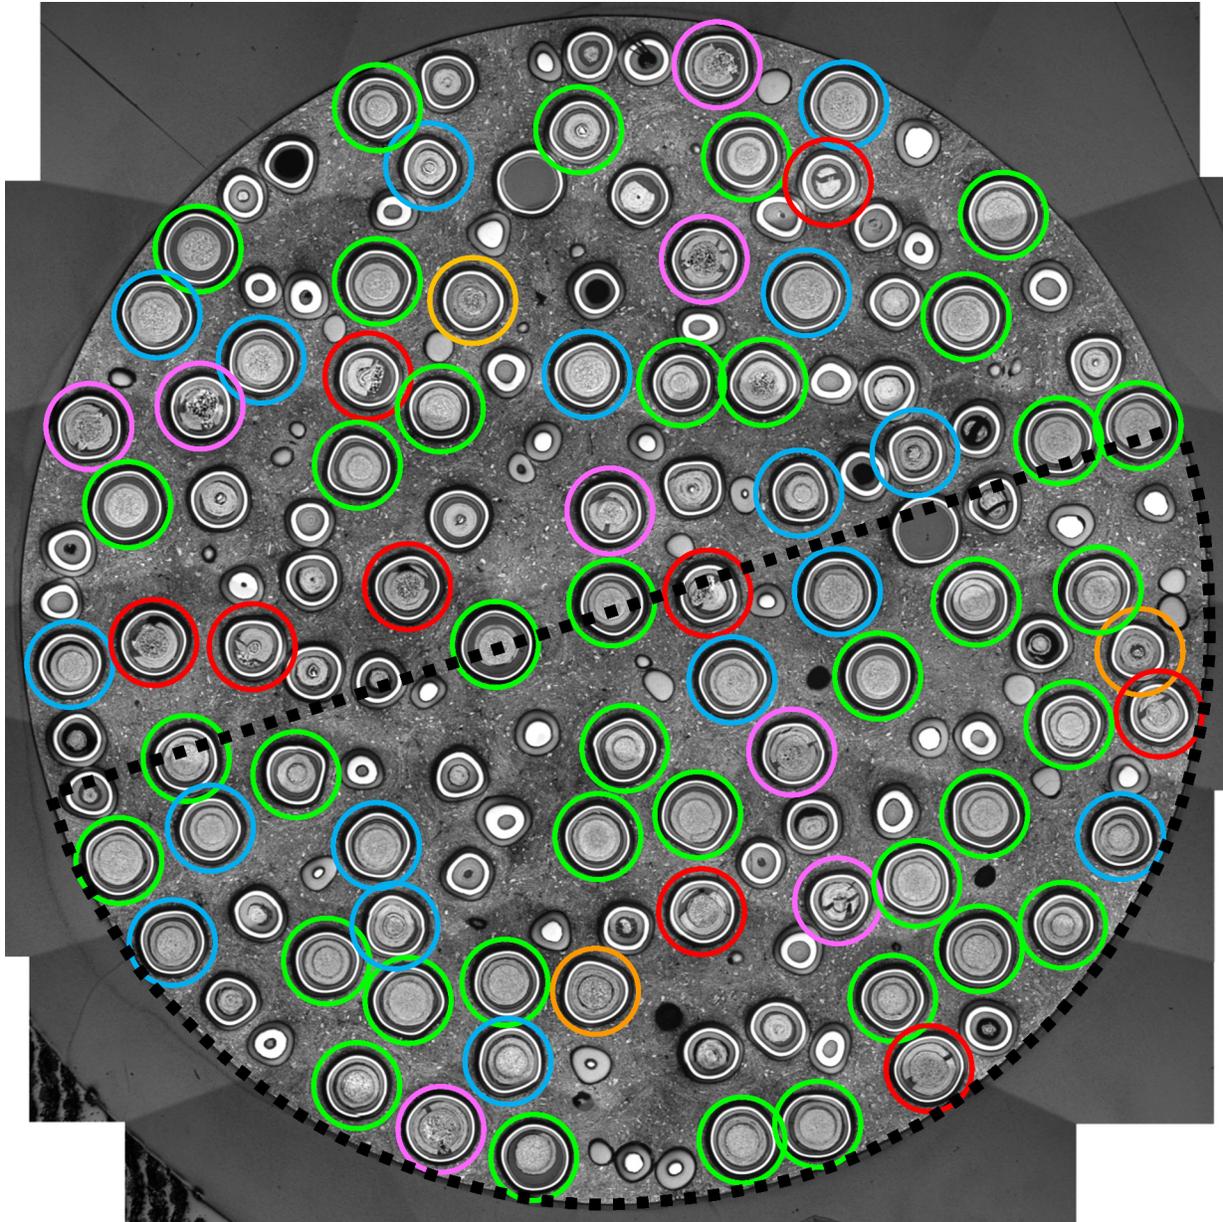
Figure A-8. Spatial distribution of particle morphologies across Compact 3-3-3 (Mount 56T).

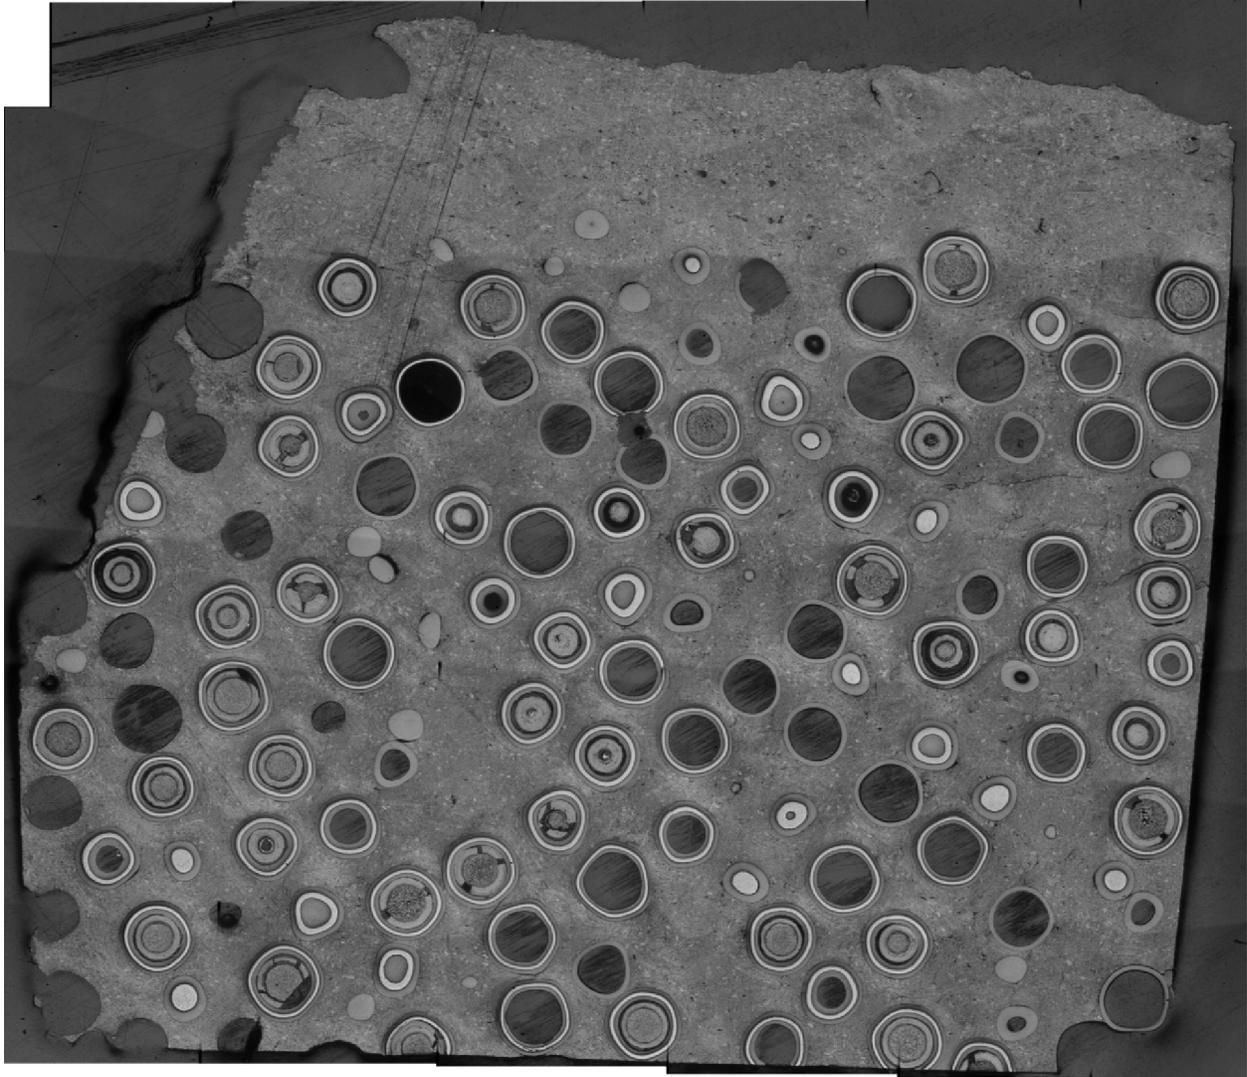
Figure A-9. Longitudinal cross section through top portion of Compact 3-3-3 (Mount 62T).

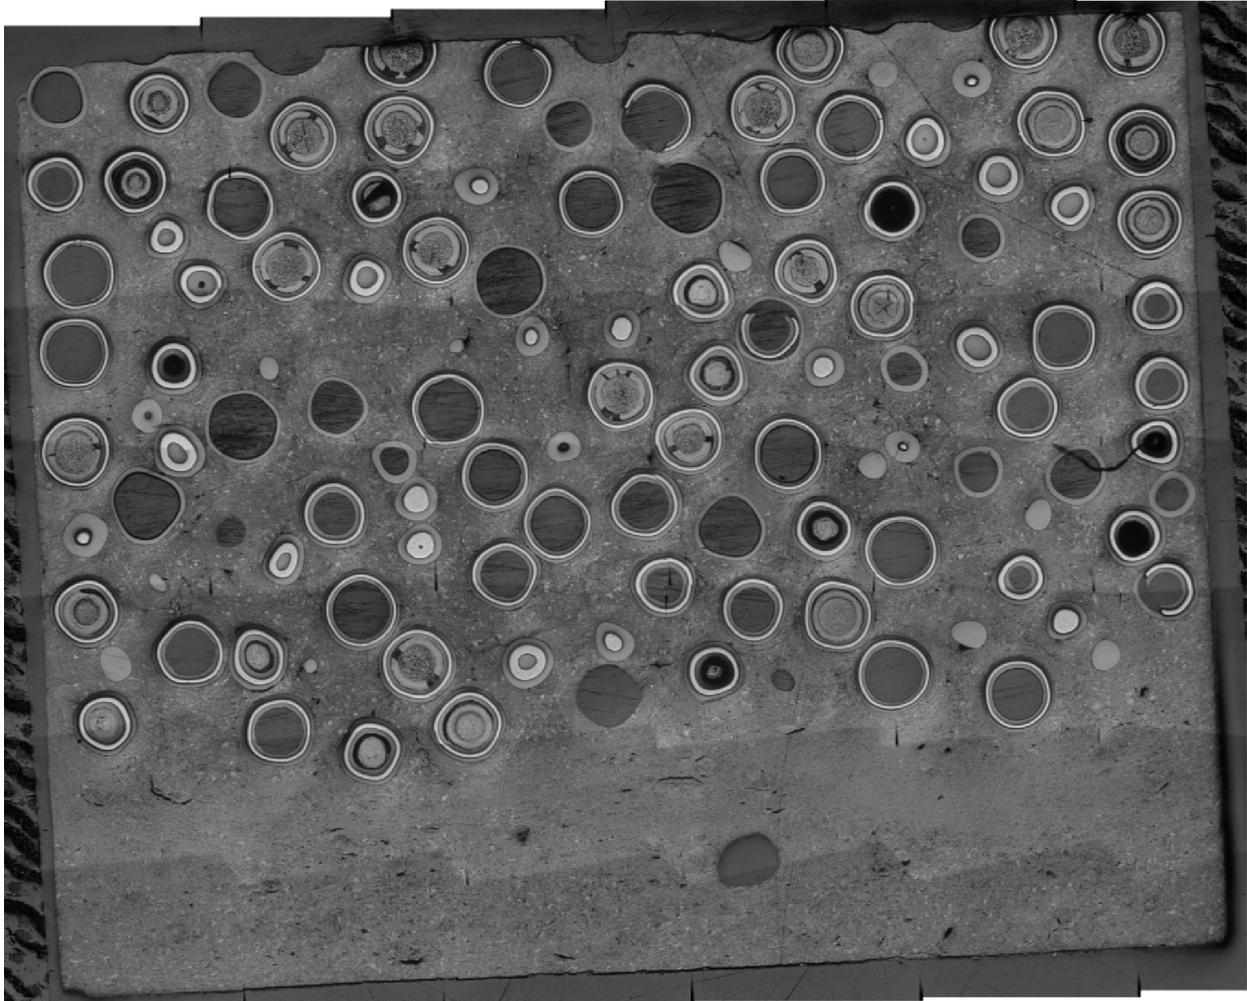
Figure A-10. Longitudinal cross section through bottom part of Compact 3-3-3 (Mount 68T).

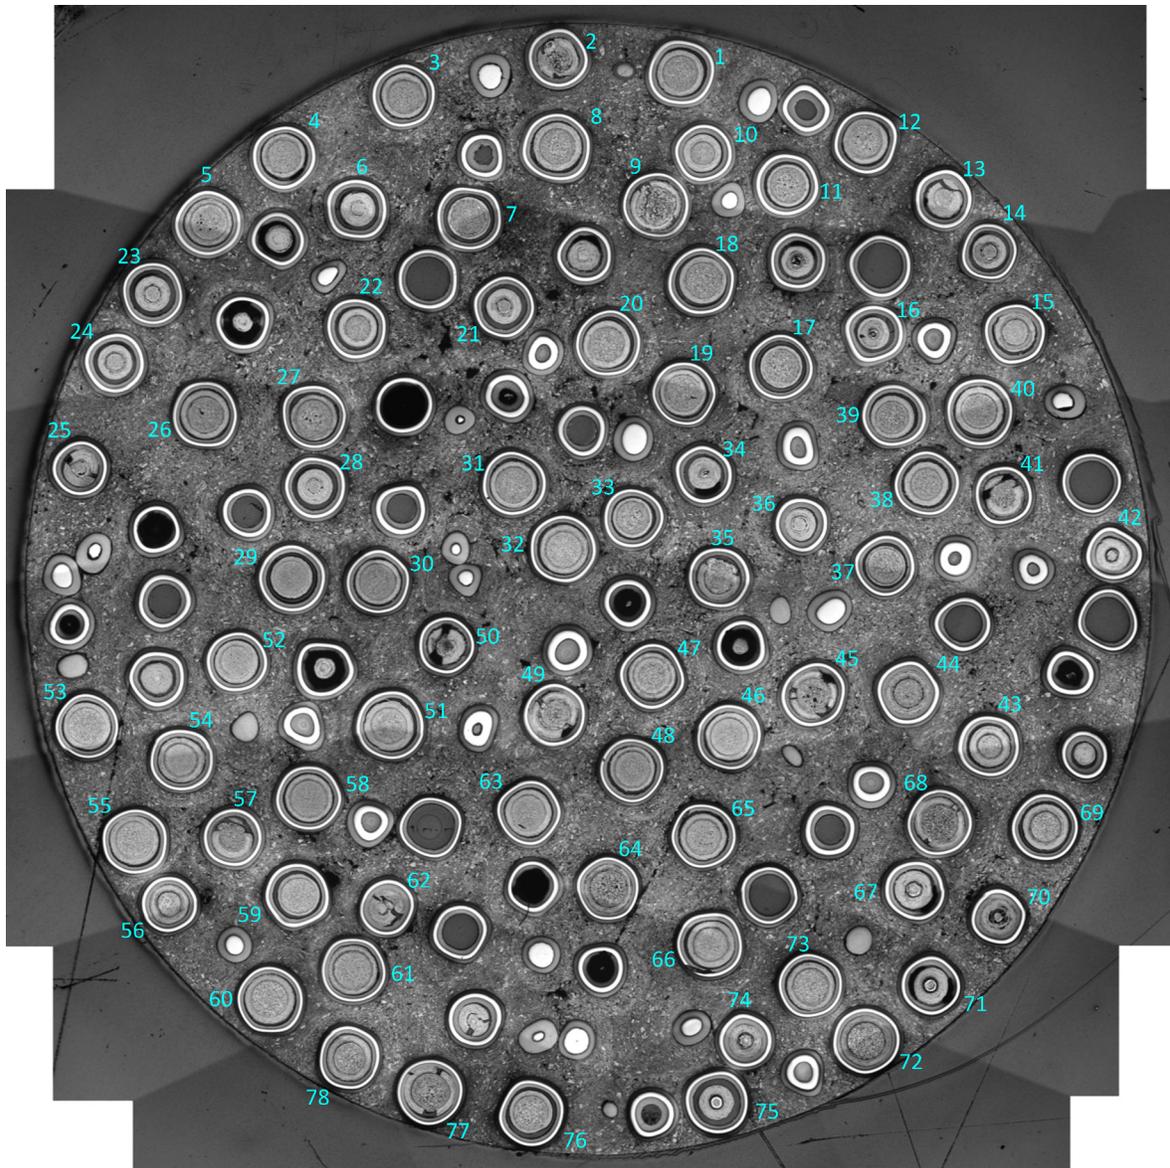
Figure A-11. Transverse cross section through middle of Compact 4-1-3 (Mount 59T) with particle identifiers.
