Ceramographic Examinations of Irradiated AGR-1 Fuel Compacts

Very High Temperature Reactor Project

INL/EXT-12-25301
Revision 1

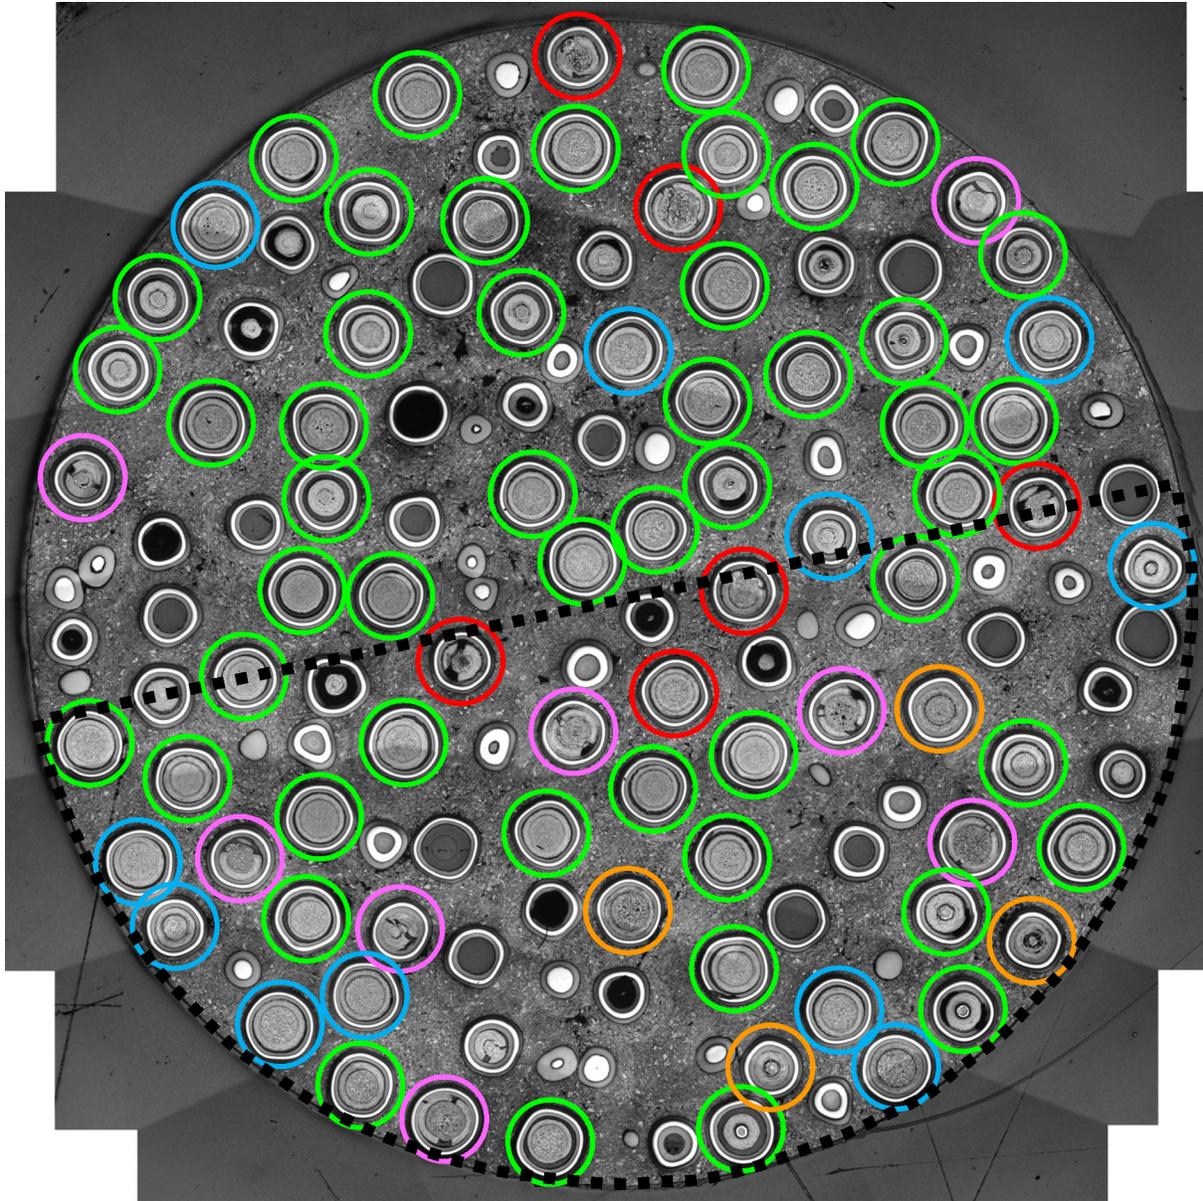
Figure A-12. Spatial distribution of particle morphologies across Compact 4-1-3 (Mount 59T).

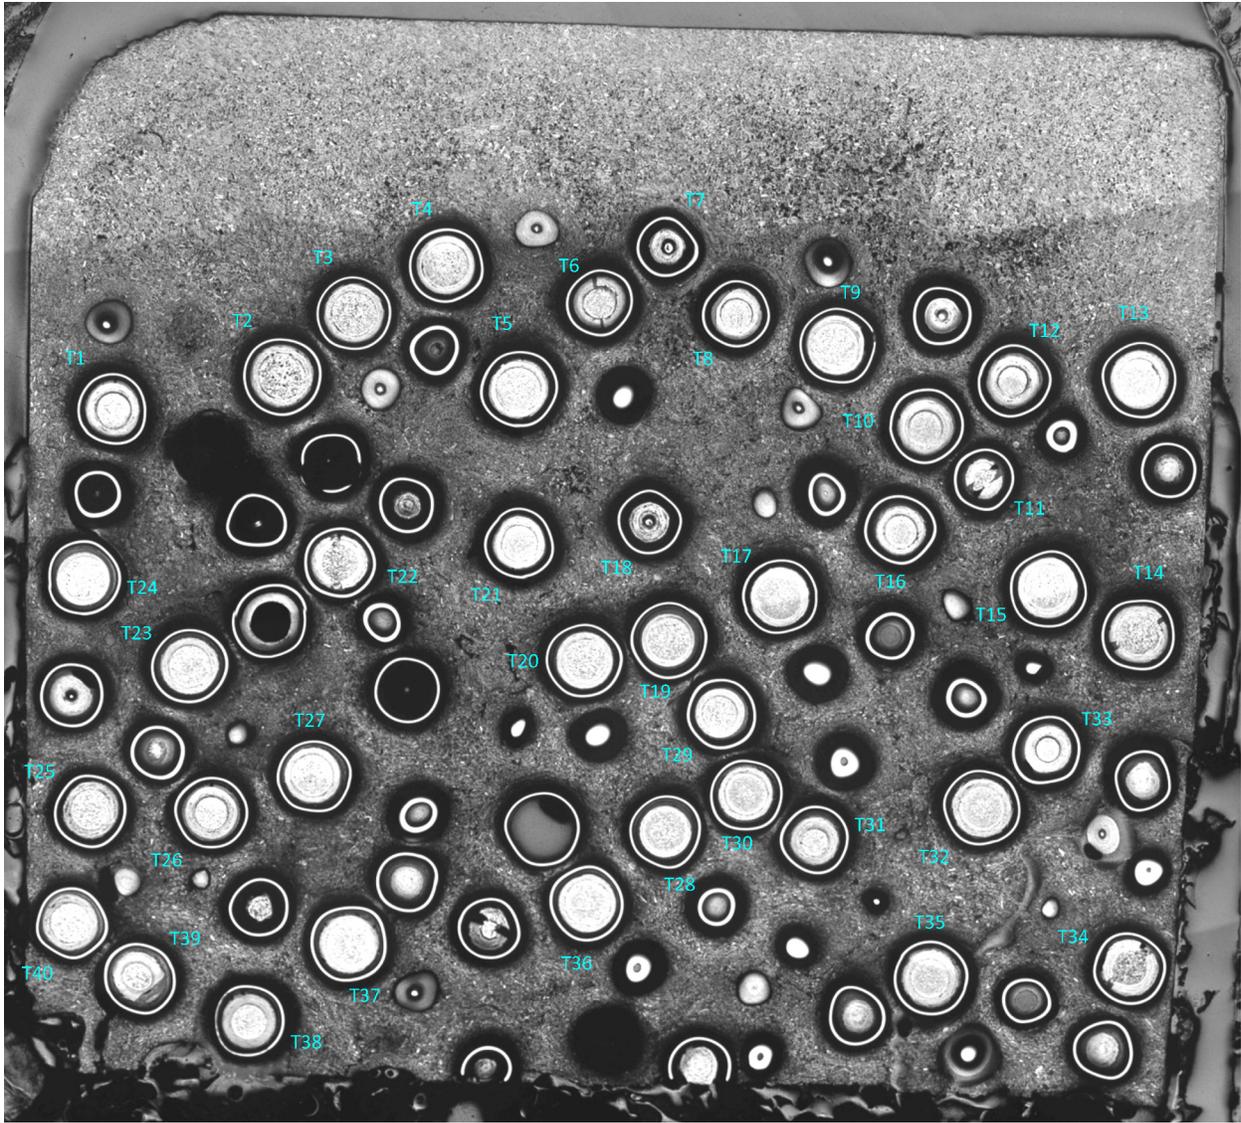
Figure A-13. Longitudinal cross section through top portion of Compact 4-1-3 (in Mount 64T) with particle identifiers. The “T” before the numbers denotes the top longitudinal section.

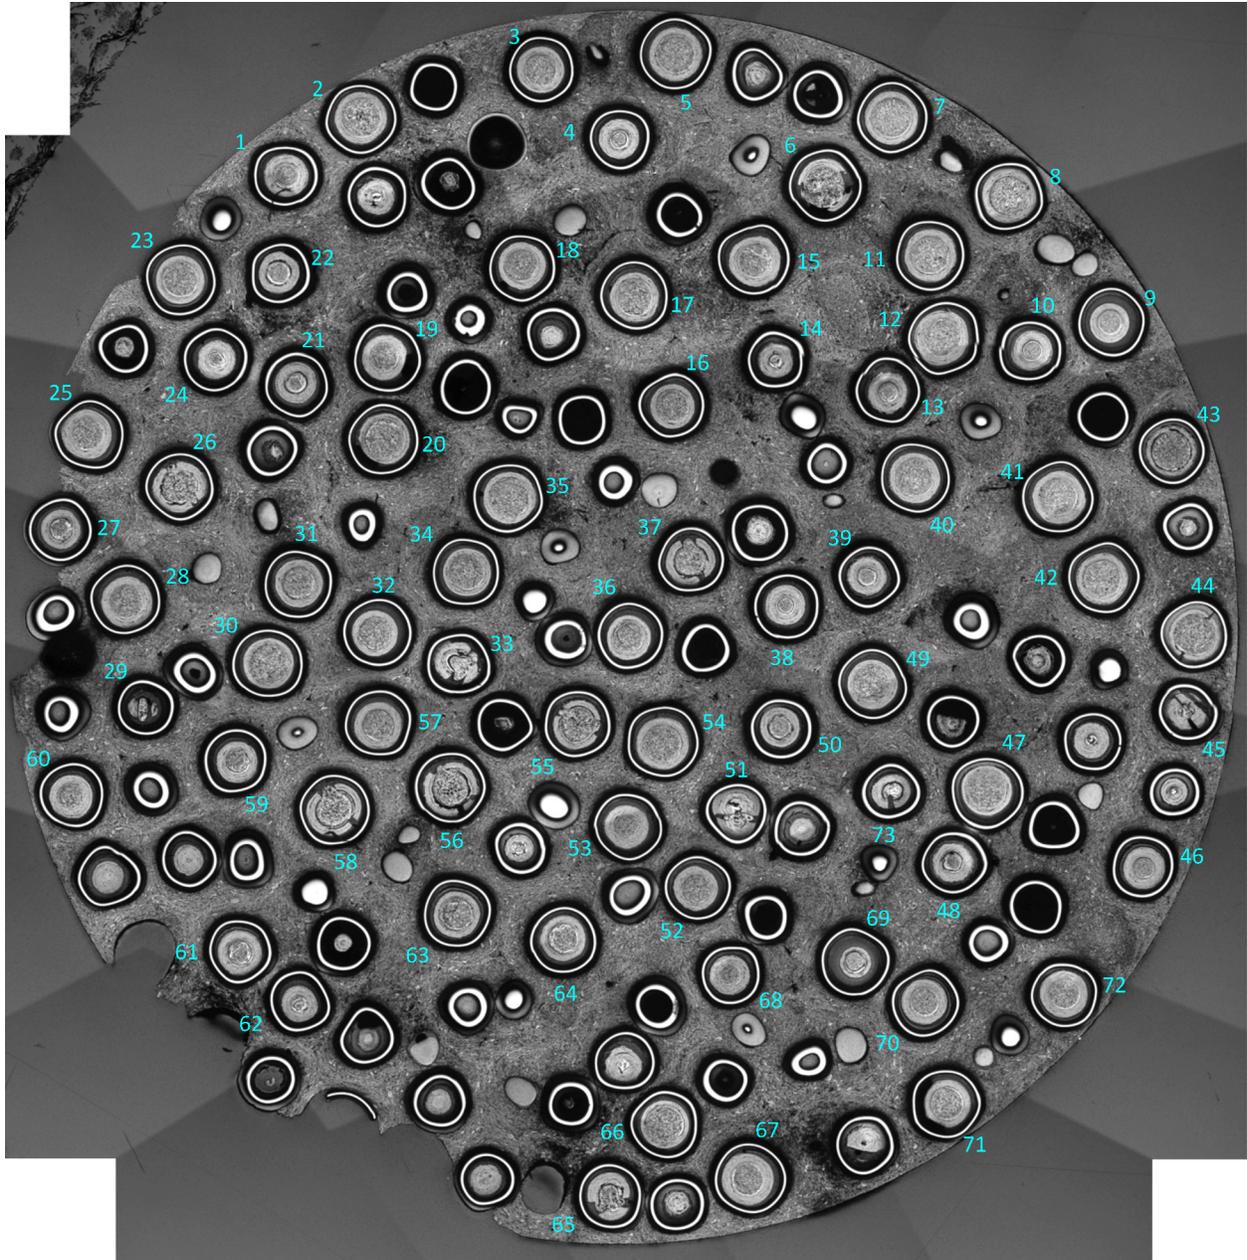
Figure A-17. Transverse cross section through middle of Compact 5-1-2 (Mount 133T) with particle identifiers.

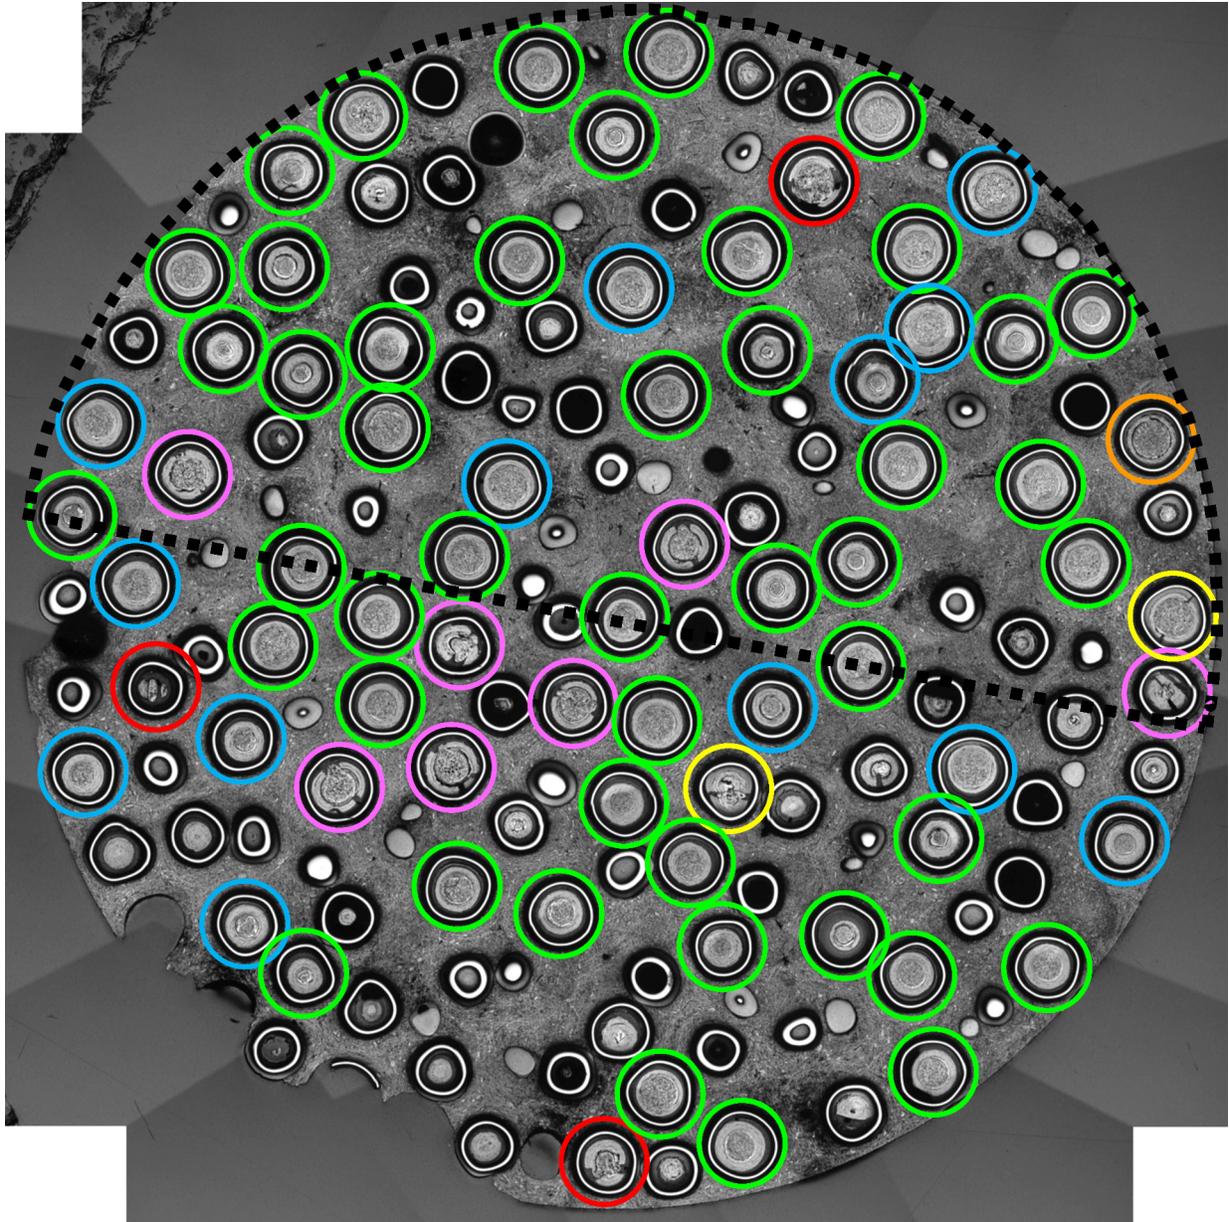
Figure A-18. Spatial distribution of particle morphologies across Compact 5-1-2 (Mount 133T).

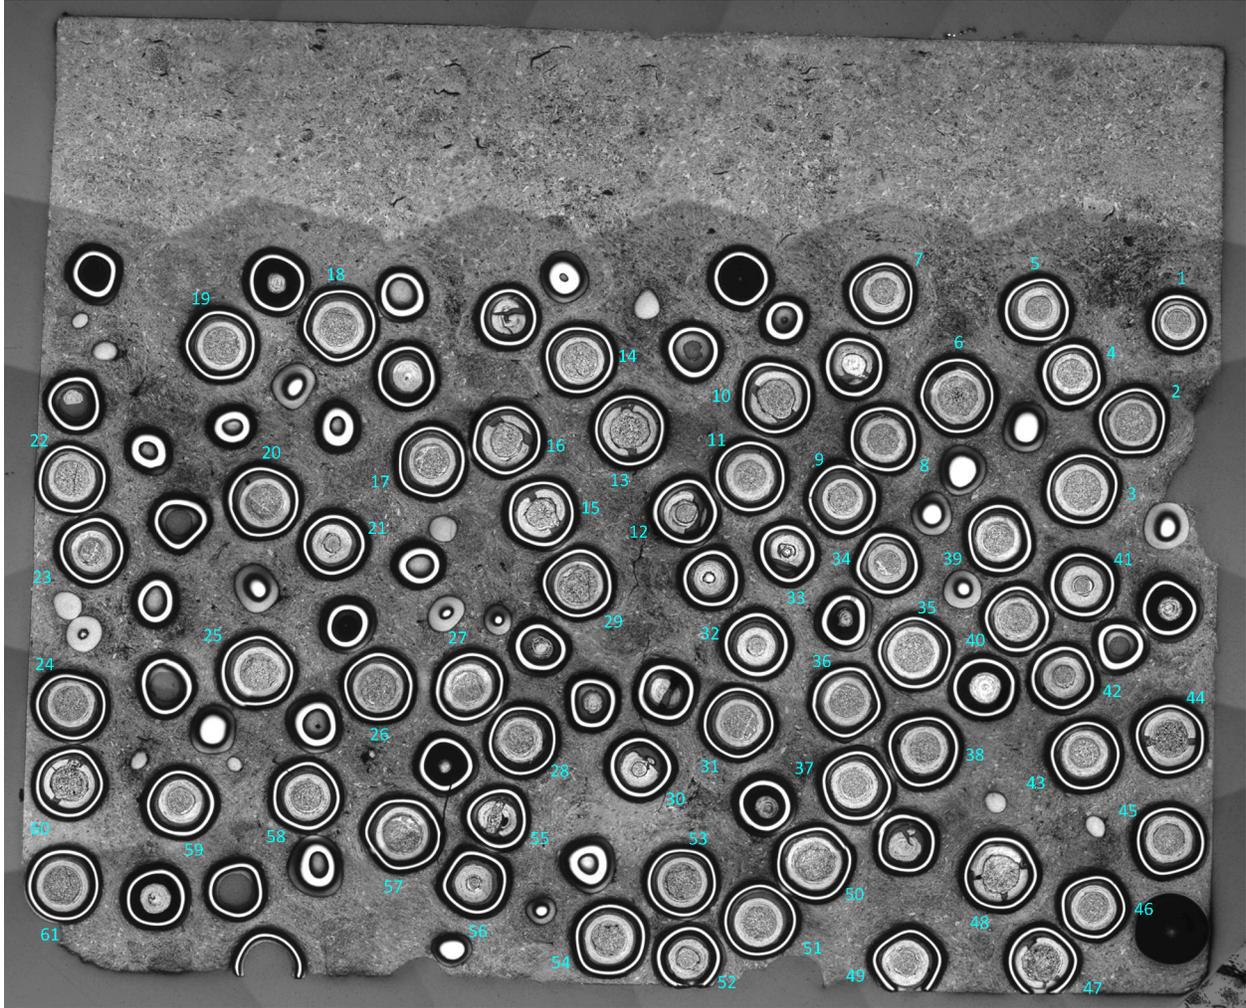
Figure A-19. Longitudinal cross section through top portion of Compact 5-1-2 (Mount 134T) with particle identifiers.

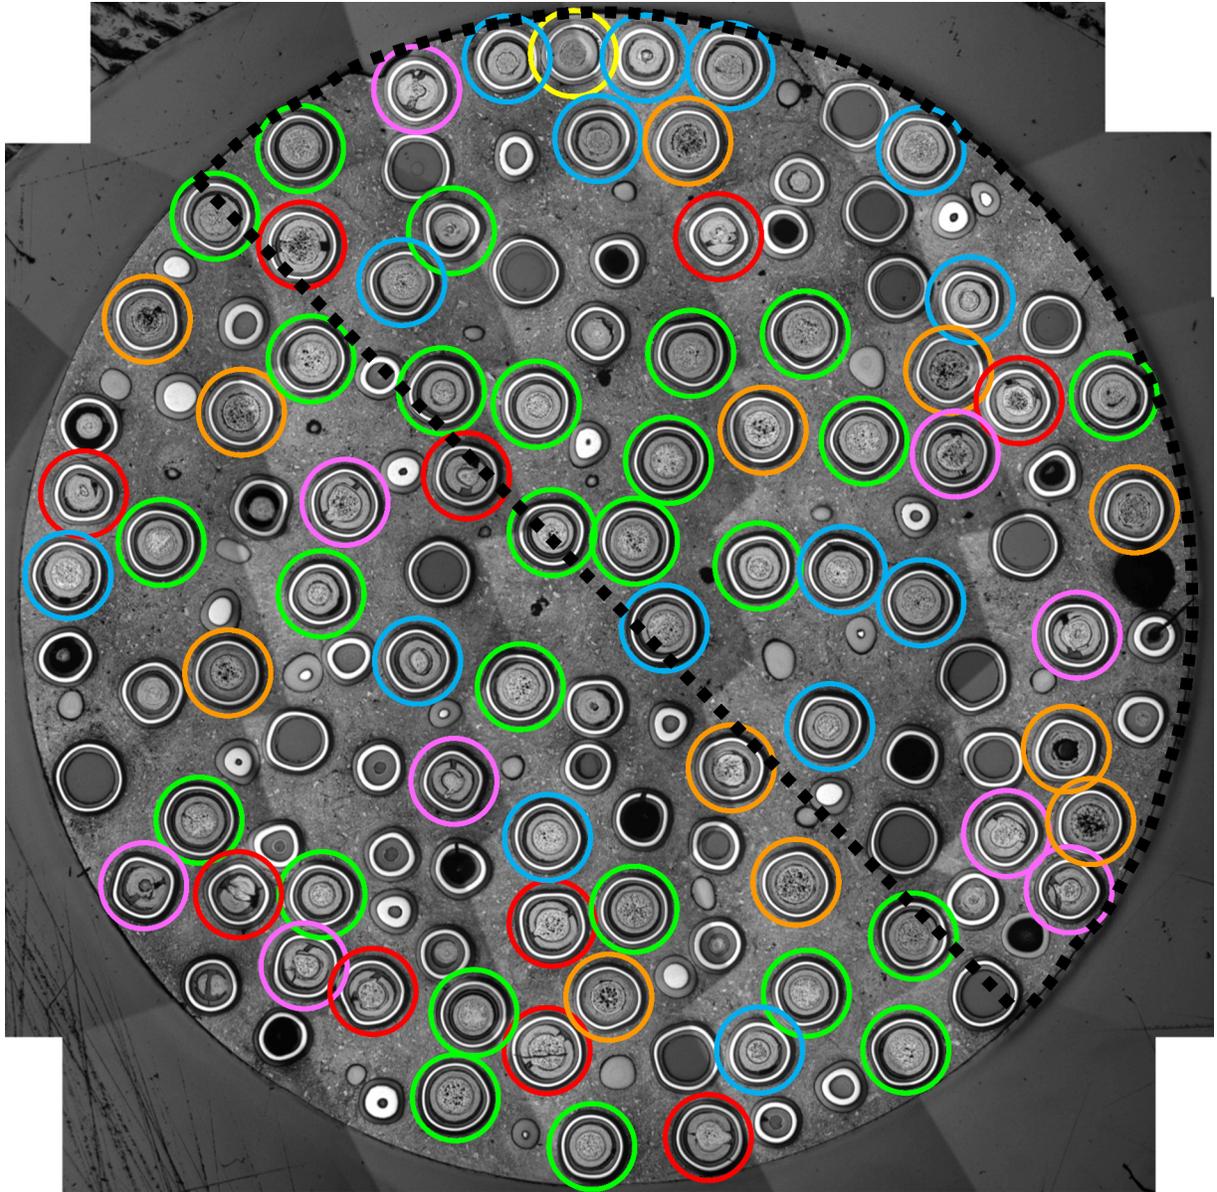
Figure A-24. Spatial distribution of particle morphologies across Compact 6-3-3 (Mount 57T).

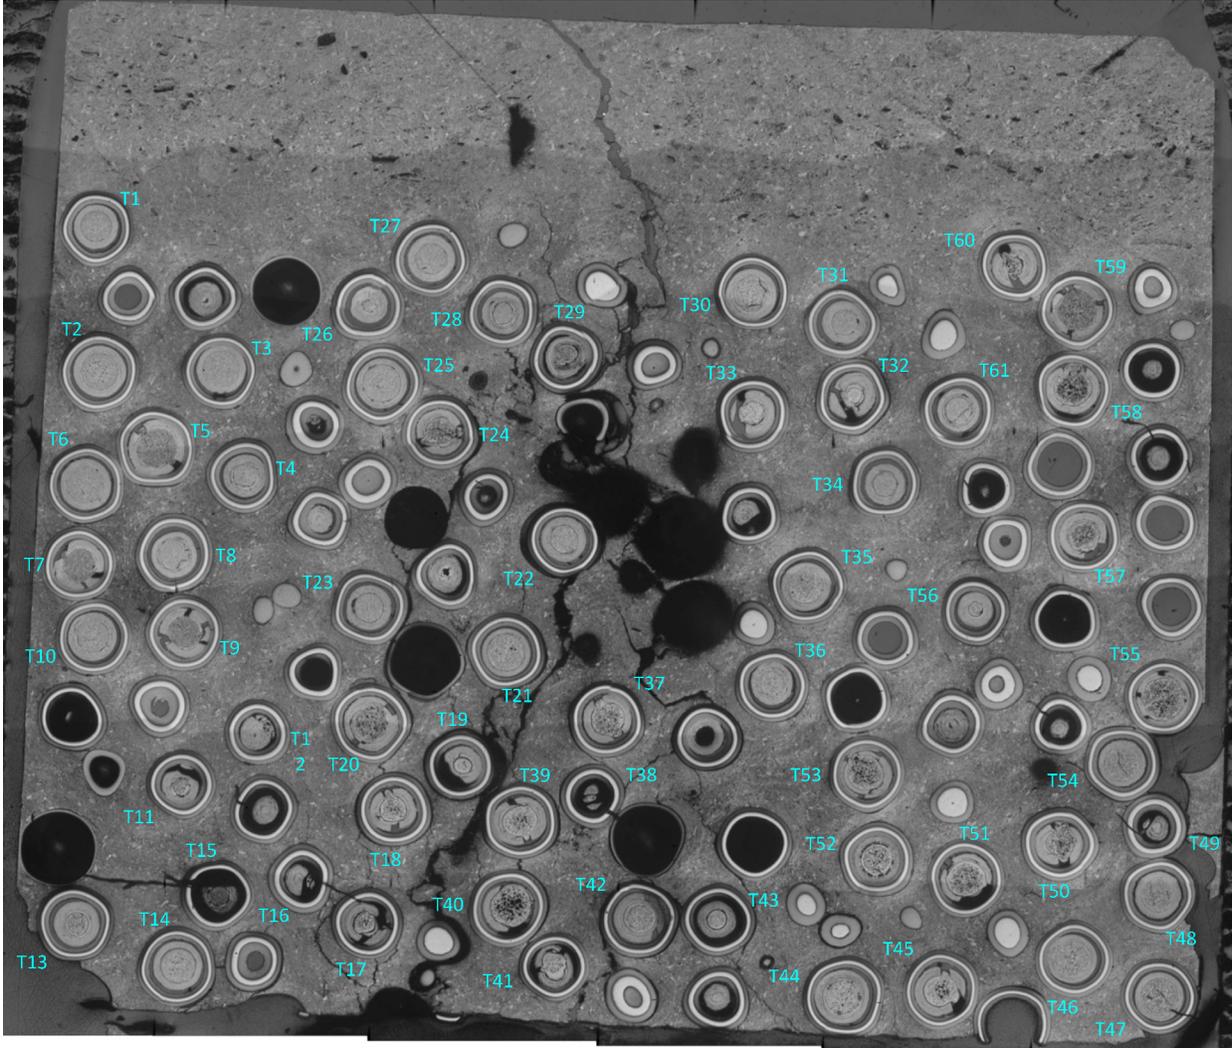
Figure A-25. Longitudinal cross section through top portion of Compact 6-3-3 (in Mount 67T) with particle identifiers. The “T” before the numbers denotes the top longitudinal section. This portion of the compact fractured during sawing.

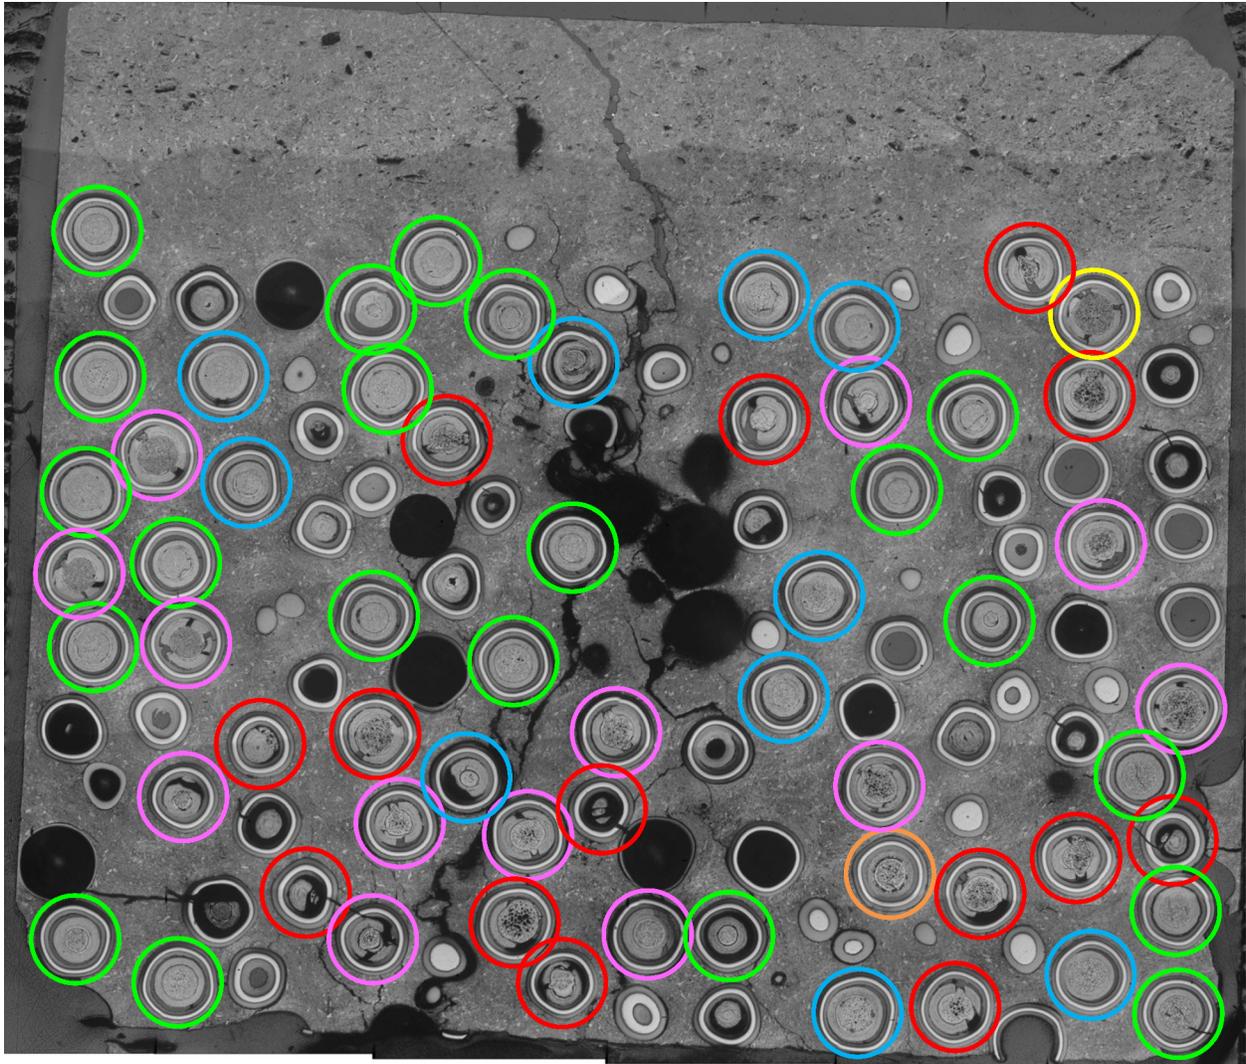
Figure A-26. Spatial distribution of particle morphologies across top portion of Compact 6-3-3 (in Mount 67T).

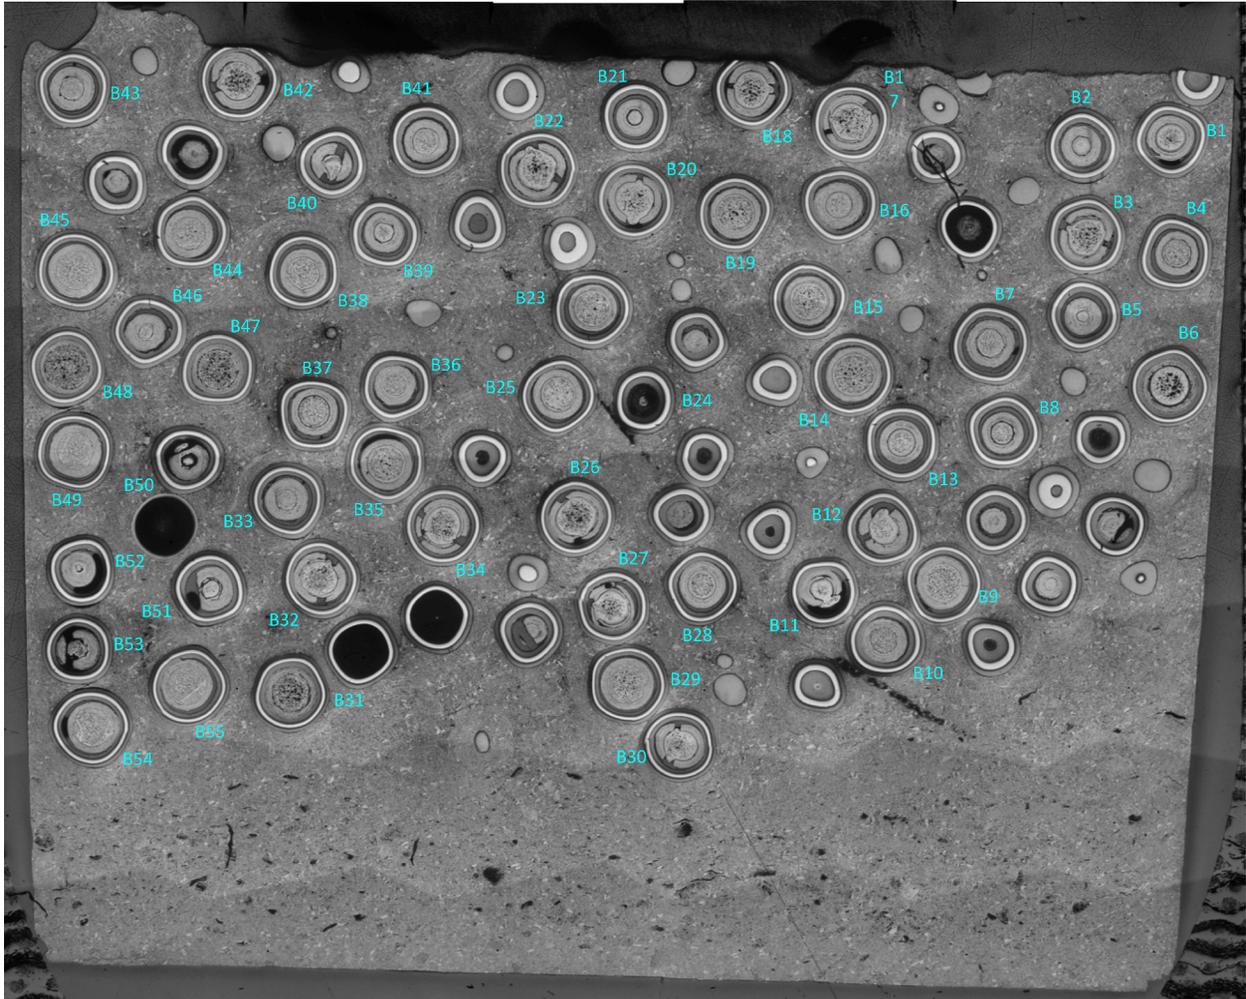
Figure A-27. Longitudinal cross section through bottom portion of Compact 6-3-3 (in Mount 67T) with particle identifiers. The “B” before the numbers denotes the bottom longitudinal section.

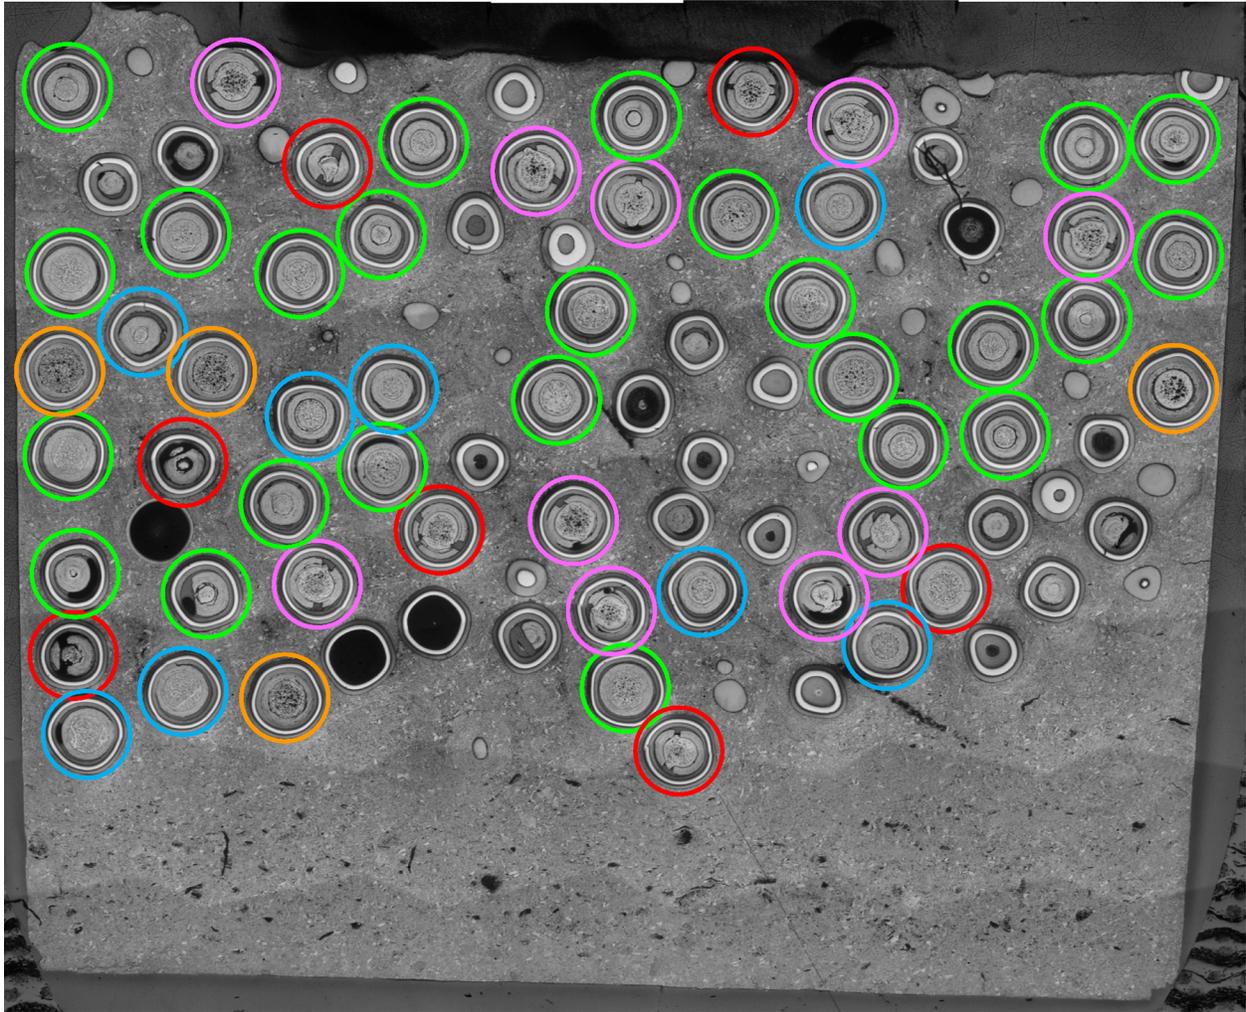
Figure A-28. Spatial distribution of particle morphologies across bottom portion of Compact 6-3-3 (in Mount 67T).

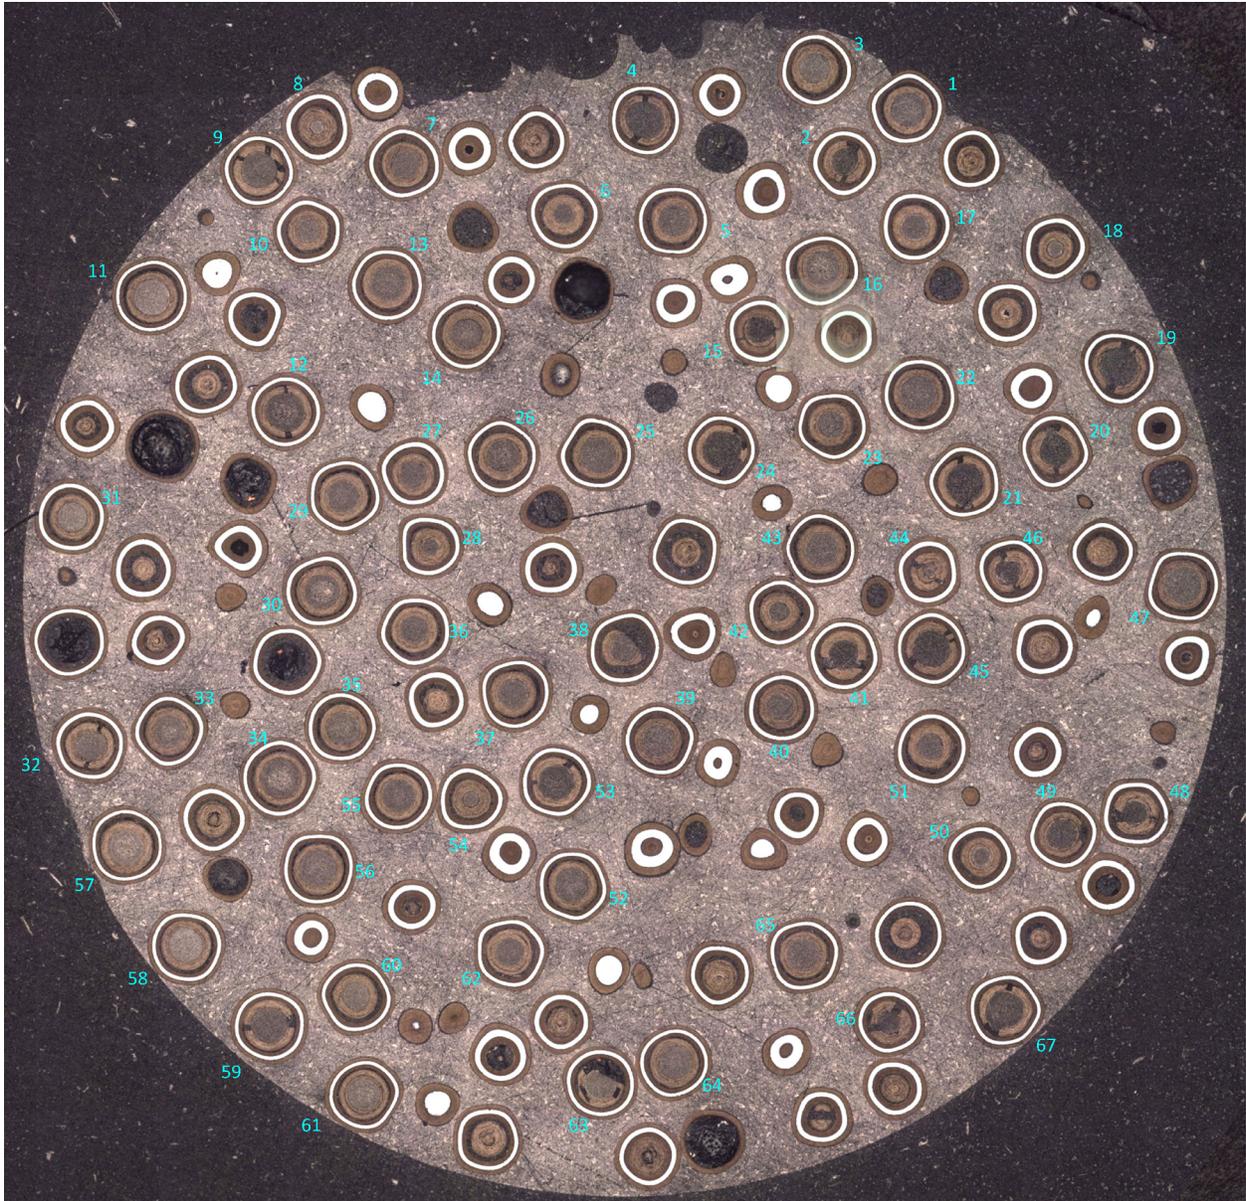
Figure A-29. Transverse cross section through middle of Compact 6-4-2 (ORNL Mount 6360) with particle identifiers.

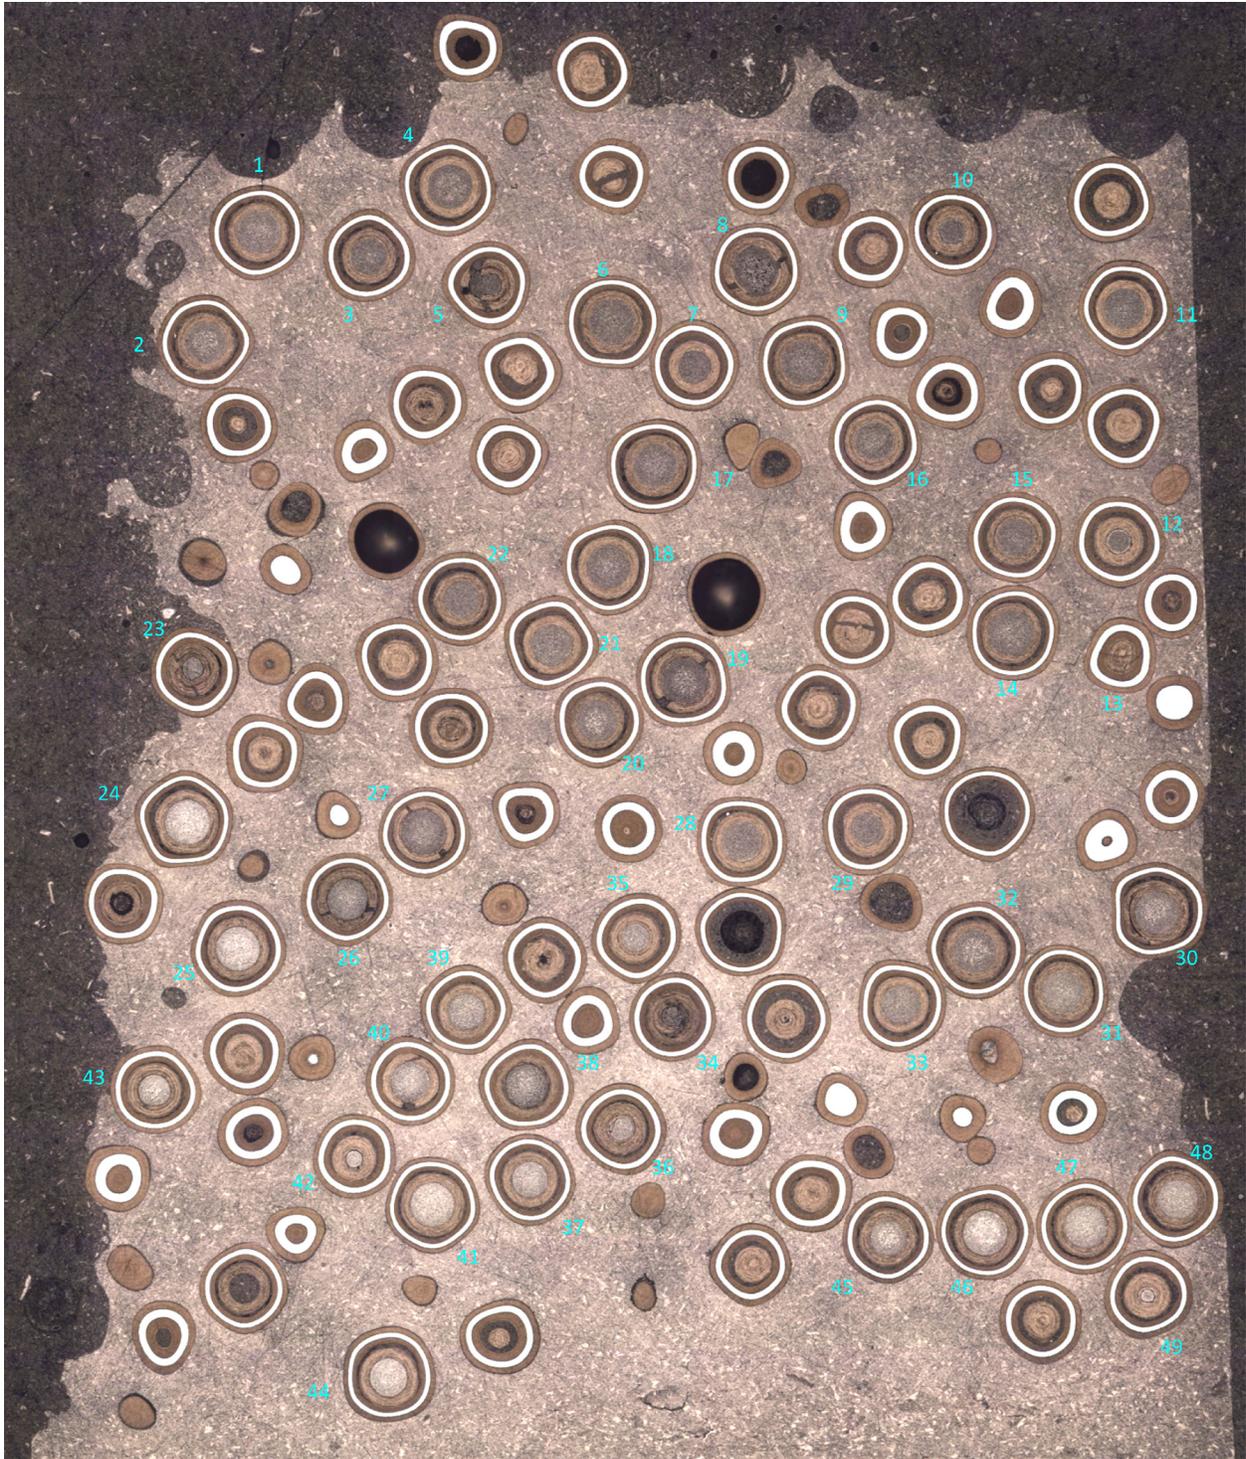
Figure A-33. Longitudinal cross section through bottom portion of Compact 6-4-2 (ORNL Mount 6362) with particle identifiers.

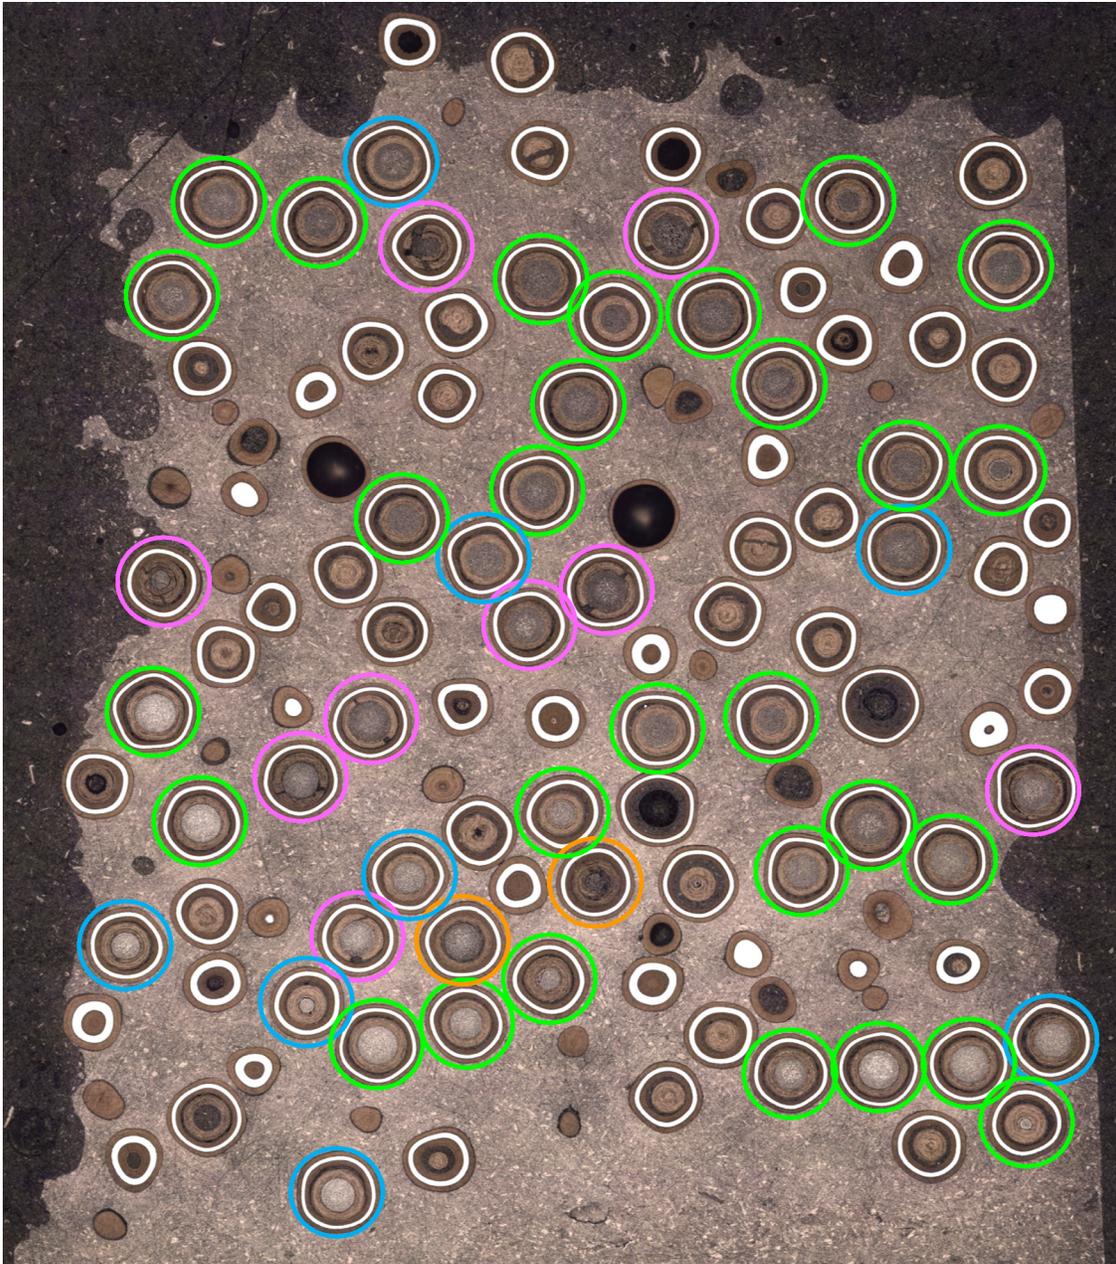
Figure A-34. Spatial distribution of particle morphologies across bottom portion of Compact 6-4-2 (ORNL Mount 6362).
