PIE on Safety-Tested AGR-1 Compact 5-1-1

August 2015

Fusion and Materials for Nuclear Systems Division

PIE ON SAFETY-TESTED AGR-1 COMPACT 5-1-1

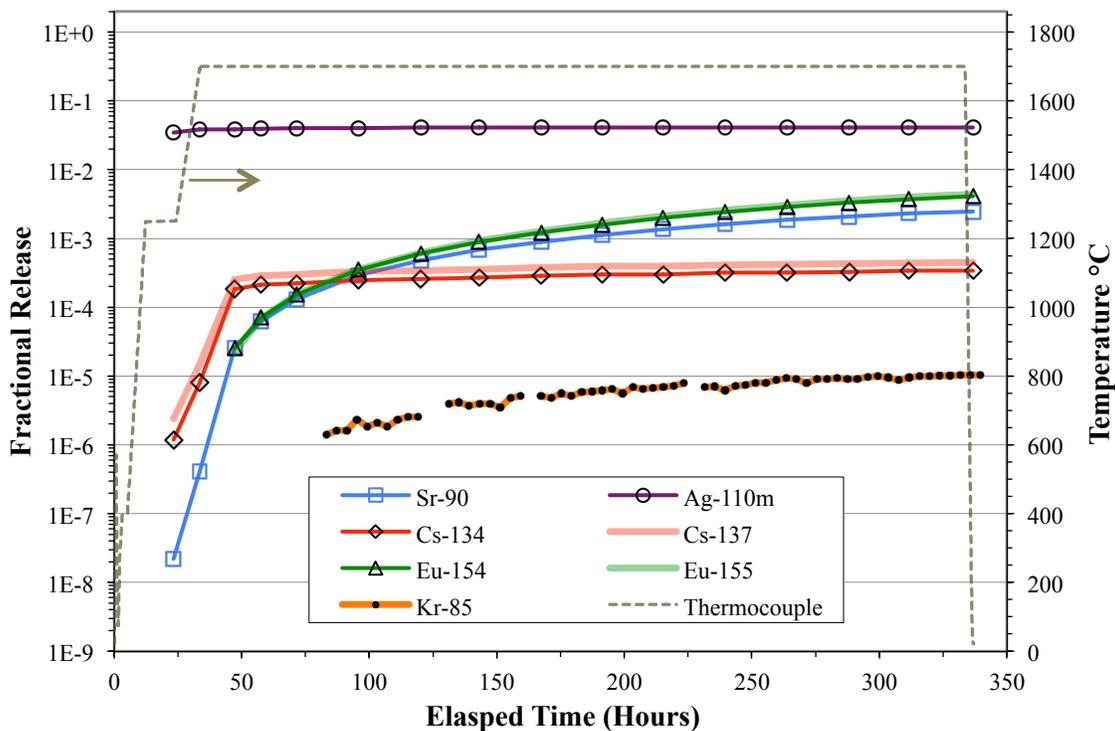
Figure 1. Release of fission products from Compact 5-1-1 during safety testing to 1700°C, plotted on a logarithmic scale.

The time-dependent results of the Compact 5-1-1 safety test are shown in Figure 1 and Figure 2, using a logarithmic and linear scale, respectively. The plotted fractional release values are the cumulative amount of each fission product collected on the deposition cups, adjusted for radioactive decay and average collection efficiency, and divided by the predicted compact inventory for each fission product at the end of the irradiation [Sterbentz 2013]. Figure 3 shows the average release rate of the various isotopes for each deposition cup exchange period. The fission product release from Compact 5-1-1 during the 1700°C safety test was qualitatively similar to other AGR-1 safety tests.

Most of the silver was released as the compact was heated, followed by a significant decrease in the ^{110m}Ag release rate after the first 1600°C cup change. No ^{110m}Ag could be detected on the deposition cups after the cup change at 142 hours into the test due to the very low silver release during the later part of the test, coupled with the fact that the compact's ^{110m}Ag inventory was nearly exhausted after 7.5 half lives since the end of the irradiation. Release of silver as compacts are heated to the safety test temperature has been observed in all the AGR-1 safety tests and is presumed to be dominated by release from the matrix and outer pyrolytic carbon (OPyC) of silver previously released through intact SiC during irradiation. Conversely, europium and strontium release rates increased over the first 100 hours at 1700°C and then were fairly constant throughout the remainder of the test. Based on DLBL data from as-irradiated compacts, this europium and strontium release is also thought to be dominated by slow release from the matrix and OPyC, although additional diffusive release from SiC has not been ruled out and seems to be indicated by the safety testing results at 1800°C [Hunn et al. 2013-2, page 9; Hunn et al. 2014-1, page 7].

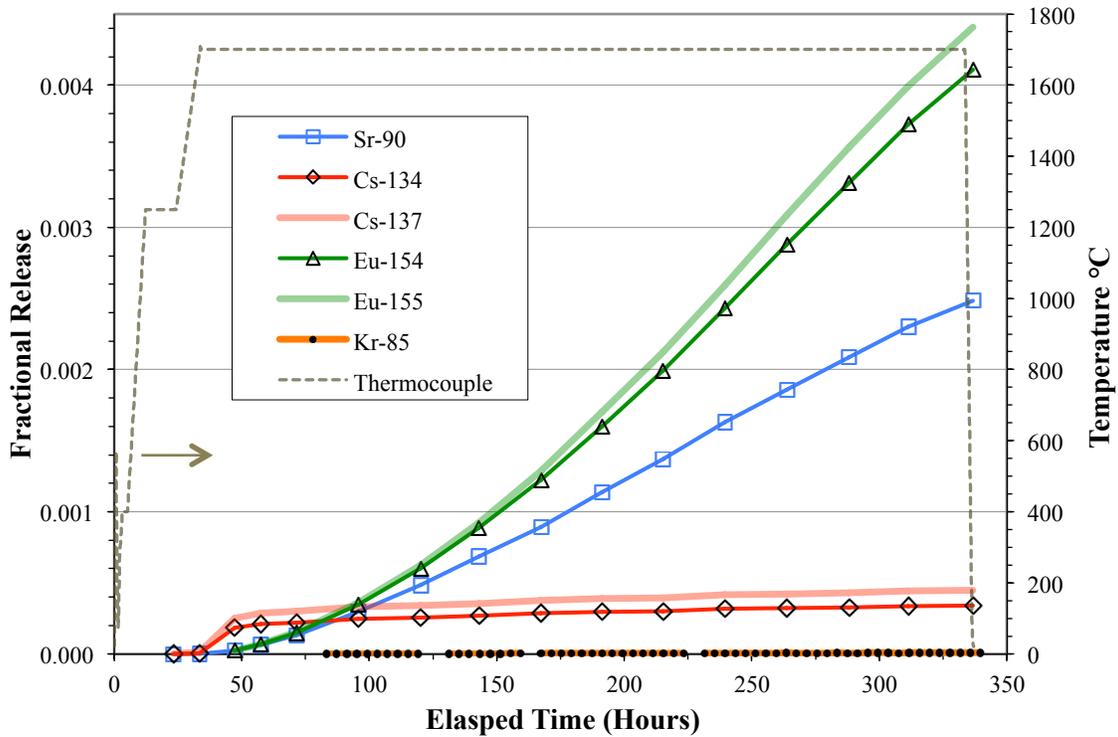
Figure 2. Release of fission products from Compact 5-1-1 during safety testing to 1700°C, plotted on a linear scale.

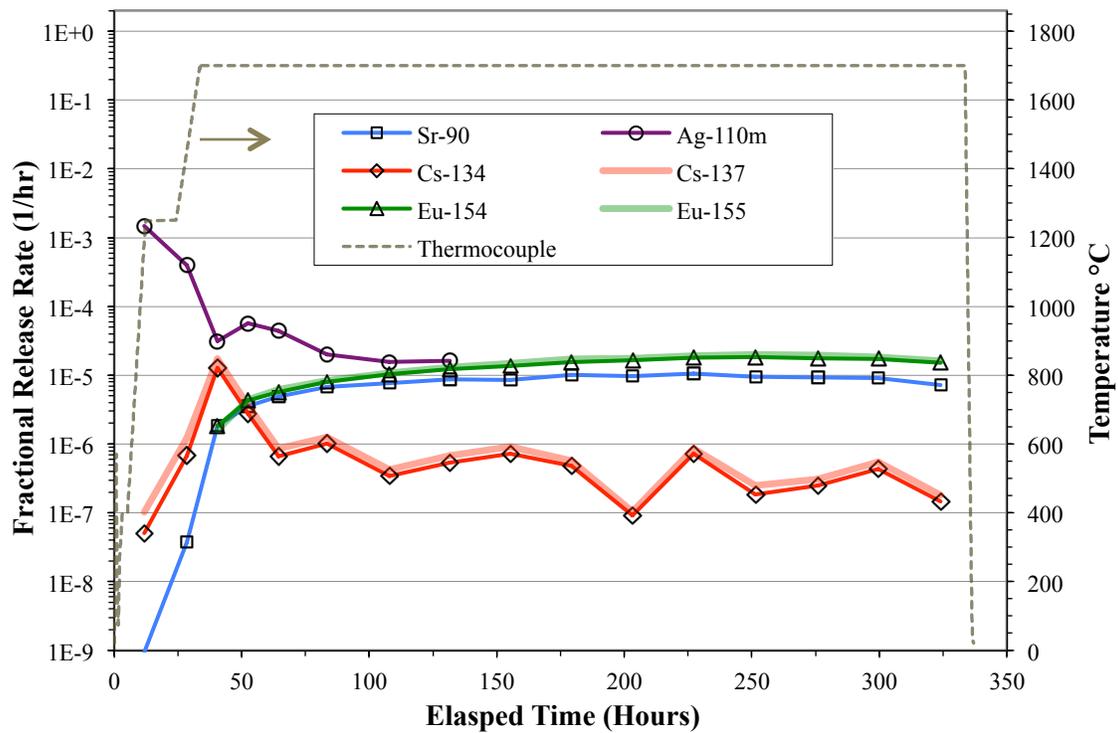
Figure 3. Release rates of fission products from Compact 5-1-1 during safety testing to 1700°C.

The cesium release rate was highest during the 14-hour period immediately after reaching the 1700°C test temperature. The amount of cesium released during this period was typical for cesium release from two or three particles with failed SiC. After the initial burst of cesium release, the release rate dropped off by an

order of magnitude and there was no additional significant increase in the release rate that would indicate additional SiC failure later in the test. The small increase in ^{110m}Ag release rate on the cup following the peak cesium release rate may be from silver escaping through the failed SiC. A slow release of krypton was observed that was well below the level that would indicate a failed TRISO coating, only reaching a cumulative fraction equivalent to a few percent of one particle's inventory. It is hypothesized that this krypton came from slow diffusion through the intact OPyC of the few particles that were releasing cesium. This type of krypton release has been observed in all the AGR-1 CCCTF safety tests at 1800°C (all of which had particles with failed SiC) and in the 1700°C safety test of AGR-1 Compact 3-3-1 [Hunn et al. 2013-2, page 7], which also exhibited cesium release from particles with failed SiC.

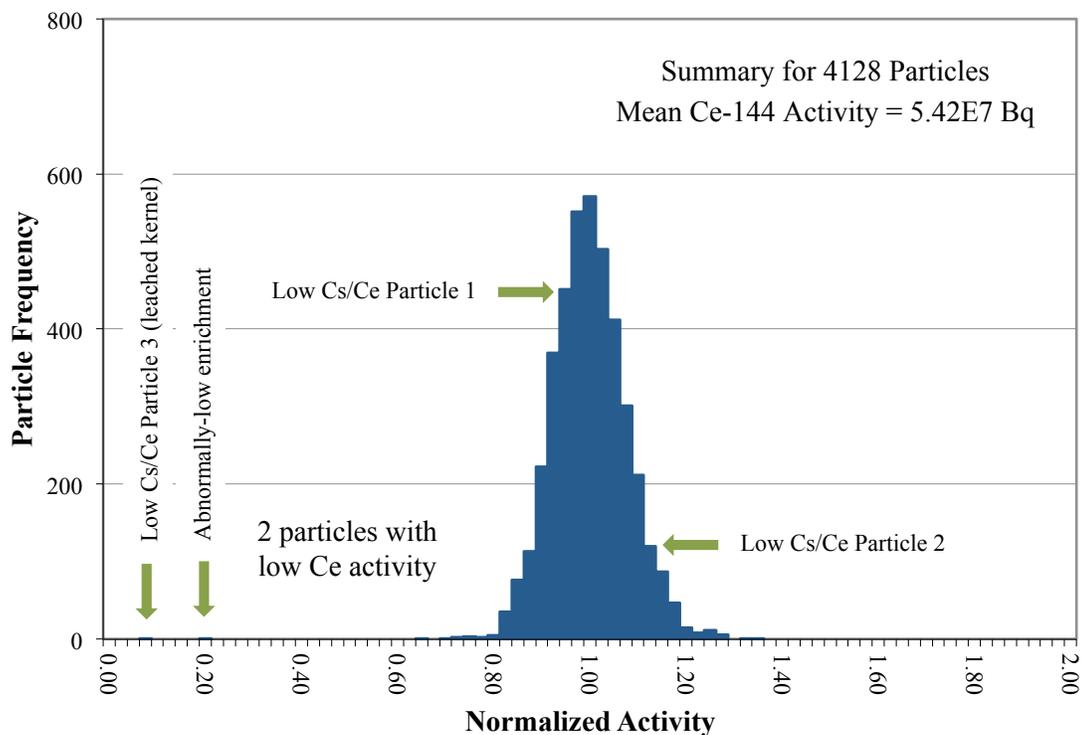
Figure 4. Normalized ^{144}Ce activity in particles from Compact 5-1-1. Arrows show location of particles of interest.

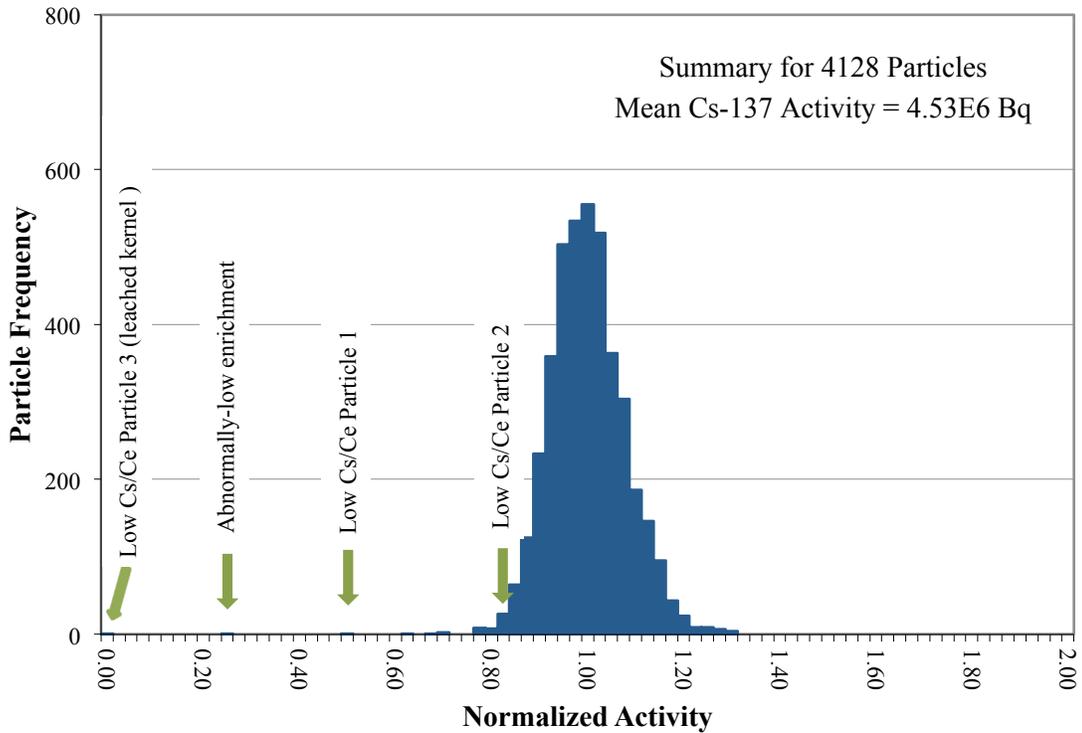
Figure 5. Normalized ^{137}Cs activity in particles from Compact 5-1-1. Arrows show location of particles of interest.

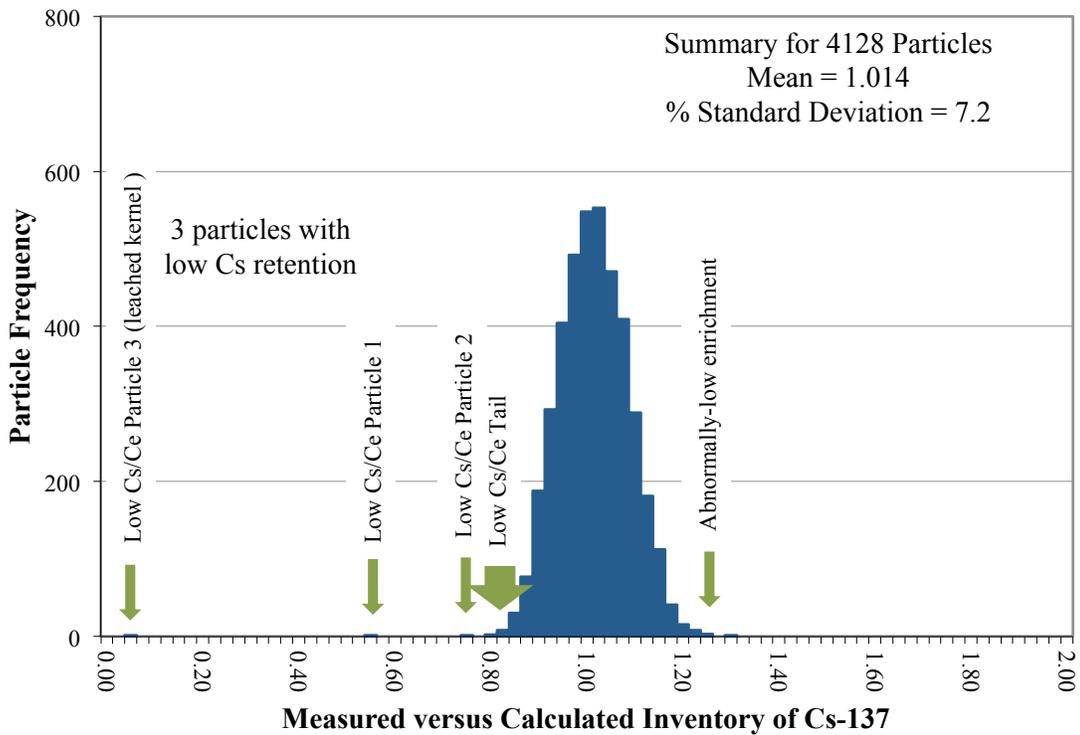
Figure 6. Estimated fraction of ^{137}Cs retained in particles from Compact 5-1-1, based on calculated inventory and adjusted for variation in fissionable material and burn-up using the measured ^{144}Ce activity. Arrows show location of particles of interest.

Table 6 lists the measured activities of the 20 particles from the low-end tail of the Cs/Ce distribution shown in Figure 6. Comparison of the inventories in these 20 specially-selected particles to those in the 45-particle sample of randomly-selected particles shows that the 20 particles from the low-end tail tended to have below-average cesium and above-average cerium inventories, which combined to put them at the lower-end of the calculated ratio for $^{137}\text{Cs}/^{144}\text{Ce}$. The average measured ^{106}Ru and ^{125}Sb inventories in these particles were not significantly different than in the randomly-selected particles; however, the average ^{154}Eu inventory was also inexplicably lower. Three of the 20 specially-selected particles from the low-end tail of the Cs/Ce distribution with the lowest measurable $^{137}\text{Cs}/^{144}\text{Ce}$ ratios (SP17, SP18, and SP20) were imaged with three-dimensional x-ray tomography, as discussed below, to look for any indication of SiC degradation that might explain the relatively-lower cesium and europium content; no SiC degradation was observed.

X-ray tomography was used to image three particles from the lower end of the Cs/Ce distribution (see Table 6 and Figure 6). All three particles exhibited similar, defect-free microstructures (Figure 19), where buffer densification resulted in clean delamination between the buffer and IPyC layers, with buffer layers remaining intact. No damage or degradation was evident in the outer three coating layers that would indicate these particles would experience below-average cesium retention, which leads to the conclusion that the below-average cesium inventory in these particles was most likely due to variations in initial fissile content or burnup, as opposed to cesium release.

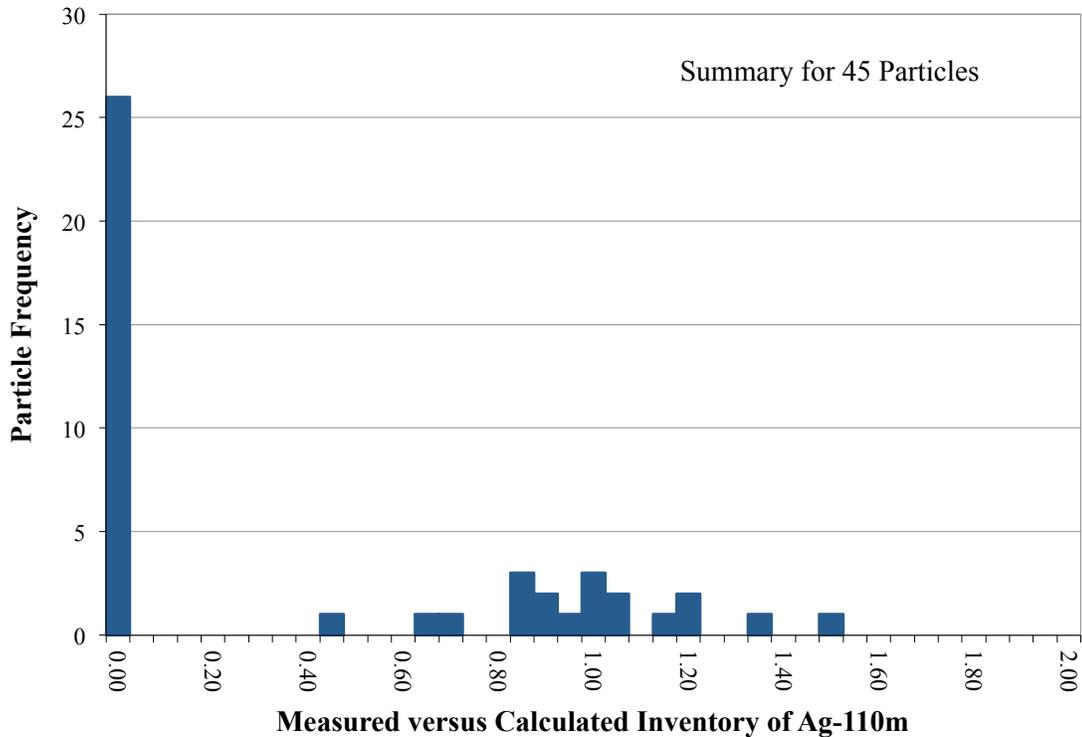
Figure 7. Ratio of ^{110m}Ag retained in 45 particles randomly-selected from Compact 5-1-1. Note that the ^{110m}Ag activity in these particles was very low at the time of analysis and uncertainty in peak analysis ranged from 30% for particles with more silver to 78% for particles with barely detectable silver. The 26 particles with undetectable inventory contained less than a minimum detectable M/C of <0.59–0.75.

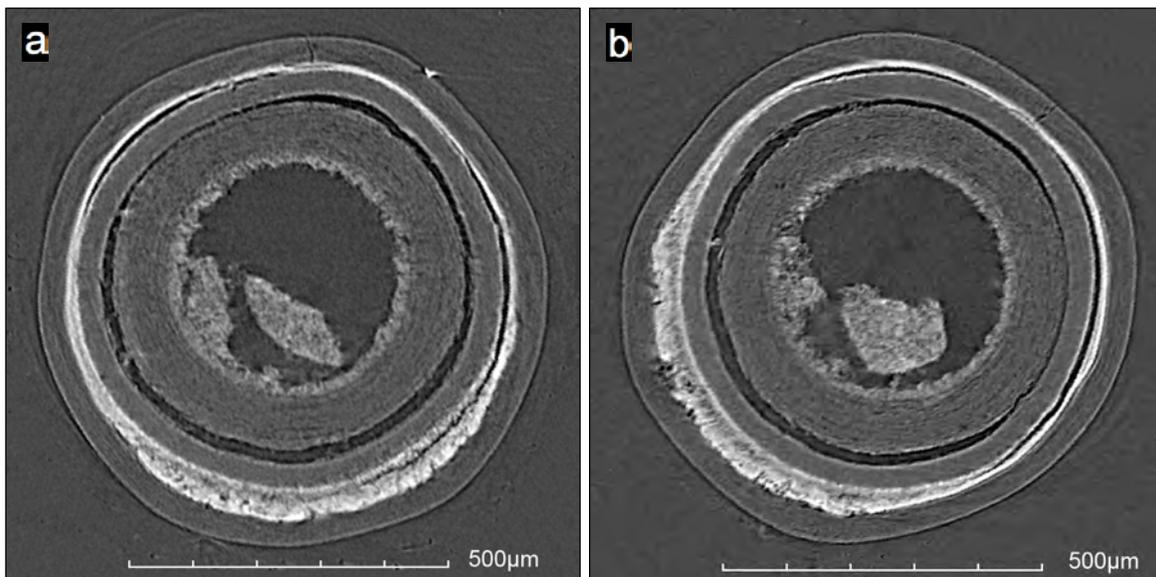
As mentioned in the IMGGA discussion, Low-Cs/Ce Particle 3 (511-SP02) exhibited a measurably-low inventory for all the radioisotopes detected with IMGGA. X-ray tomographs of this particle (Figure 8), show that it was missing most of its kernel material. This particle is an example of a fluidization defect sometimes called a SiC soot inclusion. The abnormal SiC layer structure was caused by the particle getting temporarily trapped somewhere in the coater, such that it spent a significant fraction of the 140-minute SiC deposition period not circulating through the primary coating region. The x-ray tomographs in Figure 8 show a thin dense SiC layer at the IPyC interface, another thin dense layer at the OPyC interface, and an abnormal layer sandwiched between. This structure was presumably formed when the particle was temporarily ejected from the fluidized particle bed and stuck in the carbon soot on the walls of the upper coater section. The particle then apparently returned to the fluidized bed near the end of the SiC deposition period and received a normal OPyC coating. Irradiation test data [Collins 2015] and post-irradiation inspection of the Capsule 5 graphite holder [Harp 2013] indicate that this as-fabricated defect survived the three-year AGR-1 irradiation test without releasing significant quantities of cesium or krypton, only experiencing a through-layer SiC failure during the 1700°C safety testing. Because there was no large release of krypton during the safety test, it is reasonable to assume that the OPyC crack, visible in Figure 8b, did not occur until the deconsolidation or pre-burn acid leaching; at which time acid apparently penetrated to the kernel and removed material.

Figure 8. Low Cs/Ce Particle 3 (511-SP02): oblique orthogonal x-ray tomographs showing a gross SiC inclusion (pre-irradiation defect), and only residual kernel material remaining after pre-burn leaching.

The three particles from Compact 5-1-1 with failed SiC were successfully detected and sorted out with IMGA for further analysis. The OPyC layer in one particle was damaged during deconsolidation, resulting in acid leaching of most of the kernel, but x-ray tomography of the leached particle showed it to be an as-fabricated defect (Figure 8). This was the third AGR-1 particle identified with a failed SiC layer due to an as-fabricated defect; the other two were found after 1600°C safety testing of Compact 3-3-2 [Hunn et al. 2012-2] and Compact 4-1-2 [Hunn et al. 2013-3]. All three of the PIE-observed AGR-1 as-fabricated defects were due to fluidization anomalies during coating.

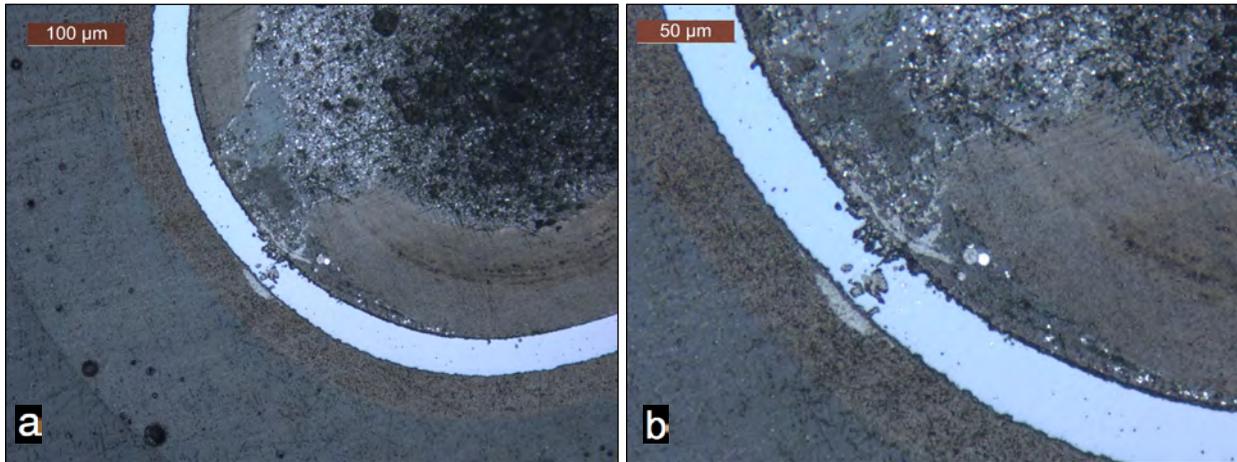
The other two particles that released cesium during safety testing exhibited the typical degraded SiC and general particle microstructure that has been identified in other particles with SiC failure during 1700 and 1800°C safety testing [Hunn et al. 2014-2]; namely, localized SiC degradation by palladium where radiation-induced shrinking of the buffer has led to IPyC cracking and exposure of the inside surface of the SiC. Low-Cs/Ce Particle 1 showed extensive SiC degradation where it was exposed by a fracture through the buffer and IPyC layer, which remain bonded to each other where the fracture occurred (Figure 9). Kernel protrusion into the fracture gap resulted in a significant amount of kernel material coming in contact with the SiC. Metallic fission products can be seen within the degraded SiC and piled up in the OPyC outside the SiC penetration point (Figure 10). This pileup in the OPyC has not been previously observed, and is discussed further below in conjunction with the electron microscopy results.

Figure 9. Low-Cs/Ce Particle 1 (511-SP03): optical micrographs showing buffer and IPyC fracture, IPyC/SiC delamination, kernel protrusion reaching the SiC, and localized SiC degradation by palladium.

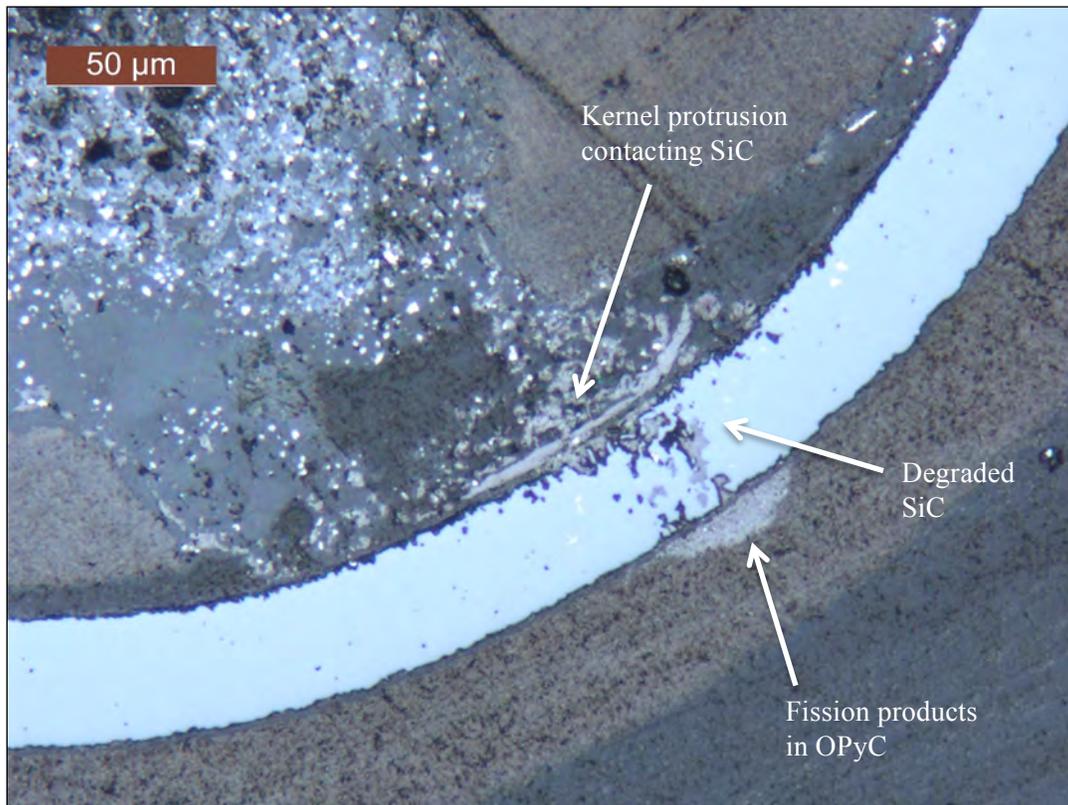
Figure 10. Low-Cs/Ce Particle 1 (511-SP03): optical micrograph showing same region as Figure 9 after additional polishing; a significant concentration of fission products can be seen in the OPyC layer, adjacent to the degraded SiC.

The SiC degradation in Low-Cs/Ce Particle 1 presents a unique case, as the presence of fission products in the OPyC layer surrounding a region of SiC degradation (Figure 10 and Figure 11f) have not been previously observed. The primary features of the SiC degradation remained consistent with previously-observed degraded SiC; namely, high-Z fission product features surround the SiC degradation and appear to advance in front of C-rich phases in the SiC layer, where silicon has presumably been removed by formation and out-diffusion of silicide [Hunn et al. 2014-1; Hunn et al. 2014-2]. Figure 14 shows a set of single-element EDS maps of the higher-concentration elements found in the degraded area. Collocated with these predominant elements were measurable amounts of rhodium, zirconium, molybdenum, and palladium. Lighter-areas visible in the SiC (without color assigned during EDS mapping) were also identified as fission product features by longer-count EDS point analysis. In the SEI and BEC images in Figure 11f, darker areas in the SiC correspond to higher-intensity regions in the Figure 14 carbon map and show greatly-reduced intensity in the silicon map, confirming that these regions are C-rich, Si-depleted zones. Ruthenium and uranium were the dominant fission products remaining in the degraded area with U-rich features at the IPyC/SiC interface and Ru-rich features in the SiC and OPyC. The fission products in the OPyC surrounding the SiC degradation zone are suggested to be silicides of ruthenium, uranium, and rhodium. Oxygen and carbon were also identified in this area; however, accurate confirmation of the contributions from these elements is difficult due to matrix effects and low-Z sensitivity challenges. The relative composition of the features in the OPyC layer is estimated to be 28.5% Ru, 12.1% U, 6.9% Rh, and 52.5% Si (assuming insignificant oxygen or carbon content). The features in the SiC degradation zone were similar in composition, but also contained measurable palladium. Within the SiC layer, the presence of silicon, carbon, or oxygen could not be directly determined due to matrix effects and poor

The other two Compact 5-1-1 particles with SiC failure (Figure 10 and Figure 16) exhibited the same degradation mechanism that has been observed in all the other AGR-1 particles with SiC failure during irradiation or safety testing [Hunn et al. 2014-2]. In these particles, dimensional changes in the buffer and kernel due to buffer densification and kernel expansion led to cracking of the IPyC layer. Two general mechanisms for IPyC cracking were buffer fracture propagating directly into an attached IPyC layer and buffer layer delamination resulting in damage to the IPyC as the buffer layer was tearing away. IPyC cracks did not always result in SiC failure, but SiC failure appeared to always be related to IPyC cracking. Exposure of the SiC, either along the edge of the IPyC crack or where the IPyC crack led to delamination at the IPyC/SiC interface, allowed fission products (predominantly palladium and uranium) to pileup and react with the SiC layer. Degradation of the exposed SiC eventually resulted in a localized penetration of the layer. Removal of silicon along this penetration pathway left behind a low-density, C-rich material through which cesium could escape. Elemental mapping of the degraded SiC in Particle 511-SP03 showed large regions in the SiC that were C-rich and Si-poor (Figure 14). This particle also exhibited previously unobserved pileup of fission products (mainly ruthenium and uranium) in the OPyC layer adjacent to the SiC degradation (Figure 11f), as well as unusual concentrations of molybdenum in the kernel protrusion closest to the SiC degradation (on the other side of the SiC).

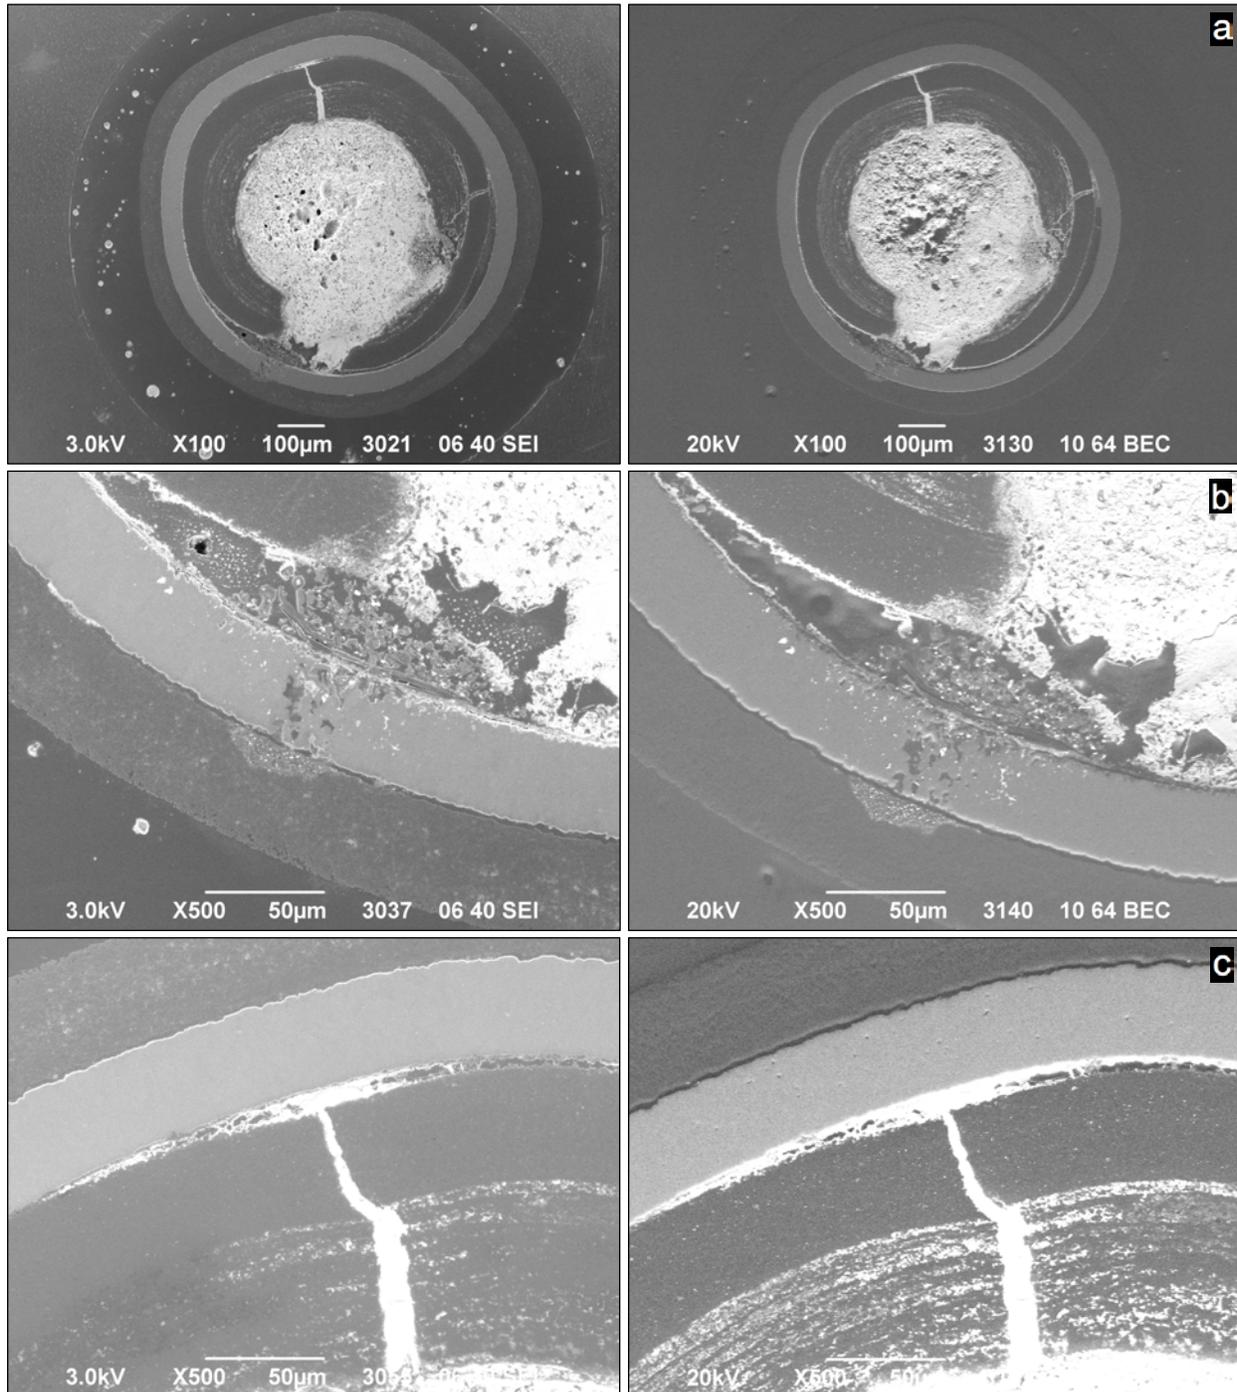
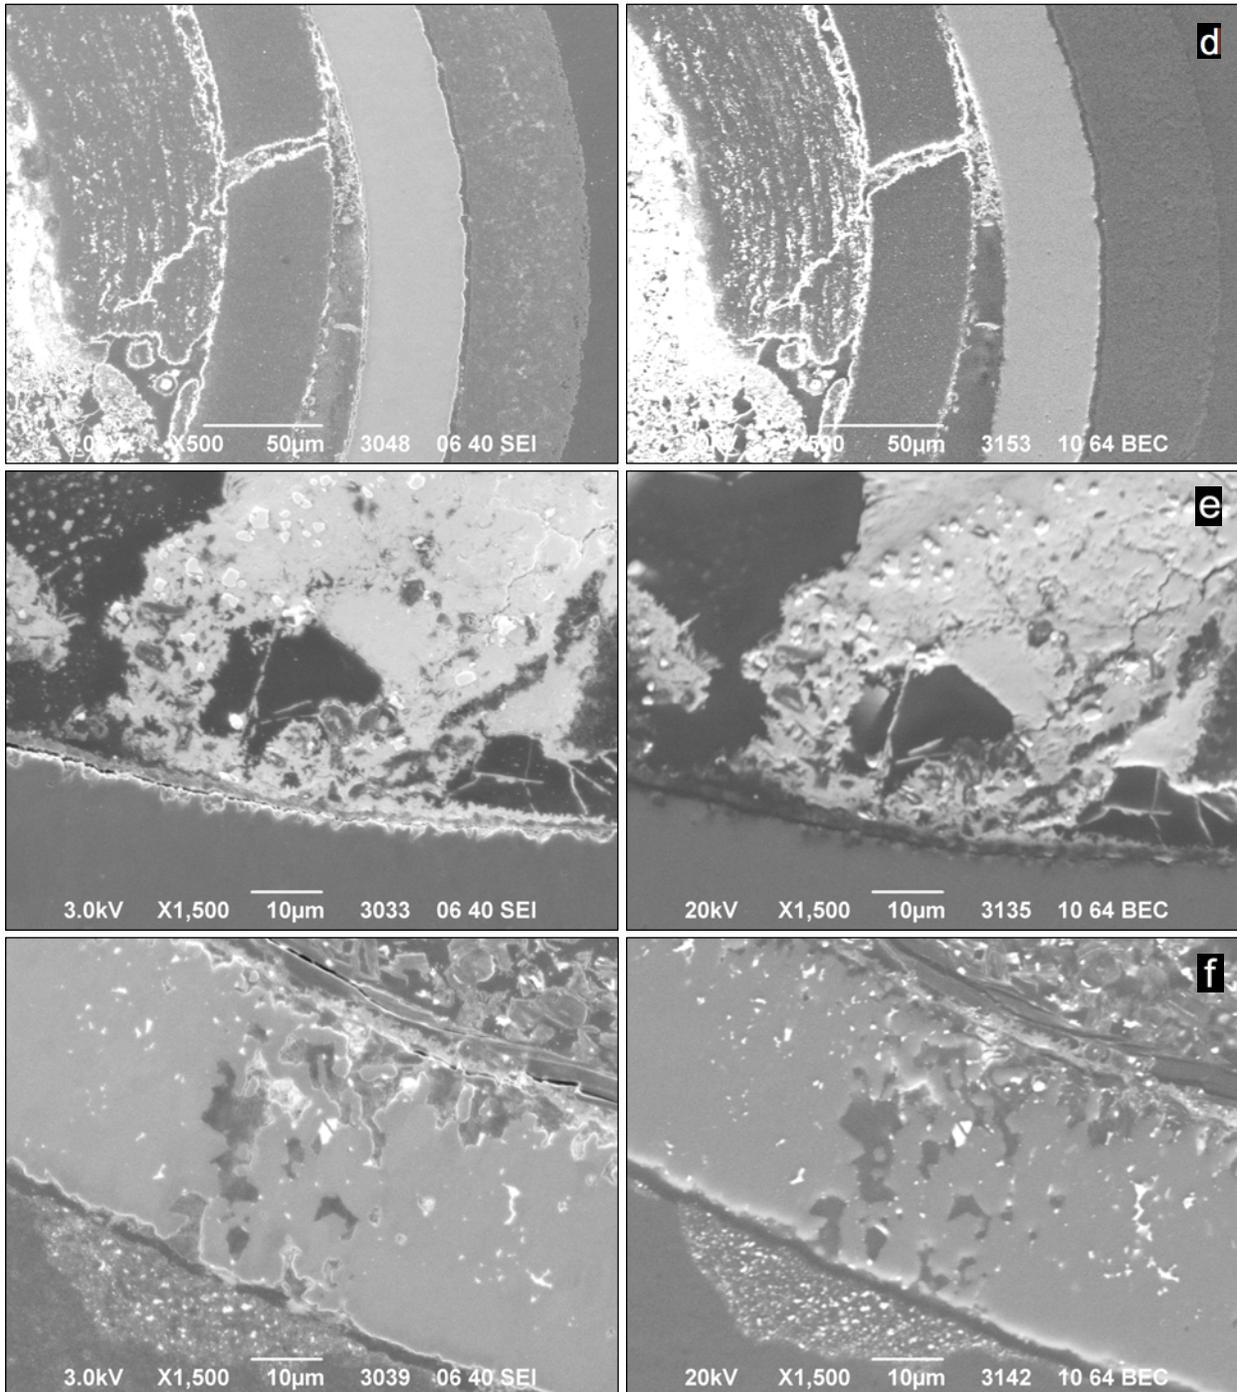
Images of select areas of interest in Low-Cs/Ce Particle 1 are presented in Figure 11 using SEM secondary-electron imaging (SEI) and backscattered-electron composition (BEC) image pairs to highlight the anomalies. The contrast observed in BEC imaging is dependent on the atomic number (Z), with low- Z regions appearing dark and high- Z regions appearing bright. The BEC imaging is ideal for identifying high- Z fission products clustered in the low- Z TRISO layers. The SEI imaging is more topographically sensitive and allows for differentiation of surface features such as hot cell contamination and polishing artifacts from actual embedded fission products. Three distinct features were observed involving the

distribution of high-Z elements within the particle. Significant redistribution or protrusion of the kernel material into open areas formed by buffer and IPyC fracture is apparent in Figure 11a–c and Figure 11e, where high-Z kernel material can be seen to have migrated all the way to the SiC layer through the failed buffer and IPyC. A second feature of interest is the layer of high-Z material lining the IPyC and SiC layers in the region where the IPyC delaminated from the SiC layer, shown in Figure 11b and Figure 11d. The last region of interest is the SiC degradation region. The SiC degradation was adjacent to the largest IPyC failure and most-prominent kernel protrusion; BEC imaging shows a large buildup of fission product features in and around the degraded SiC.

Figure 11. SEI/BEC-paired images of Low-Cs/Ce Particle 1 (511-SP03): a) particle overview, b) kernel protrusion adjacent to SiC degradation, and c) fission products filling IPyC crack.

Figure 11 (continued) SEI/BEC-paired images of Low-Cs/Ce Particle 1 (511-SP03): d) IPyC crack and IPyC/SiC delamination lined with fission products, e) kernel in contact with SiC, and f) SiC degradation with fission products in OPyC.

Analysis with EDS was employed on all features of interest identified in Figure 11. Elemental maps of the protruded kernel are shown in Figure 12; both features are primarily mixtures of uranium and molybdenum with included oxygen and carbon. (Uranium is not shown in Figure 12a, as its intensity limits the ability to visualize the distribution of ruthenium and zirconia.) The large segregation of a Mo-rich phase has not been noted in previous observations of kernel protrusions, which typically have elemental content consistent with the bulk of the kernel. The EDS map of Figure 12a indicates secondary Zr-rich phases in the kernel, as well as a buildup of ruthenium near and within the SiC degradation.

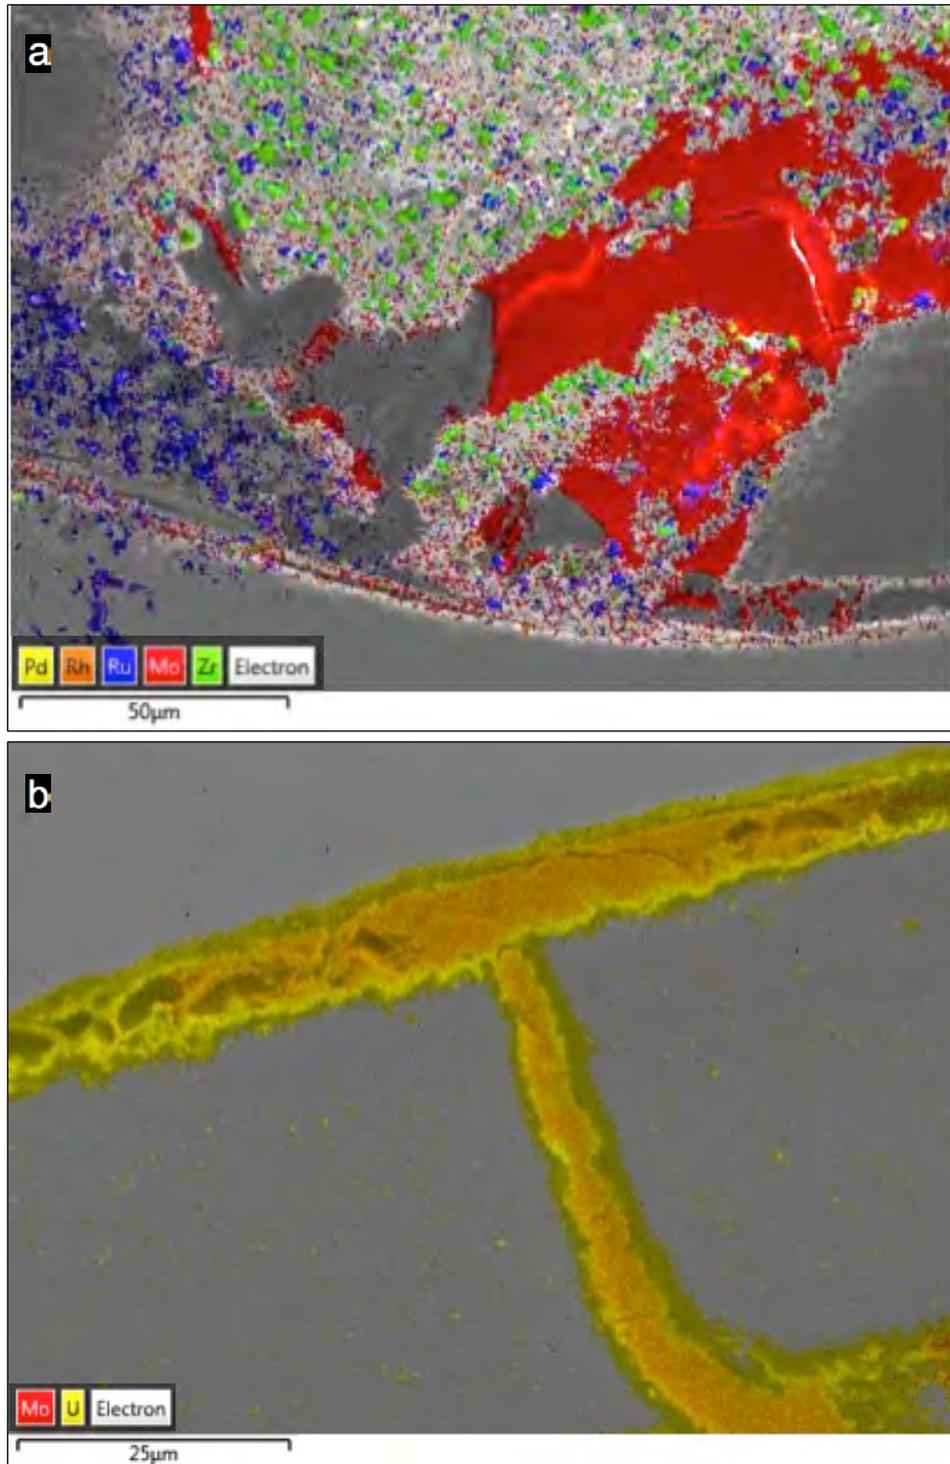
Figure 12. Low-Cs/Ce Particle 1 (511-SP03): EDS elemental-intensity maps overlaid on SEI reference images of a) the large kernel protrusion near the degraded SiC region (Figure 11b and e), and b) fission products in the IPyC crack shown in Figure 11c. U is not shown in (a) as its intensity limits observable details in Mo, Ru, and Zr distributions.

Analysis of randomly selected particles from Compact 5-1-1 showed finely-dispersed secondary Mo-rich and Zr-rich phases distributed throughout the kernel. The observation of a segregated U-Mo phase in Low-Cs/Ce Particle 1 indicates significant kernel chemistry changes occurred.

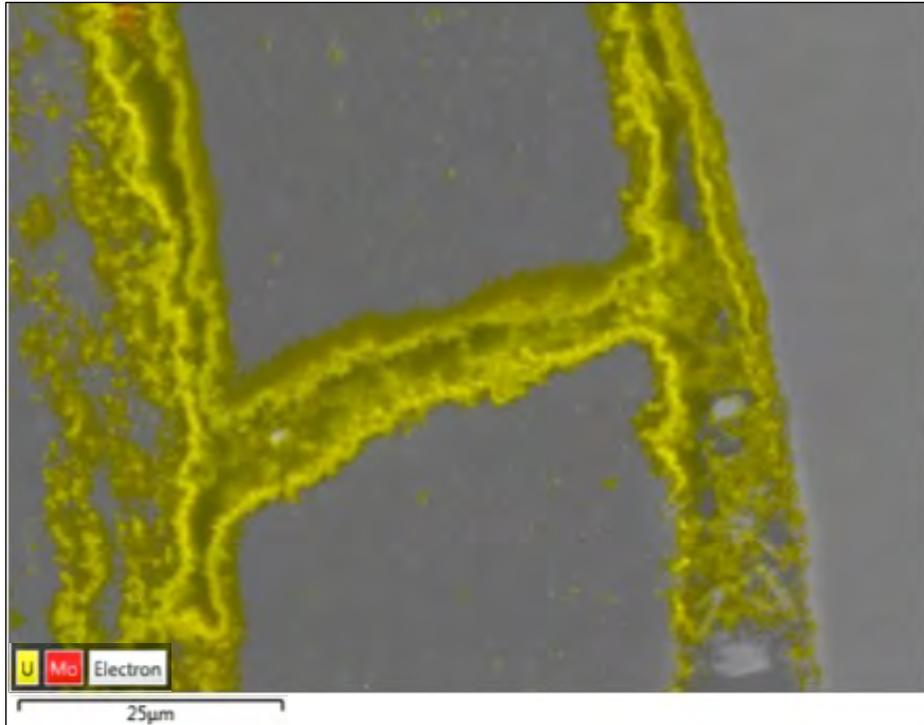
Figure 13 shows an EDS map of the high-Z material lining the IPyC and SiC layers in the region where the IPyC is delaminated from the SiC (Figure 11d). The map confirms the layer is uranium. No significant molybdenum or contribution from other elements was noted. The reason for the different elemental distribution in the two IPyC crack regions shown in Figure 12b and Figure 13 is not explicitly known. Notable differences included the fact that the Mo-rich material in Figure 12b is in contact with the kernel while the U-rich layer in Figure 13 does not have a directly observable pathway to the kernel.

Figure 13. Low-Cs/Ce Particle 1 (511-SP03): EDS map of the IPyC crack with high-Z lining shown in Figure 11d.

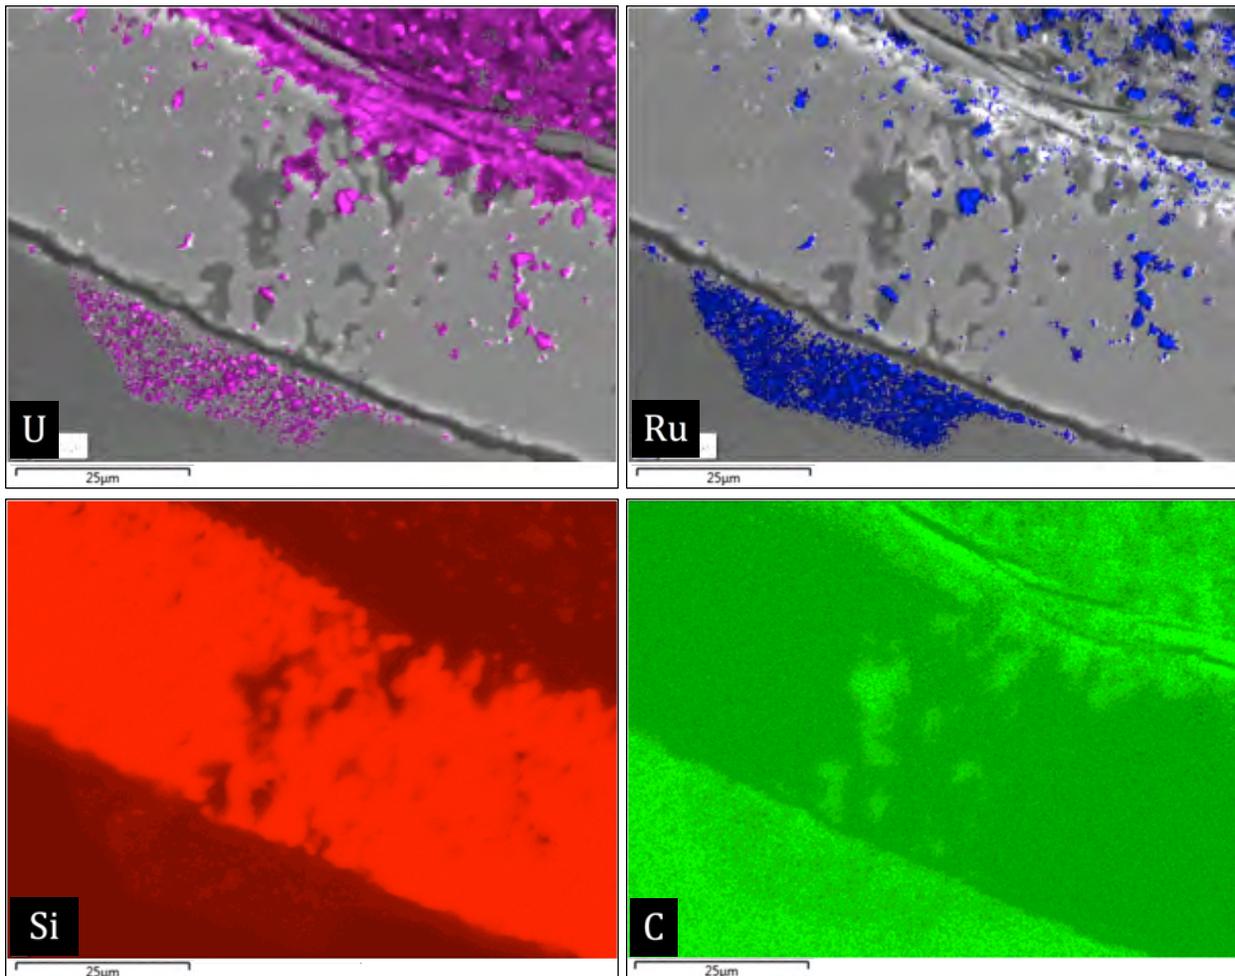
low-Z sensitivity. Assuming a similar composition of silicides, the relative concentration of the constituent fission product elements would be 21.5% Ru, 17.1% U, 6.2% Rh, and 2.7% Pd; as such, the composition is very similar to the features in the OPyC layer, with the exception of the presence of palladium and an increase in uranium content at the expense of ruthenium. The majority of features at the IPyC/SiC interface are U-rich. Ruthenium, molybdenum, and zirconium were also observed with uranium in some interface features. A few other features at the IPyC/SiC interface had similar composition to the features observed in the SiC degradation region. The reason for the higher concentration of elements other than the palladium and uranium usually observed in degraded SiC is not explicitly known, but appears to be related to the greater out-diffusion of fission products into the OPyC.

Figure 14. Low-Cs/Ce Particle 1 (511-SP03): EDS maps of SiC degradation area (Figure 11d) showing distributions of the higher-concentration fission products.

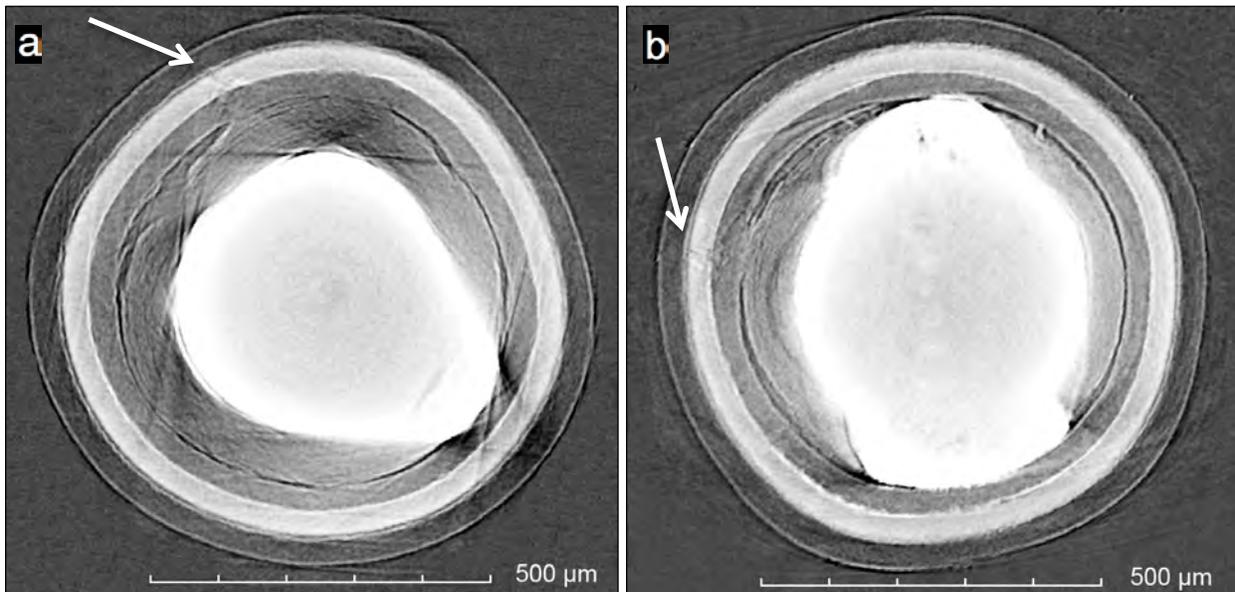
Low-Cs/Ce Particle 2 also experienced buffer fracture due to the radiation-induced shrinkage in this low-density carbon layer. X-ray tomographs in Figure 15 show kernel protrusion into the buffer fracture, but the SiC degradation is not related to this kernel protrusion. A low-density penetration of the SiC can be seen in a region where partial delamination of the buffer from the IPyC led to IPyC cracking and SiC failure; this is more evident in the optically-imaged cross sections in Figure 16. The buffer tore away from the IPyC on either side of a buffer fracture, and this buffer/IPyC delamination appears to terminate on one side at a crack through the IPyC. Fission product pileup and eventual SiC degradation occurred at the tip of the IPyC crack, where the SiC interface was exposed. The localized nature of this SiC degradation is illustrated in Figure 16 by the fact that additional polishing, which probably removed 10–20 μm from the polished surface, resulted in polishing almost all the way through the degraded zone.

Figure 15. Low-Cs/Ce Particle 2 (511-SP04): oblique orthogonal x-ray tomographs showing fractured buffer, kernel protrusion, partial buffer/IPyC delamination, and SiC degradation (identified by arrows).

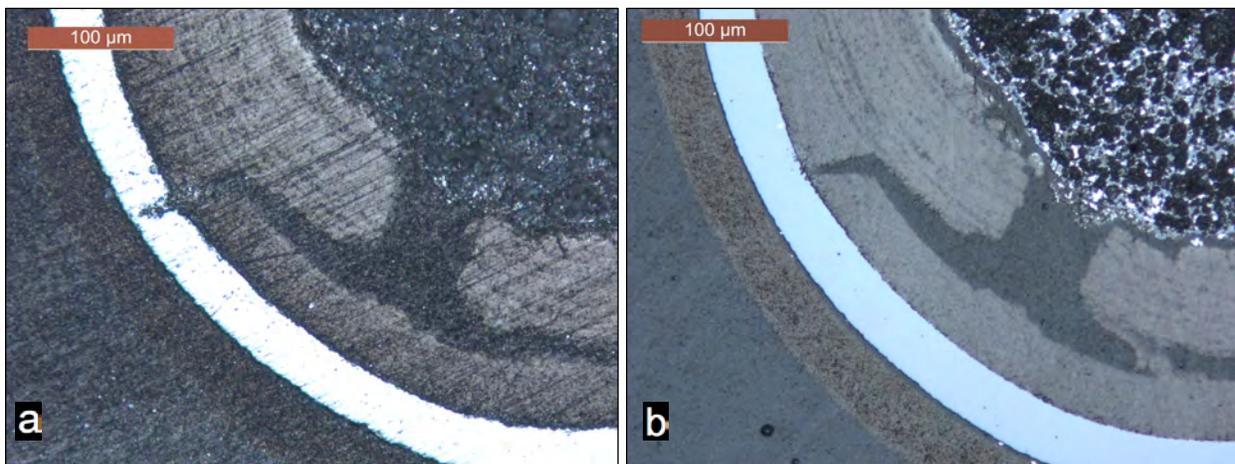
Figure 16. Low-Cs/Ce Particle 2 (511-SP04): a) optical micrograph taken during grinding showing buffer fracture, incomplete buffer/IPyC delamination, IPyC crack at the edge of buffer/IPyC delamination, and localized SiC degradation; and b) optical micrograph of fully-polished plane showing same region, but just beyond point where the SiC degradation penetrated the layer.
