PIE on Safety-Tested AGR-1 Compact 5-1-1

August 2015

Fusion and Materials for Nuclear Systems Division

PIE ON SAFETY-TESTED AGR-1 COMPACT 5-1-1

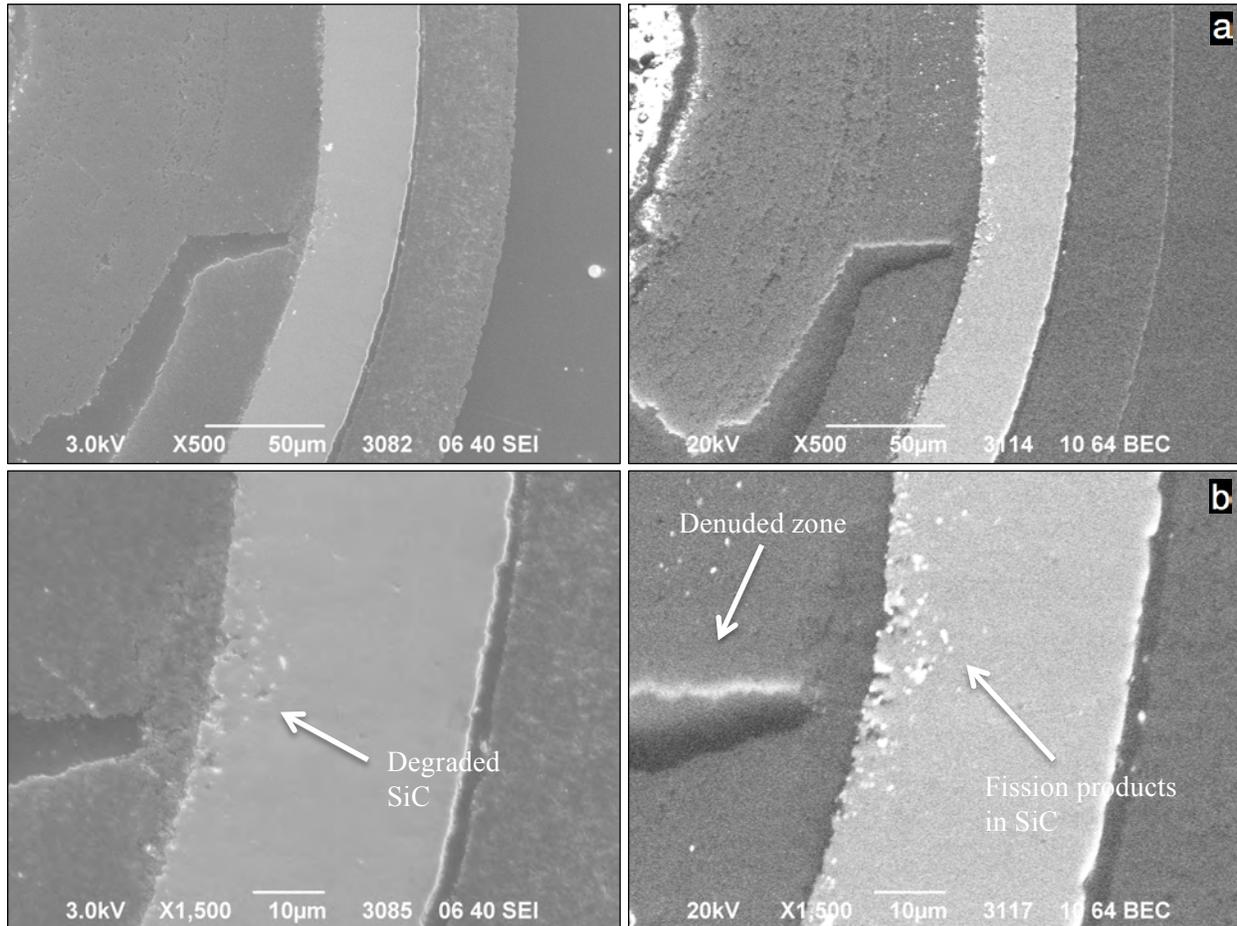
Figure 17 shows SEI/BEC-image pairs of the IPyC crack and SiC degradation area that remained after final polishing of Low-Cs/Ce Particle 2. The projection of the SiC degradation area observed in this cross section does not traverse the entire SiC layer thickness; however, it does provide indication of a SiC degradation mechanism consistent with what has been observed in most AGR-1 particles with failed SiC. Large fission product features are present in the SiC layer surrounding C-rich regions, similar to features previously observed in other particles with degraded SiC [Hunn et al. 2014-1, Hunn et al. 2014-2]. The area around the IPyC crack is depleted of the segregated fission product features seen elsewhere in the IPyC, indicating their higher mobility near the crack, which appears to facilitate the transport of fission product species to the degradation site and the transport of products of the degradation reaction away from the site. Figure 17a also indicates a thinning of the SiC layer in the immediate vicinity surrounding the SiC degradation area, in conjunction with an absence of the normally-interlaced IPyC/SiC interface.

There also appears to be a variation in the IPyC structure adjacent to the degraded SiC region that has been observed in other particles with noted SiC degradation areas [Hunn et al. 2014].

Figure 17. SEI/BEC-paired images of Low-Cs/Ce Particle 2 (511-SP04): a) IPyC crack and SiC degradation area overview and b) closeup of the SiC degradation area.

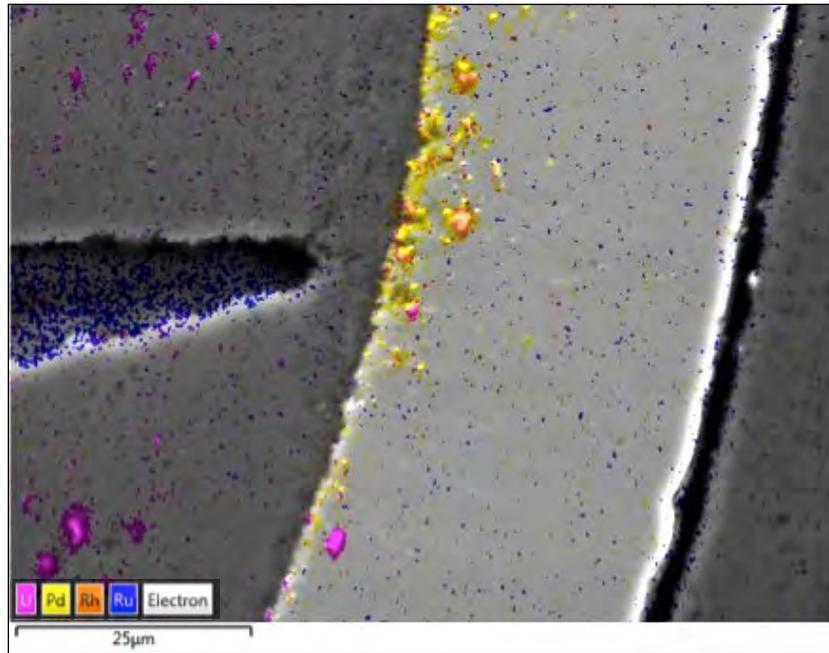
Elemental analysis of the SiC degradation area in Low Cs/Ce Particle 2 predominantly indicated the presence of palladium, uranium, and rhodium in the fission product clusters in the immediate vicinity of the SiC degradation site. Carbon and silicon were also identified in all features, but due to matrix contributions, accurate insight into their content within the fission product clusters cannot be determined. However based on the analysis of larger features, which limit matrix contribution, it is suggested the features were silicides based on their Si-rich nature. Oxygen was also identified in a majority of the features, but, as already mentioned, accurate analysis of oxygen is problematic. Figure 18 shows an EDS mapping of the palladium, uranium, and rhodium, which were mostly-located in features less than 10 µm from the IPyC/SiC interface. Neodymium and plutonium were also identified in select clusters in the SiC degradation area; however, direct confirmation of plutonium is limited due to peak overlap with uranium. The finer-scale fission product features deeper in the SiC layer were observed to be primarily palladium and uranium. Rhodium was not identified; however, it cannot be ruled out due to a minimum interaction volume limiting the sensitivity limits of the EDS system for these smaller features. At the IPyC/SiC interface away from the SiC degradation site, the fission product features were primarily palladium and uranium, or just uranium; although a few fission product clusters also showed zirconium and neodymium or a mixture of palladium, uranium, and rhodium.

Figure 18. Low-Cs/Ce Particle 2 (511-SP04) EDS map of SiC degradation area, element intensity is color coded and overlaid on the SEI reference image.

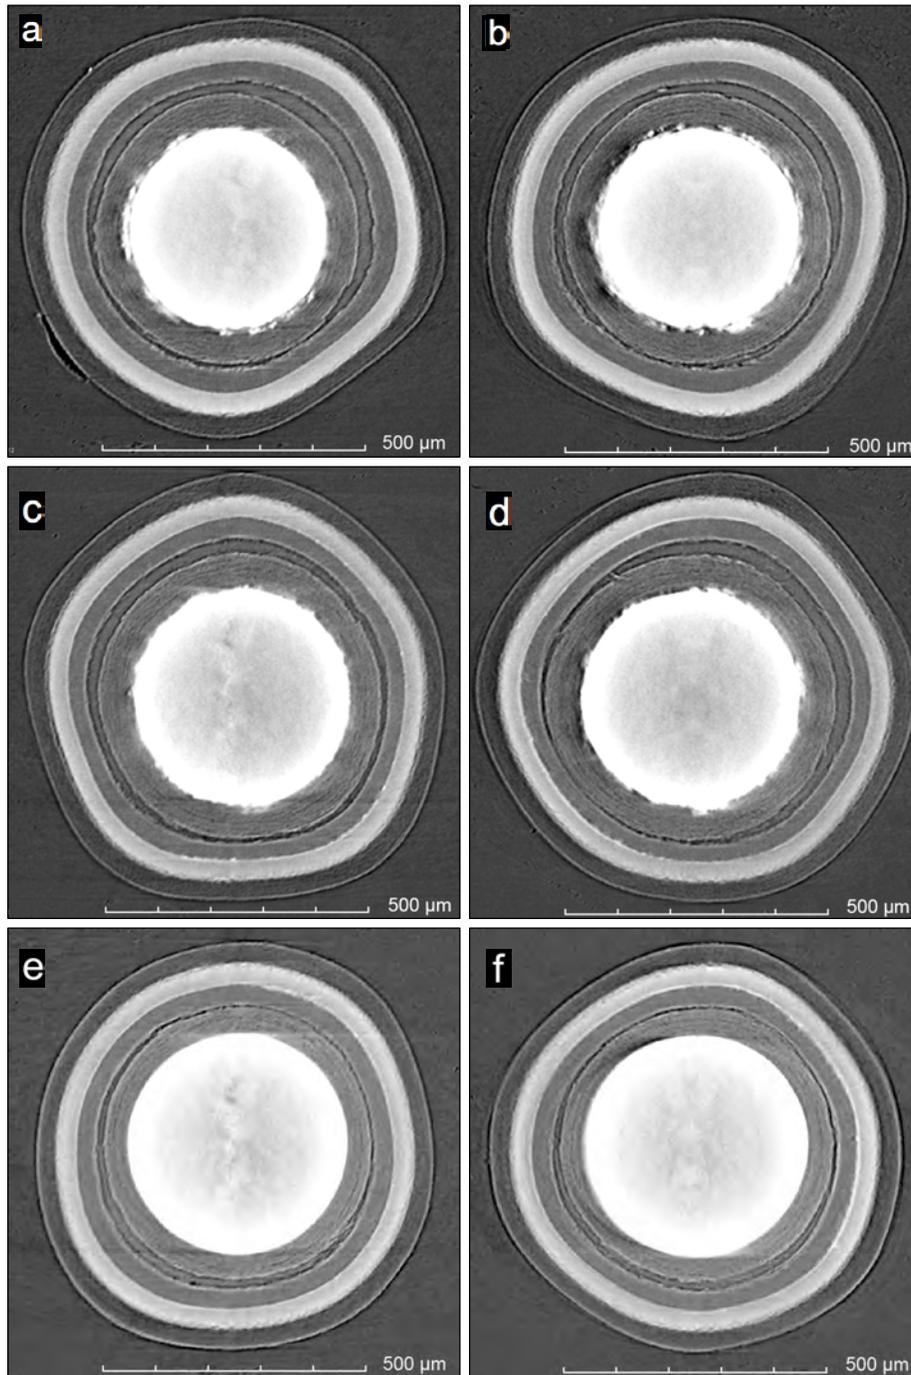
X-ray tomography was used to image three particles from the lower end of the Cs/Ce distribution (see Table 6 and Figure 6). All three particles exhibited similar, defect-free microstructures (Figure 19), where buffer densification resulted in clean delamination between the buffer and IPyC layers, with buffer layers remaining intact. No damage or degradation was evident in the outer three coating layers that would indicate these particles would experience below-average cesium retention, which leads to the conclusion that the below-average cesium inventory in these particles was most likely due to variations in initial fissile content or burnup, as opposed to cesium release.

Figure 19. Orthogonal x-ray tomographs near midplane of Particle 511-SP17 (a and b), Particle 511-SP18 (c and d), and Particle 511-SP20 (e and f) showing typical buffer shrinkage and delamination from IPyC.

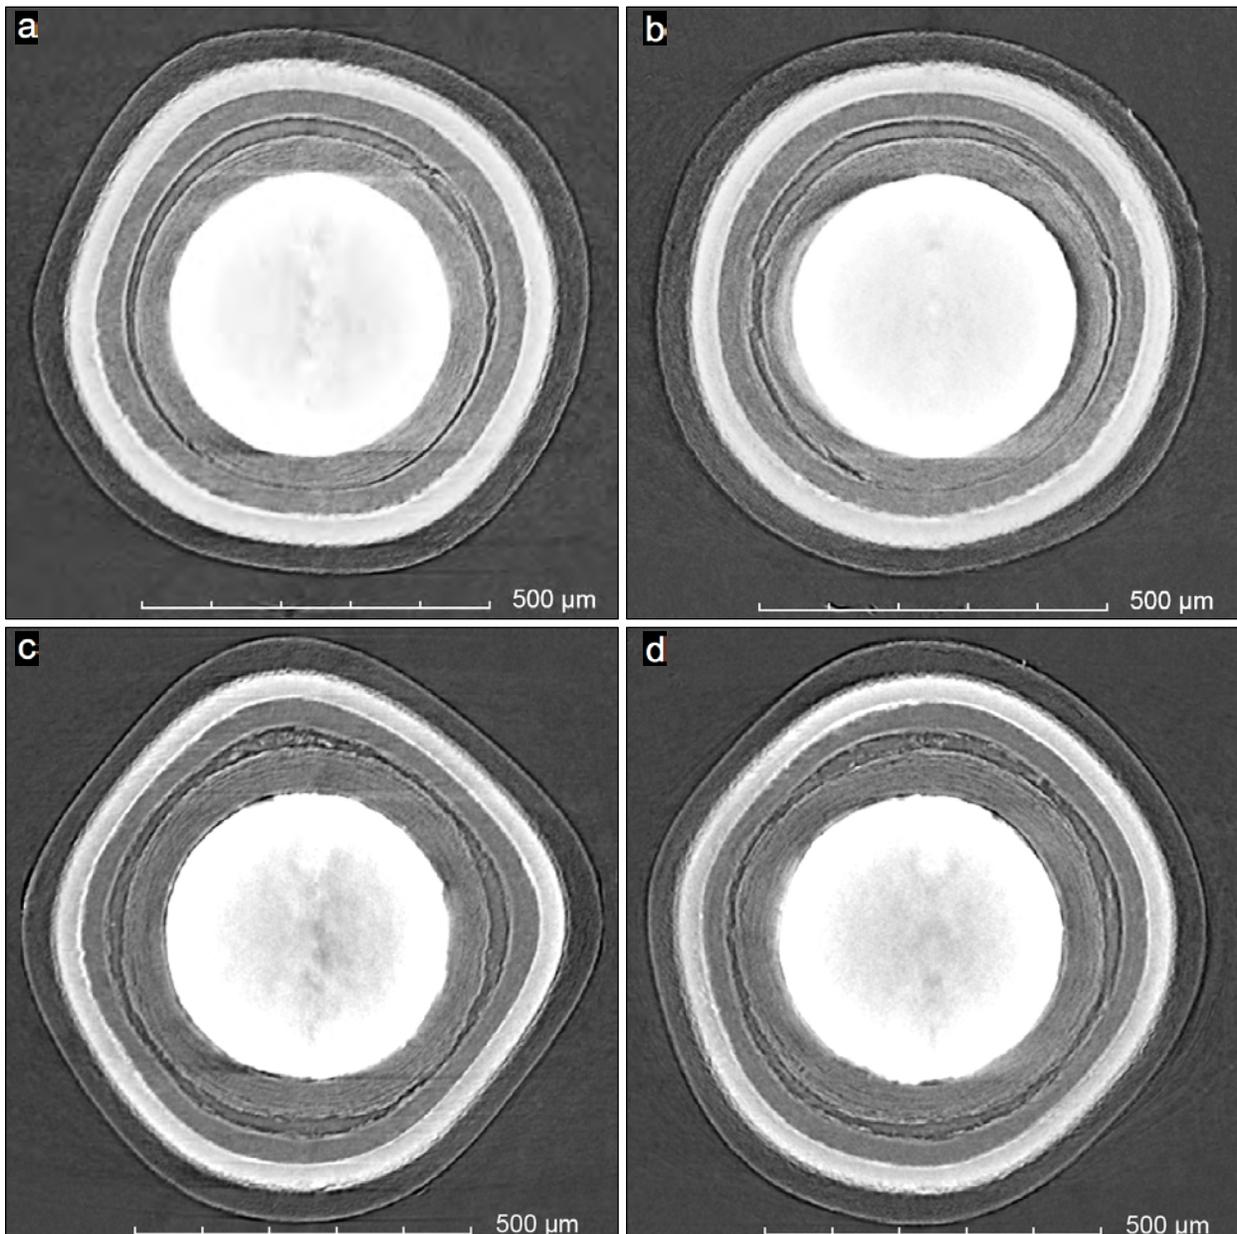
Two of the particles randomly-selected for IMGA measurement were imaged with x-ray tomography (Figure 20). Particle 511-RS03 had an average radioisotopic inventory, including a ^{110m}Ag M/C = 0.99; while Particle 511-RS05 had a similar average radioisotopic inventory, except for ^{110m}Ag , which was below a detection limit of M/C < 0.65. Both particles exhibited defect-free microstructures similar to those in Figure 19, where buffer densification resulted in delamination between the buffer and IPyC layers, but no buffer fracture. Again, no damage or degradation was evident in the outer three coating layers other than a slight separation between the SiC and OPyC which has been observed in most of the AGR-1 particles, especially after safety testing. This SiC/OPyC gap has been attributed to the shrinking matrix pulling the OPyC away from the SiC due to the stronger interface bond between the matrix and porous OPyC, compared to the OPyC and non-porous SiC [Hunn et al. 2013-2, page 27].

Figure 20. Orthogonal tomographs near midplane of Particle 511-RS03 (a and b) and Particle 511-RS05 (c and d) showing typical buffer shrinkage and delamination from IPyC.

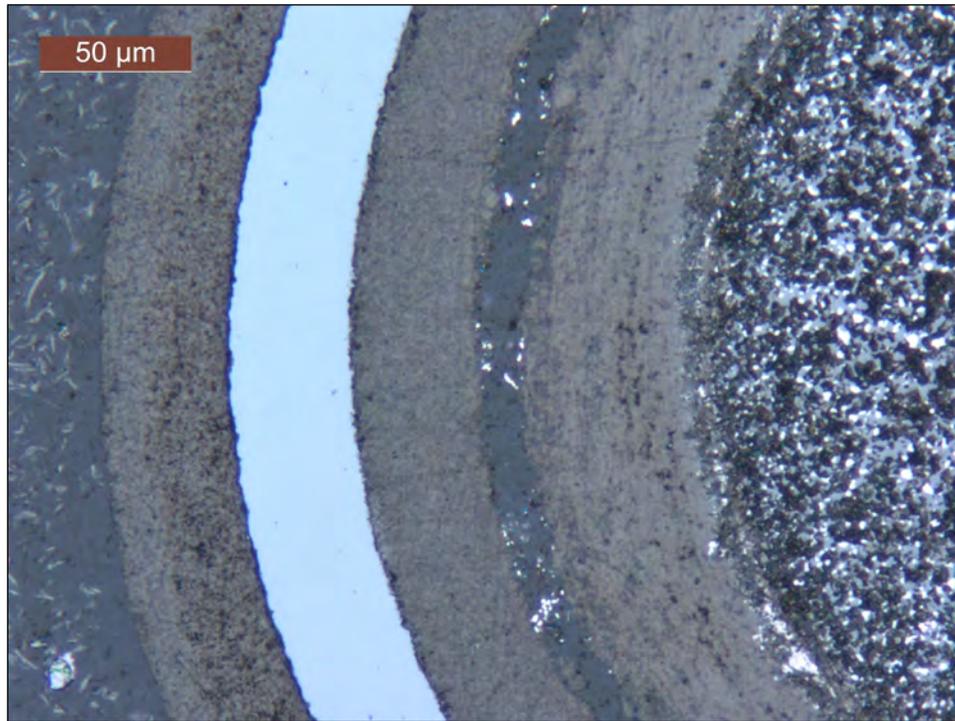
Two additional particles randomly-selected for IMGA measurement were ground and polished near midplane and imaged with optical microscopy. Particle 511-RS09 had an average radioisotopic inventory, except for ^{110m}Ag , which was below a detection limit of $M/C < 0.61$; this particle also exhibited the common buffer shrinkage causing delamination from the IPyC and narrow gap between the SiC and OPyC (Figure 21).

Figure 21. Optical micrograph near midplane of Particle 511-RS09 showing typical buffer shrinkage and delamination from IPyC. Backpot epoxy (gray) embedded with some bright fragments of kernel debris from the grinding process can be seen filling the gap between the buffer and IPyC layers. The apparent variation in porosity in the OPyC layer is a polishing artifact.

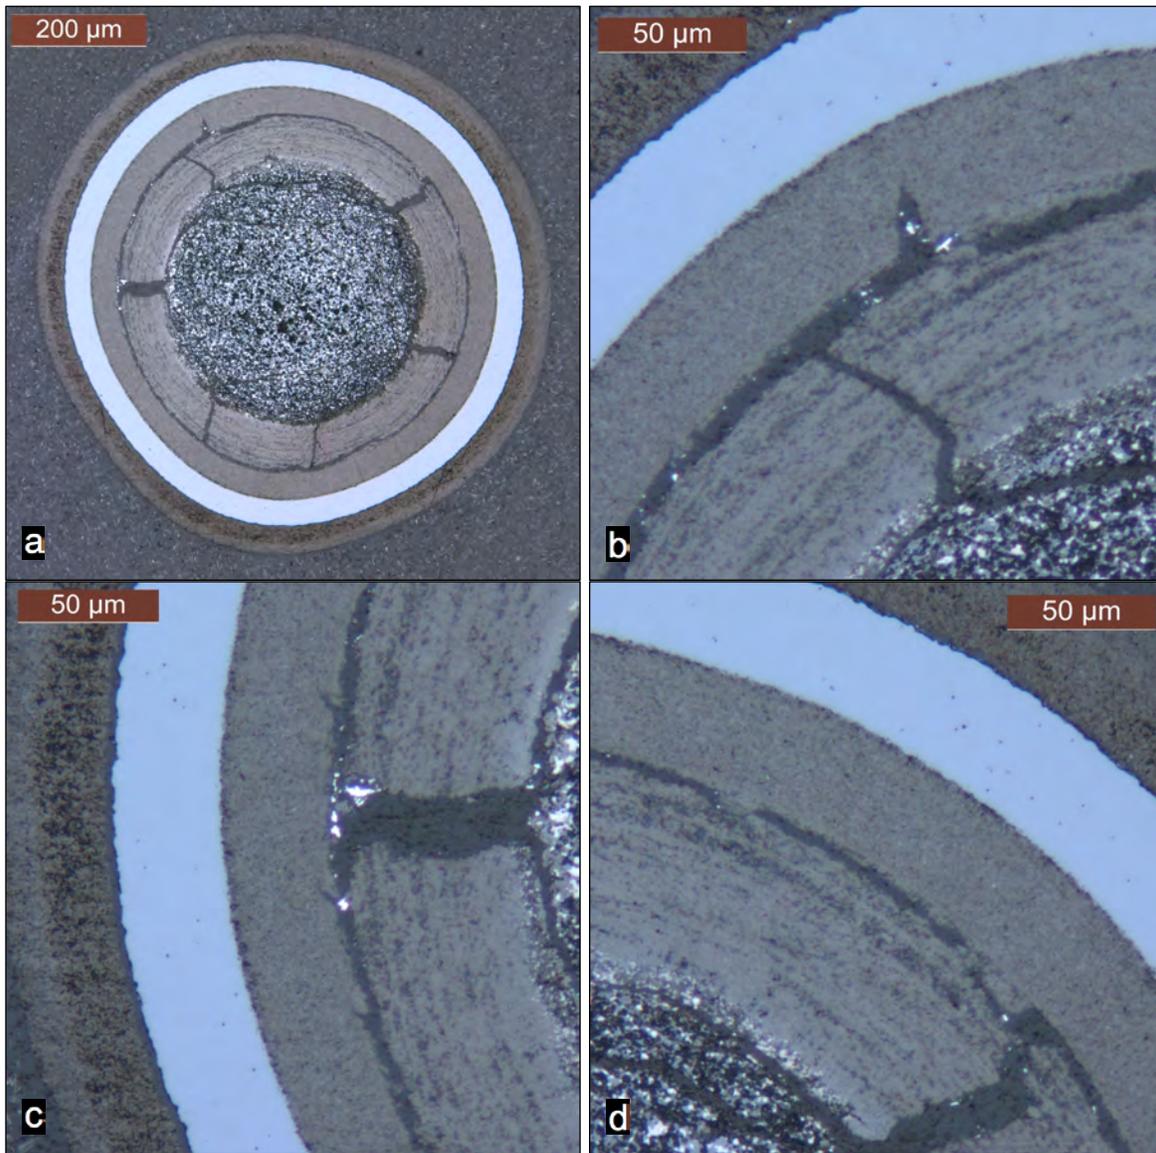
Particle 511-RS04 had an average radioisotopic inventory, including a ^{110m}Ag $M/C = 1.01$. Figure 22 shows that this particle had a different internal microstructure than the other randomly-selected particles that were analyzed by x-ray or optical microscopy. Particle 511-RS04 had multiple fractures in the buffer layer accompanied by apparent complete debonding from the IPyC (at least in the single observed polish plane). This structure has been observed in other AGR-1 particles, and has been labeled as Type Af [Ploger et al. 2012]. Figure 22b and Figure 22c show several locations where cracks have formed in the IPyC layer, which appear to have been caused by the buffer as it tore away from the inner surface of the IPyC. In this single imaged plane, the IPyC cracks do not penetrate through to the SiC. There is also no evidence of fission product pileup, which is often observed near IPyC fractures in particles with degraded SiC.

Figure 22. Optical micrographs near midplane of Particle 511-RS04 showing buffer fracture and some tearing in the IPyC that did not appear to penetrate the layer.

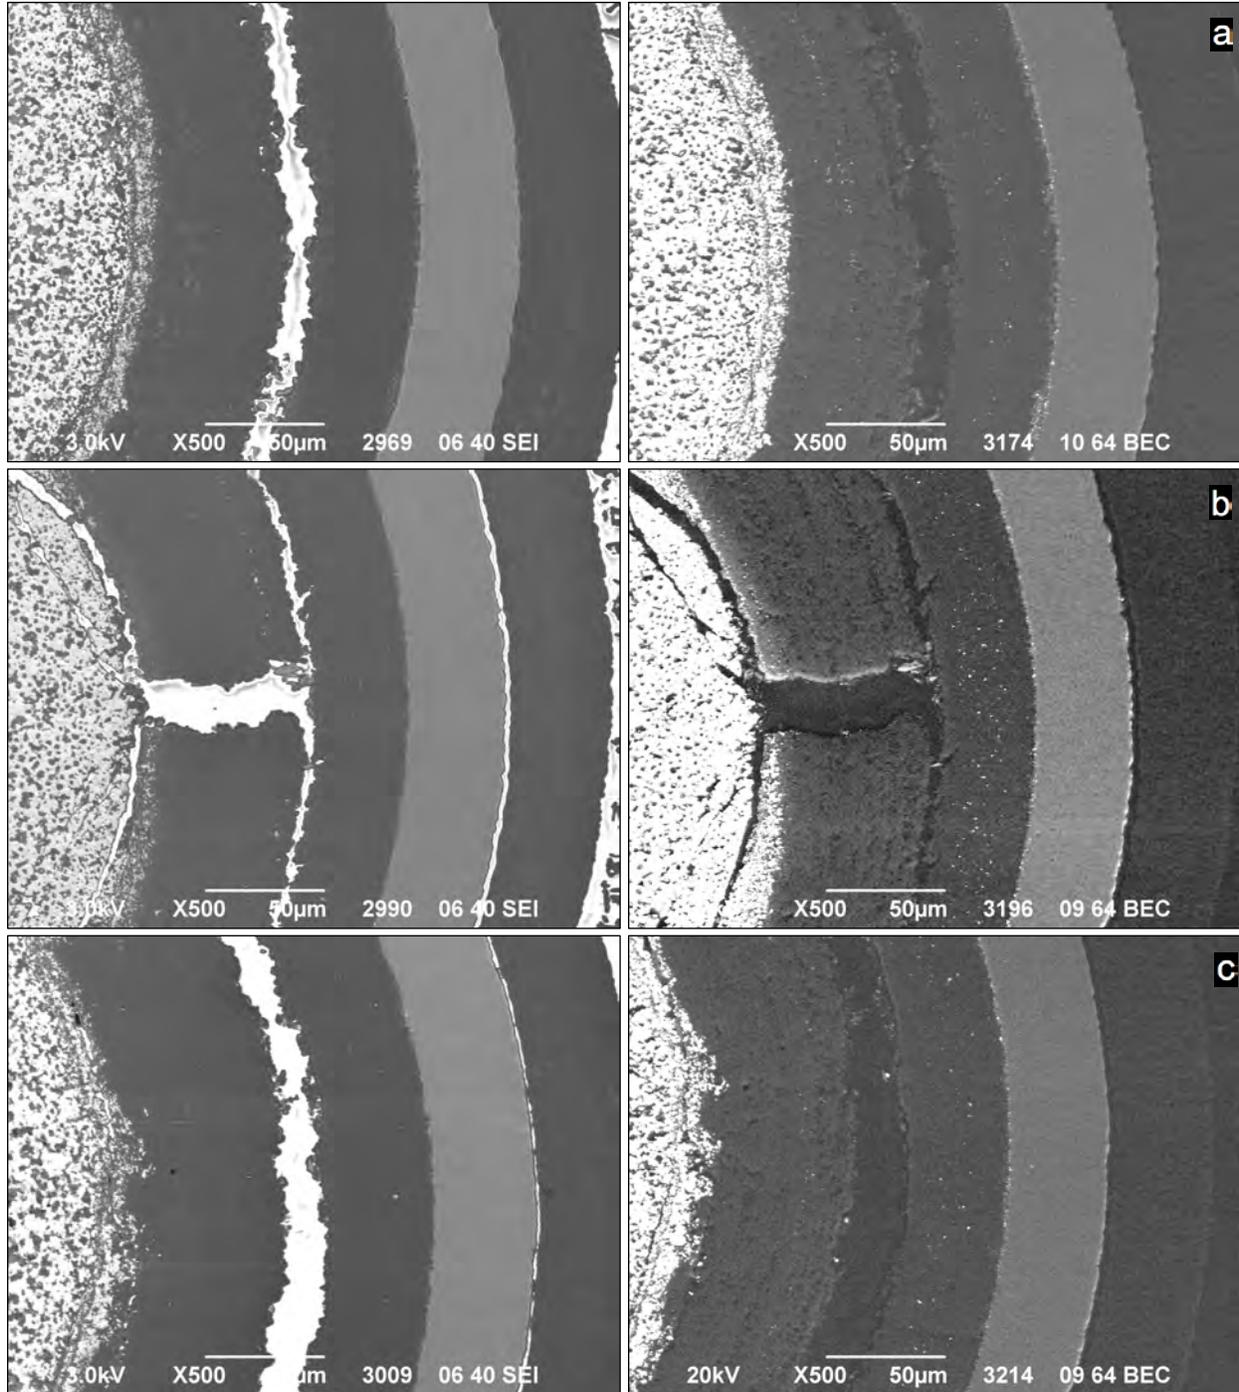
SEM analysis of randomly-selected particles was conducted on Particle 511-RS09 ($M/C < 0.61$), Particle 511-RS04 ($M/C = 1.01$), and Particle 511-RS37 ($M/C = 1.48$); these particles all had average radioisotopic inventories, but exhibited a variation in ^{110m}Ag retention behavior. The overview images in Figure 23 show fission product features segregated in the IPyC layer and piled up at the IPyC/SiC interface, this is consistent with previous observations from SEM analysis of other safety-tested particles [Hunn et al. 2014-1; Hunn et al. 2014-3]. Figure 24 shows parallel image sets of the SiC layer for these three particles. Fission product features are again observed in the IPyC and piled up at the IPyC/SiC (more obvious in the BEC images), while the higher magnification also allows for identification of fission product features isolated in the SiC layer. The SEI analysis indicates the surfaces are free of debris and the local high- Z areas are truly embedded fission product features. A qualitative assessment indicates a greater frequency of fission product features distributed in the SiC layer of the particle with the lowest silver inventory (511-RS09) relative to the other two particles, which retained most of their silver. Fission product features were also observed deeper in the SiC layer, near the SiC/OPyC interface, in the analysis of low-silver Particle 511-RS09. This trend for both higher concentration and observation of fission products throughout the thickness of the SiC layer in particles with low silver retention has been observed

throughout the AGR-1 PIE campaign and is discussed in [Hunn et al. 2014-4] for particles from compacts safety tested at 1600°C and 1700°C. It is worth noting that some variation in fission product concentration and distribution is also sometimes observed when comparing particles with high silver retention. Figure 24 shows that Particle 511-RS37 with the highest M/C value has more fission products in the SiC than Particle 511-RS04. Difference in fission product distribution in particles that have not yet released significant quantities of silver may simply indicate the progressive nature of the release.

Figure 23. SEI/BEC-paired images presenting an overview of the TRISO layers of a) Particle 511-RS09 ($M/C < 0.61$), b) Particle 511-RS04 ($M/C = 1.01$), and c) Particle 511-RS37 ($M/C = 1.48$). Bright contrast between buffer and IPyC is from charging of backpot epoxy.

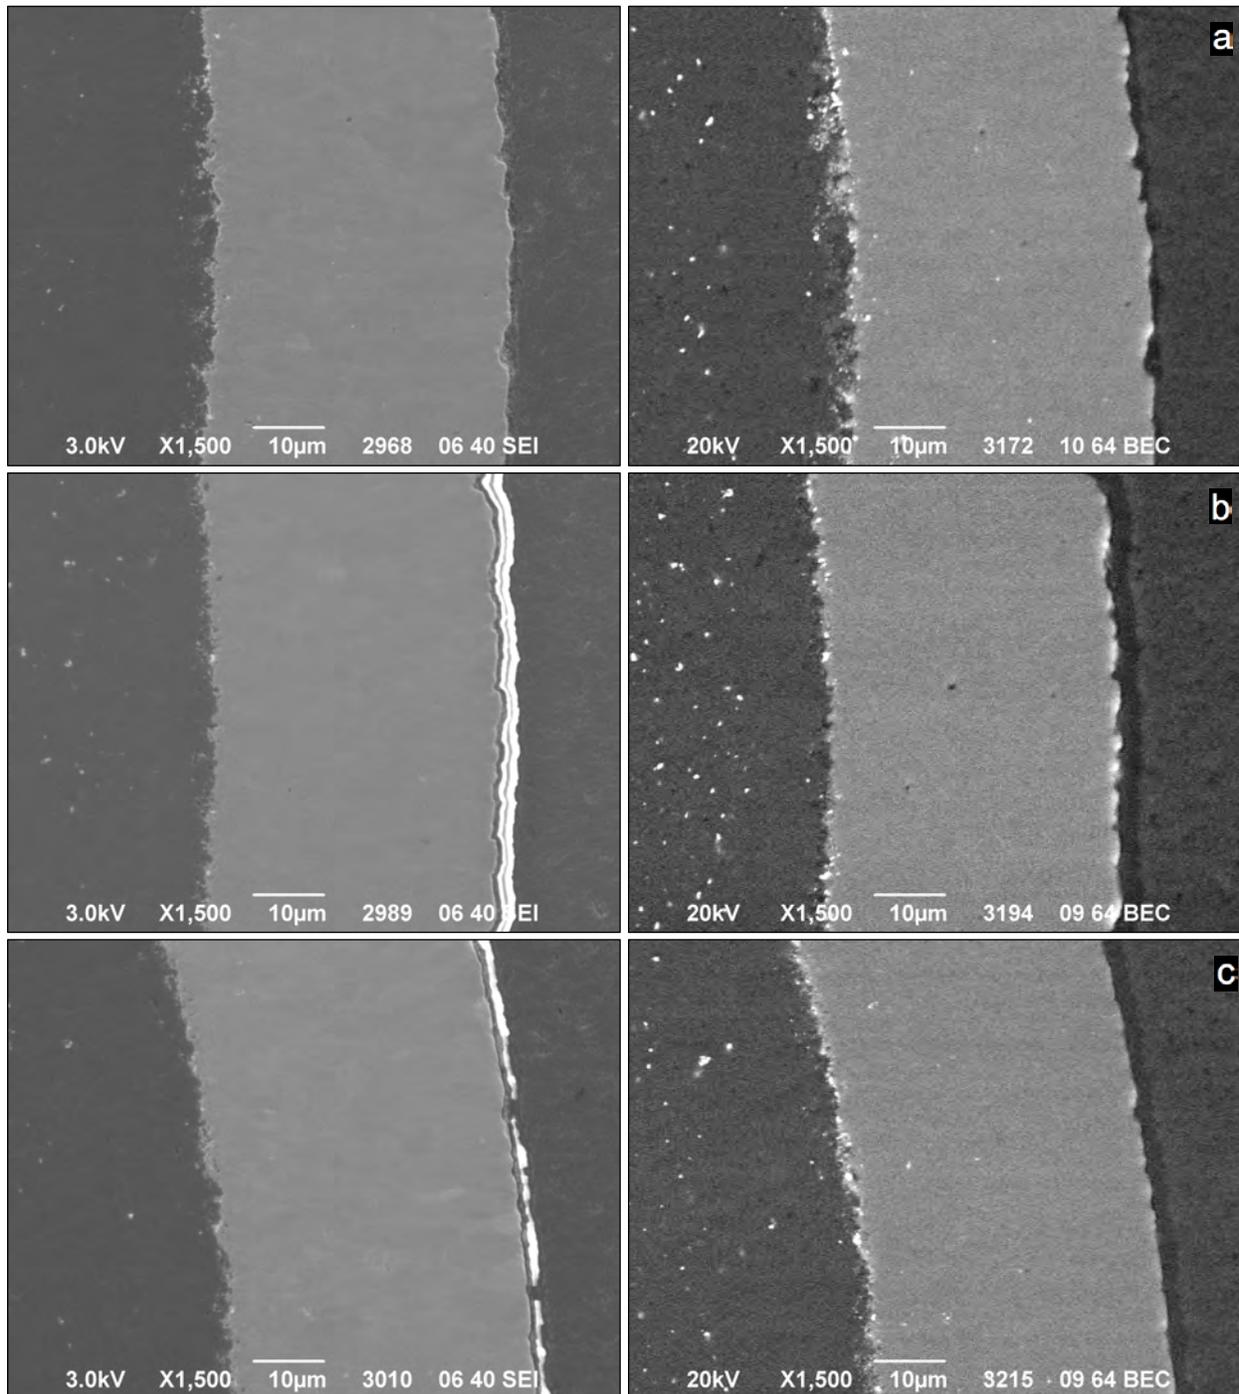
Figure 24. SEI/BEC-paired images of the SiC layer of a) Particle 511-RS09 ($M/C < 0.61$), b) Particle 511-RS04 ($M/C = 1.01$), and c) Particle 511-RS37 ($M/C = 1.48$).

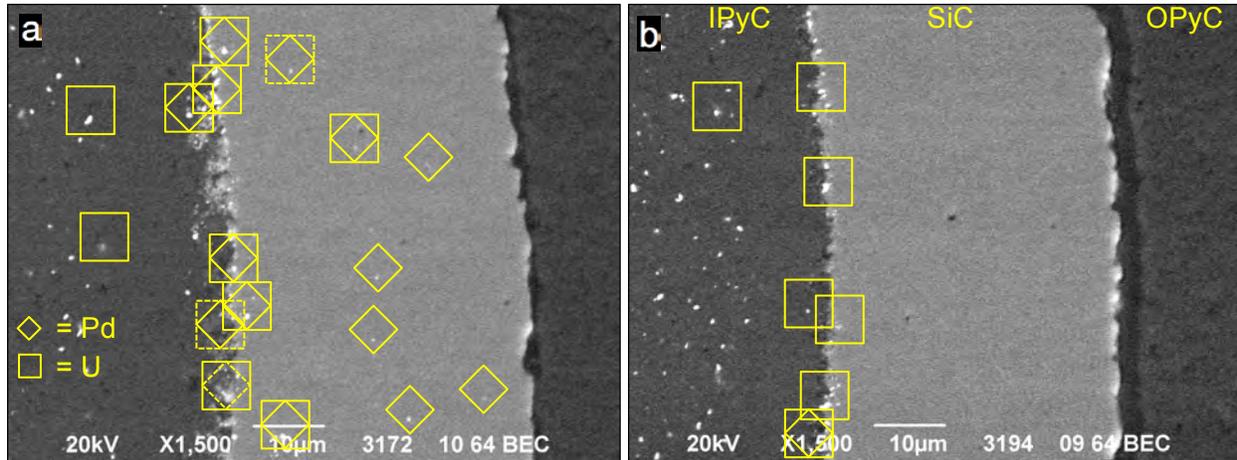
Elemental analysis was conducted on select fission product features in the IPyC and SiC layer. High-Z clusters analyzed by EDS are indicated in Figure 25 for Particle 511-RS09 and Particle 511-RS04, the composition of the features is indicated by diamonds (Pd) and squares (U), with dashed lines indicating relatively-lower peak intensity. In the high-Ag release particle (511-RS09), palladium was found in every analyzed cluster within the SiC layer. Uranium was often observed collocated with the palladium in the clusters less than $10\ \mu\text{m}$ from the IPyC/SiC interface and sometimes in features further out into the SiC. The IPyC/SiC interface features in Particle 511-RS09 contained both uranium and palladium, with relatively-higher uranium content than clusters in the SiC. Particle 511-RS04, which released little to no

silver, exhibited significantly fewer fission product clusters in the SiC. Limited quantities of palladium were observed, and features at the IPyC/SiC interface were almost exclusively uranium-bearing. This comparison further corroborates the trend for particles with low silver retention exhibiting significant differences in palladium and uranium distribution within the SiC layer and at the IPyC/SiC interface. Other elements (not shown) were sometimes observed in the analyzed features located in the interlaced region between the IPyC and SiC, or in spots in the IPyC layer away from the SiC.

Figure 25. Backscattered-electron composition micrographs showing representative IPyC/SiC regions from a) Particle 511-RS09 with high ^{110m}Ag release ($M/C < 0.61$), and b) Particle 511-RS04 with low ^{110m}Ag release ($M/C = 1.01$). Dashed diamonds or squares indicate relatively lower signal.
